ST PETER'S CHURCH, HEVER

REPORT ON THE CLEANING AND CONSERVATION
OF THE 17TH CENTURY WALL PAINTING

JUNE 2021

St. Peter's Church, Hever, Kent

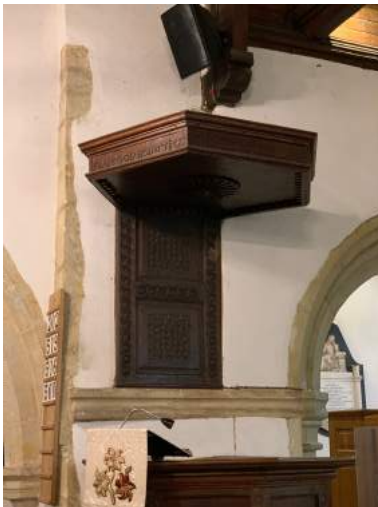
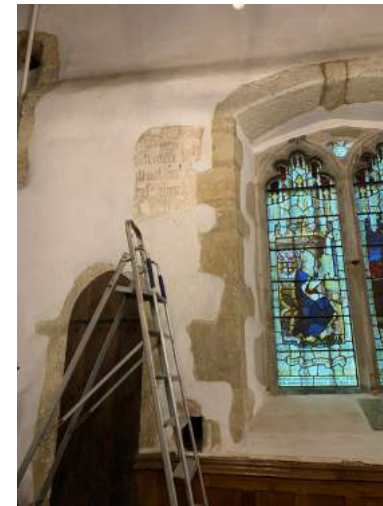
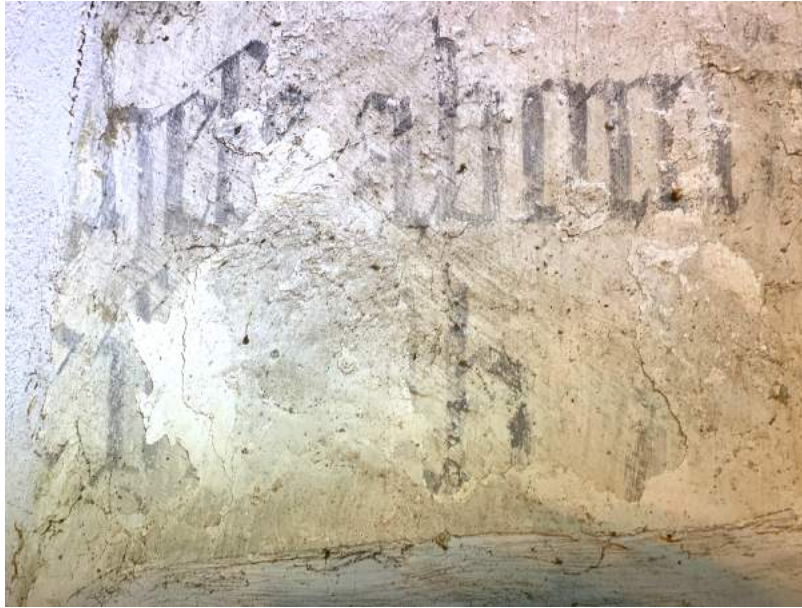
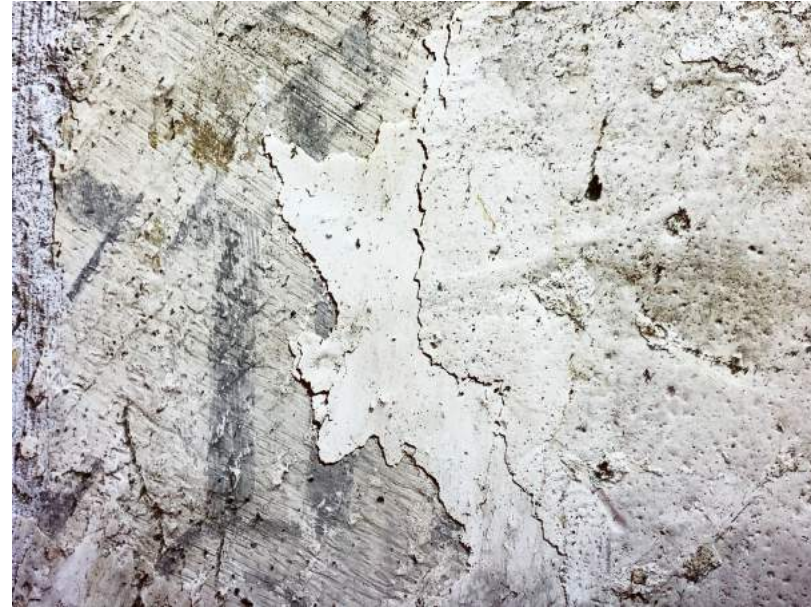
The surviving fragment of wall painting appeared to be in a relatively stable condition in most areas but there were a few areas of concern, most notably within the lower third, particularly on the lower left where it was evident that there had been some recent loss both of the limewash layer and the text – see *Condition Record on page 7*. The text was covered by accumulated dust and dirt and there were localised areas of plaster on the surface of the lettering. This is probably residual lime plaster from the 19th century restoration and extensive replastering of the interior. The black paint layer appeared to be only weakly bound and was rather powdery in places. The causes of the localised flaking and recent losses were not immediately apparent – i.e. there was no simple identifiable cause such as water infiltration – but were rather more likely to be the result of long-term issues. There is no evidence of any previous restoration work to the mural and it may be that the limewash layers have been in a weakened condition since the time that they were discovered behind the Jacobean pulpit in 1894.
