**Report on the Repairs
to the
Gillett and Bland Turret Clock
at
St Mary's Church
Woodchester Gloucestershire**

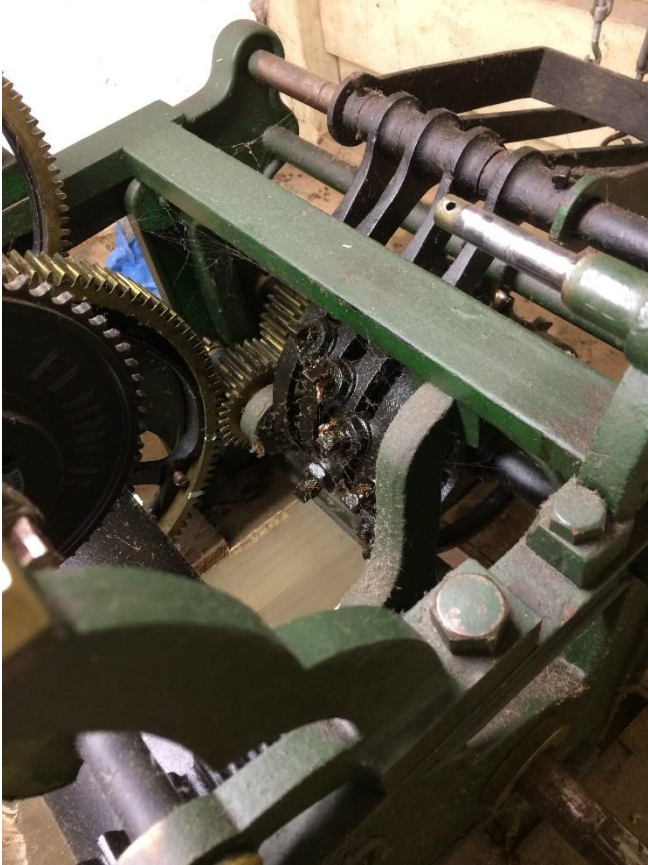
Figure 9

The wheels and pinions on all trains although dusty, dirty and suffering from some dried or congealed oil deposits between their teeth, leaves and trundles, were in good mechanical condition.

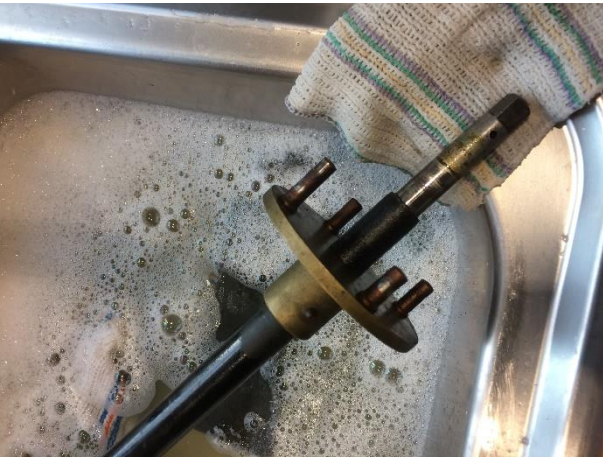
Figure 14

Where minor surface rust was present, these parts were individually soaked in a solution of 50ml of Alcohol Ethoxylate 2-Aminoethanol per 1 litre of deionised water, the rust then being gently removed with Liberon Ultrafine 0000 grade wire wool or ultra fine aluminium oxide sanding pads. The arbors were dried by hand, rinsed in pure turpentine and then fully dried using a hot air bench dryer.

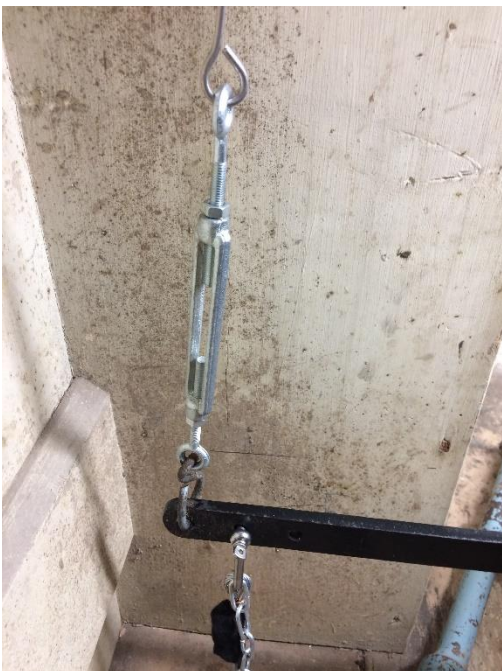
Figure 24

The chime hammers were checked and their adjustment nuts and securing mounts checked for tightness. The No.3 bell hammer was bent, and this was straightened out. The 'S' hooks were all in good condition and were reused.

All necessary adjustments were made to the new rods with hammers carefully checked for the correct pull-off, at rest and striking positions. New adjustable tensioners with integral lock nuts have been fitted between the wires and clock hammer lifting levers to facilitate any future adjustments.

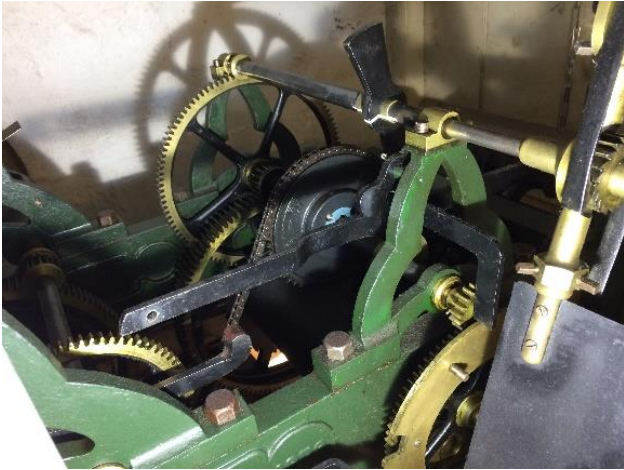
Figure 25

The old automatic winding system was driving each of the three trains of the clock from their 3rd wheels and not their main barrels. **Figure 26** illustrates the drive sprocket and chain mounted on to the 3rd wheel of the quarter chiming train.

The current guidance requires that the drive to the clock must be to the great wheel or barrel assembly (referred to as main barrel automatic winding). In other words, as the clock would have been originally driven if the weights were still being wound by hand. This is because gearing in clocks is designed for a large wheel to drive a smaller pinion. Driving a large wheel from a smaller pinion can result in abnormal wear on pinion leaves and wheel teeth, or if a jam occurs, the possibility of broken leaves and teeth.
