## **St Mary's, Nettlecombe, Somerset (Diocese of Bath and Wells)**

**Effigies attributed to Sir Simon, Sir John and Maud Raleigh**

### **Conservation and Relocation Report**

**February 2022**

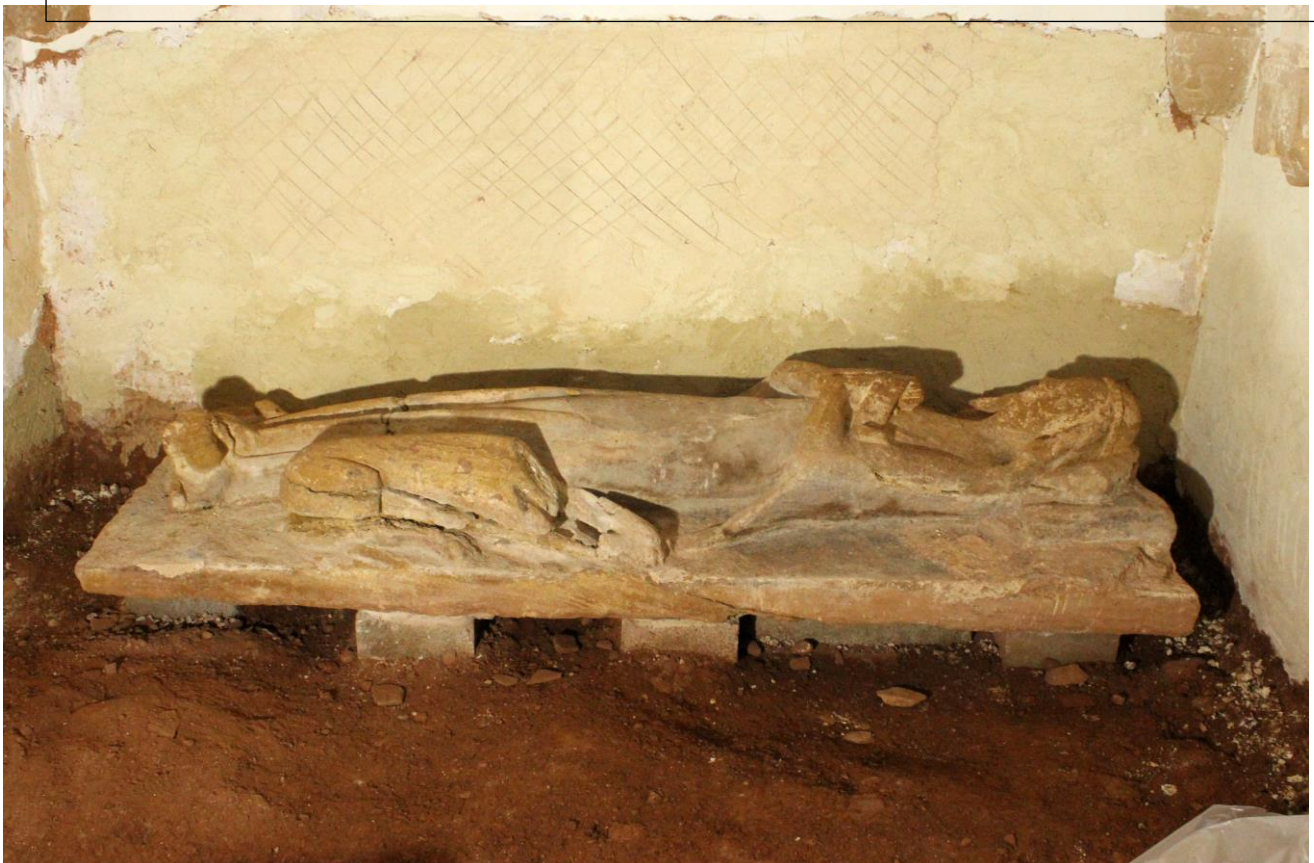
Plate 32: the effigy removed in two sections: upper fragment

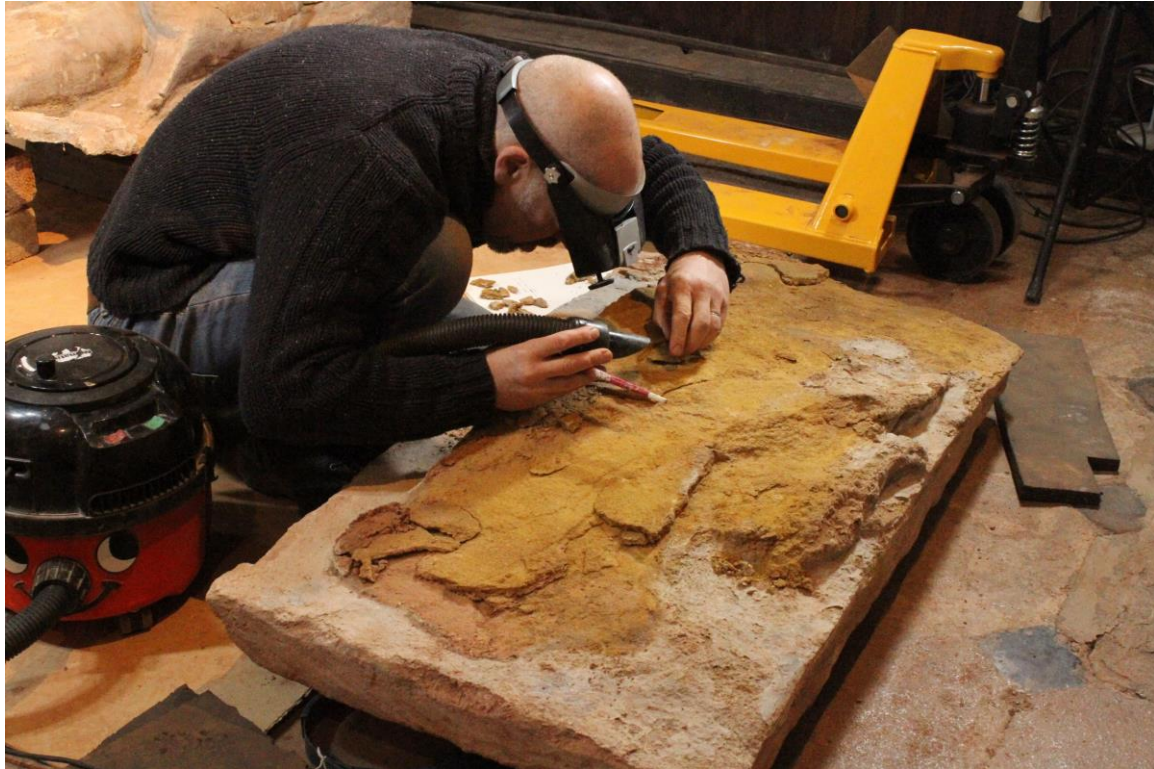
Plate 34: repairs to stone in progress

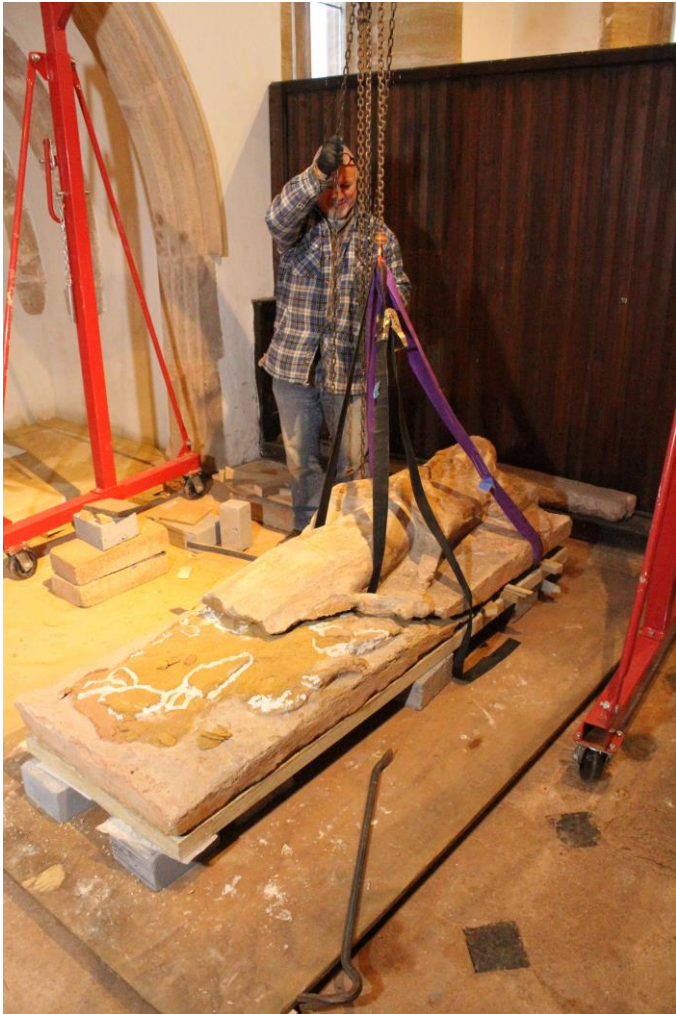
Plate 36: the effigy being reassembled with lifting gear

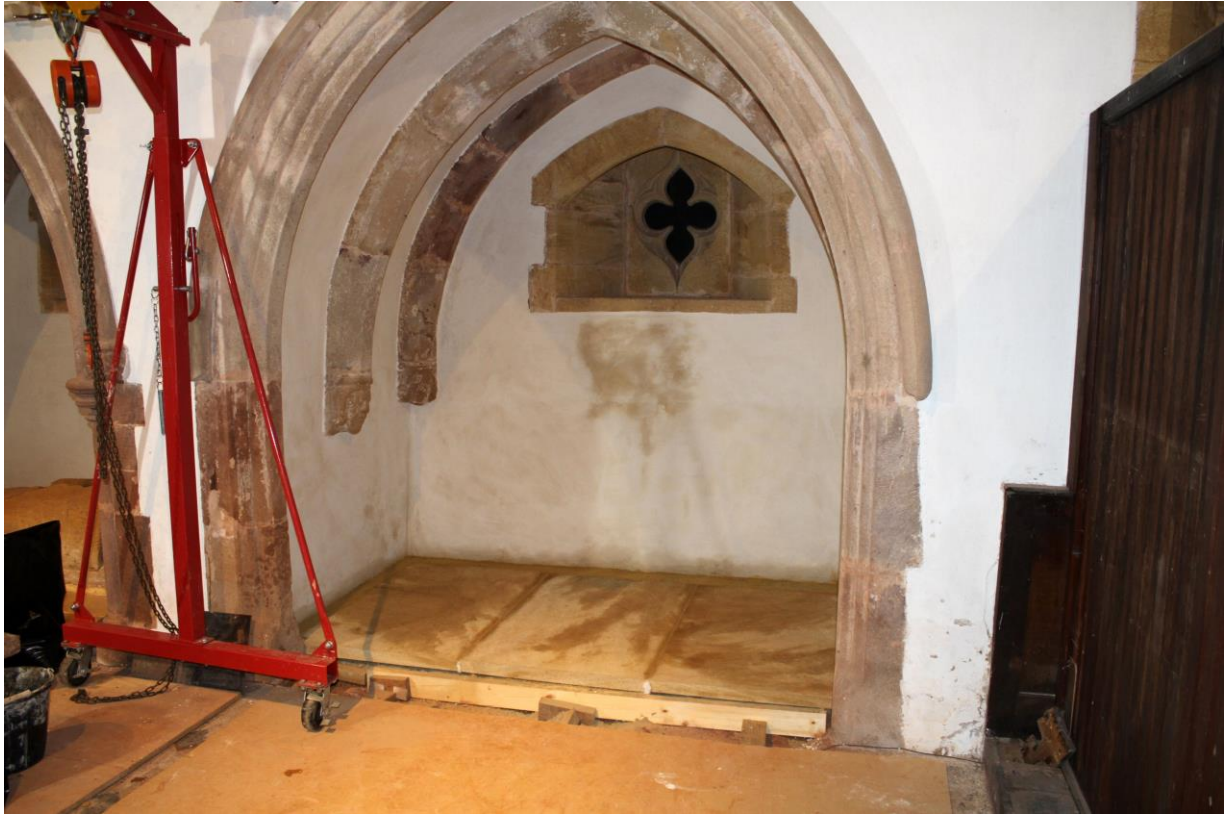
Plate 38: New Ham Hill stone floor laid and recess re-plastered and limewashed

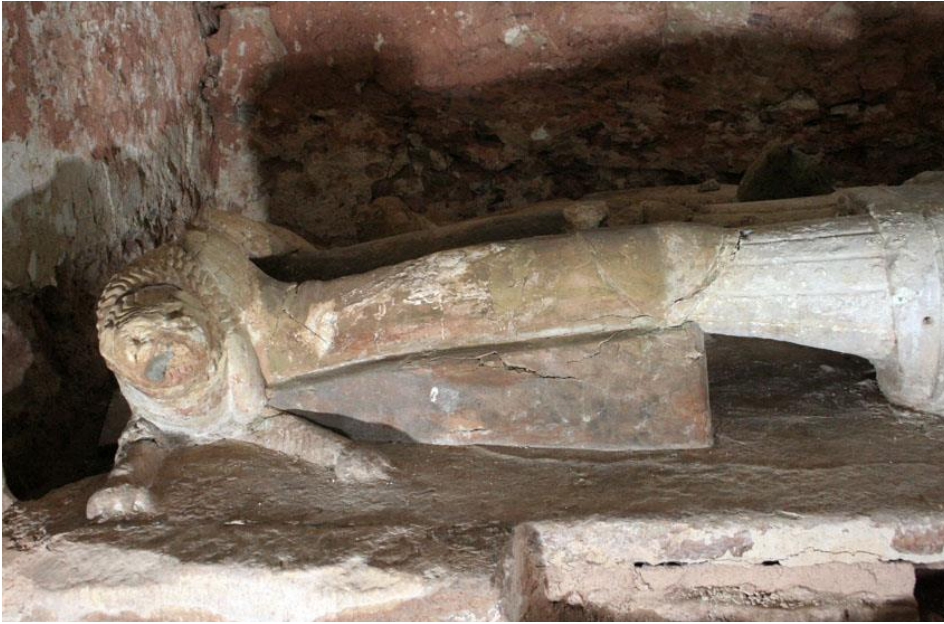
Plate 50: leg repairs to Sir John, side view
