Ledbury Surveys Ltd

Refurbishment/Demolition Survey

All Saints Church
Worcester
WR1 2HN

Ledbury Surveys Ltd has undertaken a Targeted Refurbishment / Demolition survey at All Saints Church, Worcester, WR1 2HN

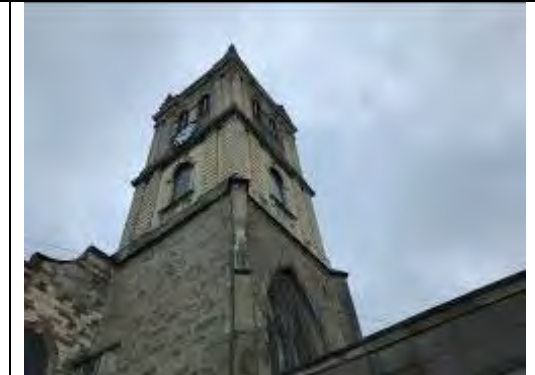
Tower no access above Ground Floor

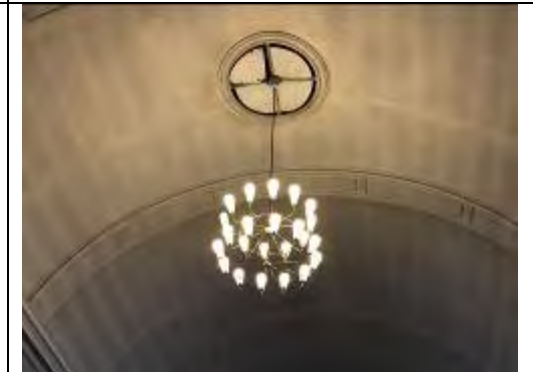
No Access to check boards to light fitting due to height

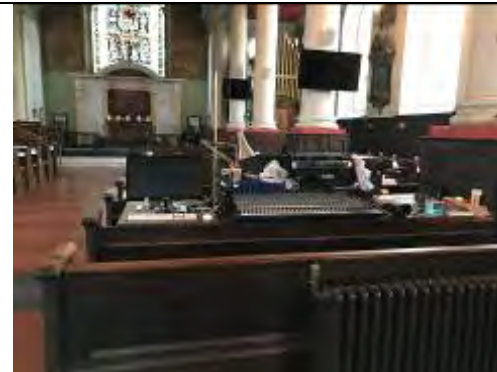
Non ACM radiator

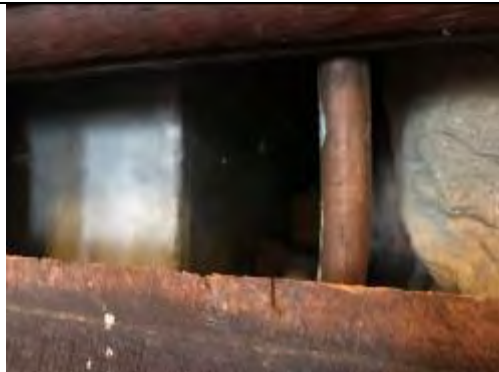
Stone and timber behind. No suspect ACMs

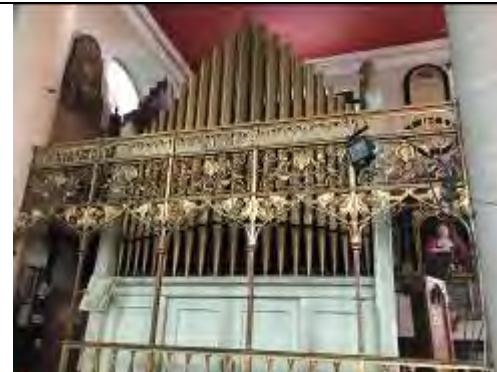
Presumed asbestos insulation board to
blower box
Crocidolite

It is recommended that all asbestos containing materials are removed prior to refurbishment work. The asbestos containing materials identified are licensable and their removal can be undertaken by an unlicensed asbestos contractor.

It is recommended that the asbestos containing materials are labelled and monitored in accordance with CAR 2012 if they are to be left for more than 3 months.

It is recommended that any removal of ACMs is undertaken by a licensed contractor and disposed of as Hazardous Waste in accordance with the Hazardous Waste (England) Regulations 2005. All of the remaining ACMs should be labelled and monitored on a regular basis.

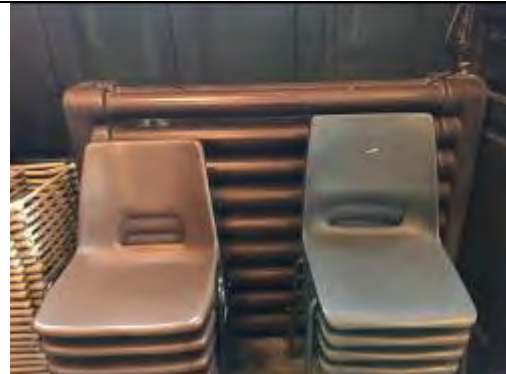
Non ACM radiator

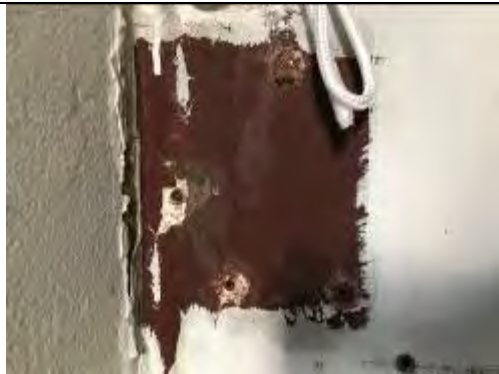
Plaster on solid walls

Plaster to be repaired

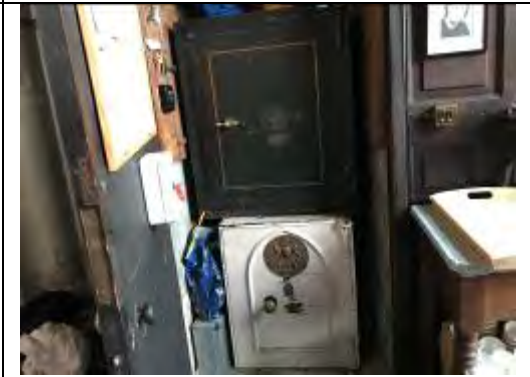
Presumed asbestos insulation board laminate to safes
Crocidolite

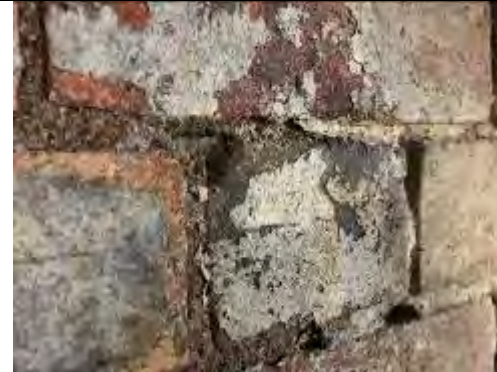
Boiler Room

Debris to walls
ASC/5
NADIS

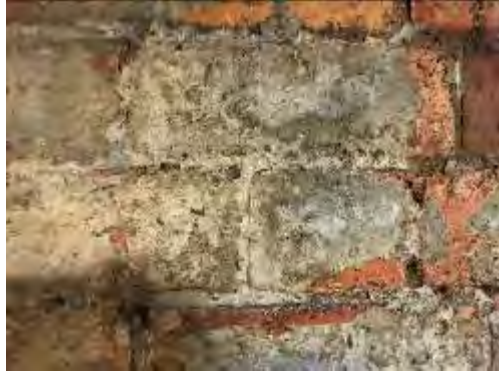
Debris to walls
ASC/5
NADIS

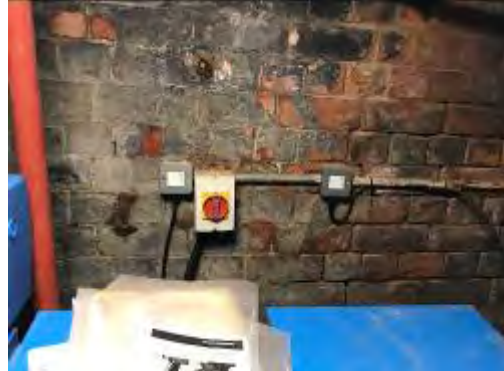
Debris to walls
ASC/5
NADIS
