**THE BLESSED VIRGIN MARY CHURCH, CLOFORD SOMERSET**

**Post Treatment Report for  
The Conservation of The Horner monument  
The Blessed Virgin Mary Church, Cloford, Somerset**

**Job No. 2601**

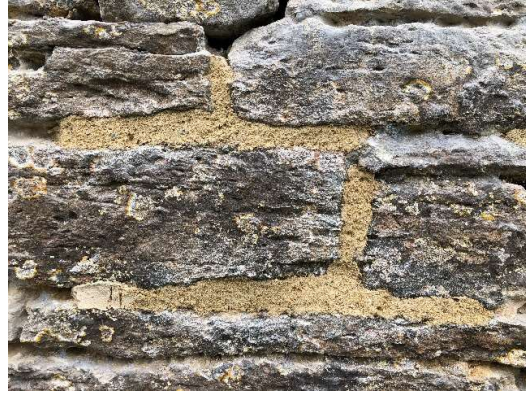
Figure 5 Mortar sample cool buff

Five samples were made as small tiles and then transferred to the wall to be assessed.

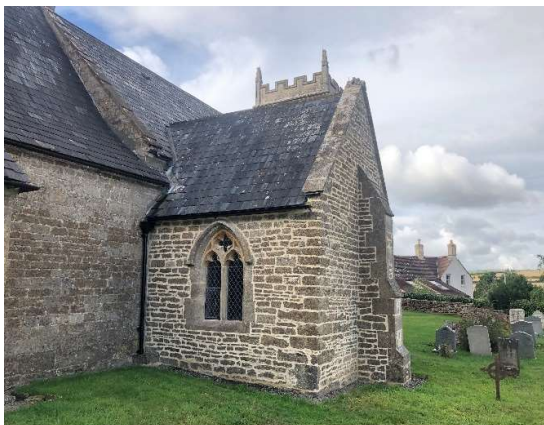
Figure 9 New pointing on the east wall

Following the removal of the historic mortars, the walls were prepared for the application of a lime mortar, any fragmented or damaged stones were replaced, and the chapel was repointed with a 1:3 lime/sand mix and tended accordingly.

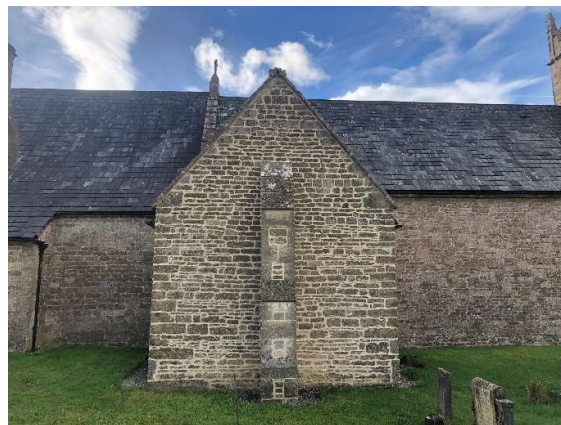
Figure 10 New pointing on the north wall

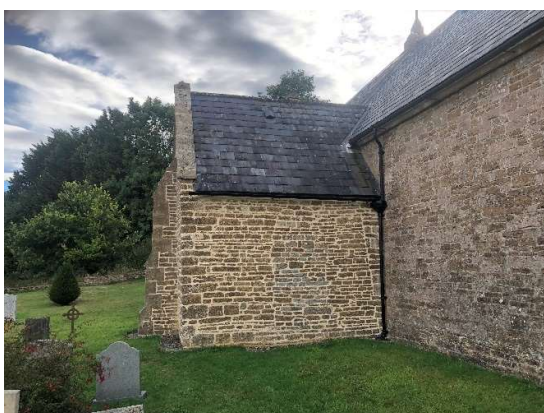
Figure 11 New pointing on the west wall

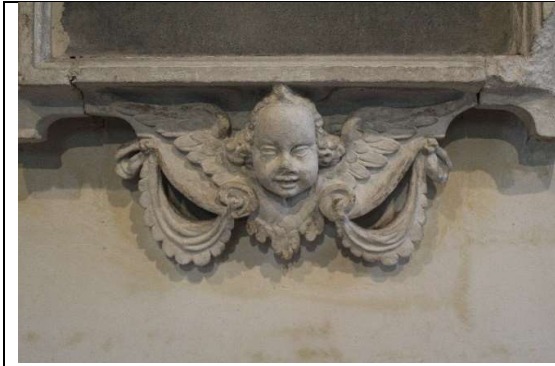
Figure 24 Before uplifting and limewashing the walls

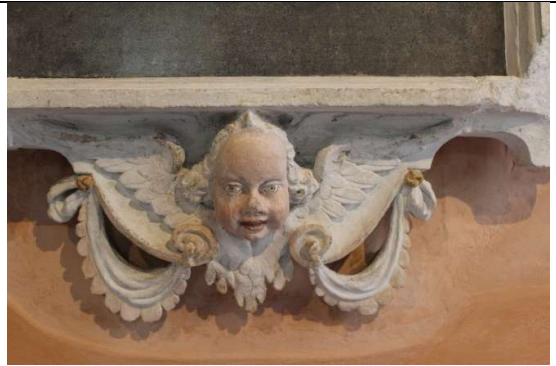
Figure 25 After uplifting and limewashing of the chapel walls

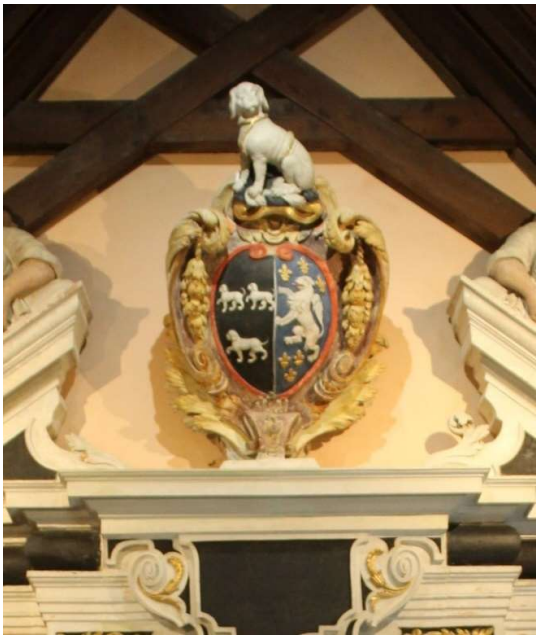
Figure 29 The crest finished with the pink limewashed wall behind

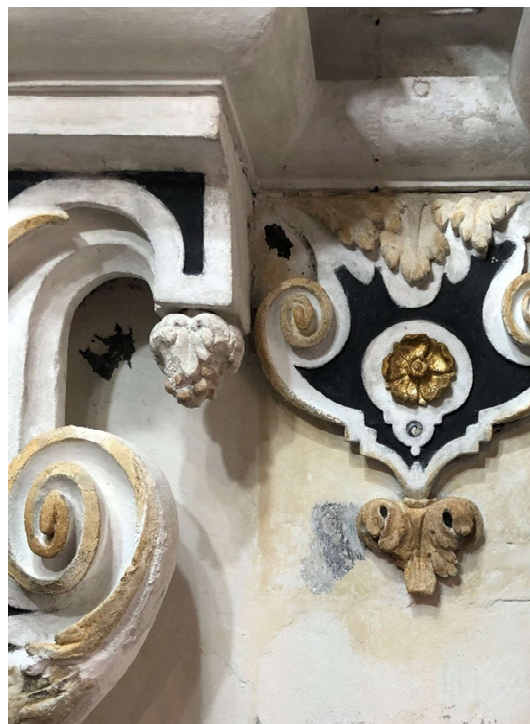
Figure 57 Sinister grape and leaf embellishment fixed in place

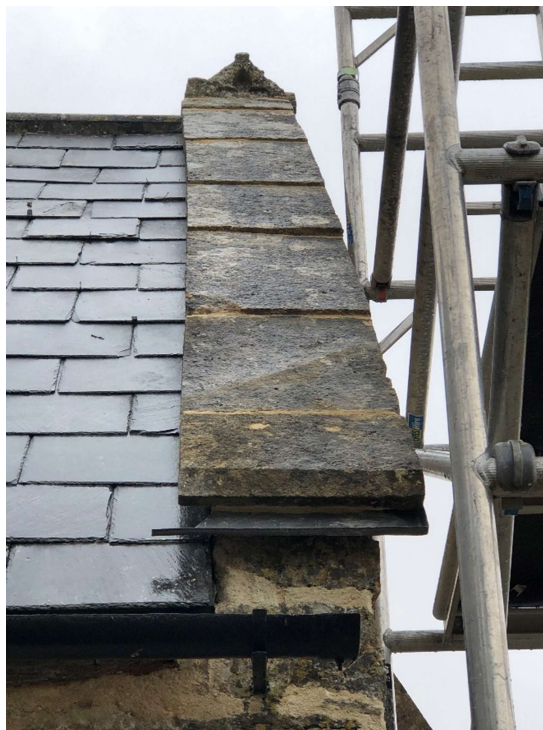
Figure 69 The east coping 45 degree cut in the wet; note how the coping is wetter above the cut.

- 45-degree angle cut – installed to move the rain run-off on to the slate roof and into the gutter before it reaches the end of the coping. The effectiveness of the 45-degree cut made in the east side copings strengthens the case for deciding to implement this cut into the west coping.
- Lead tray - built into the joint beneath the kneeler to catch any drips. These drips are then channelled again onto the slate roof and into the gutter below. Very heavy rain will shoot over these interventions and should clear the base of the chapel.

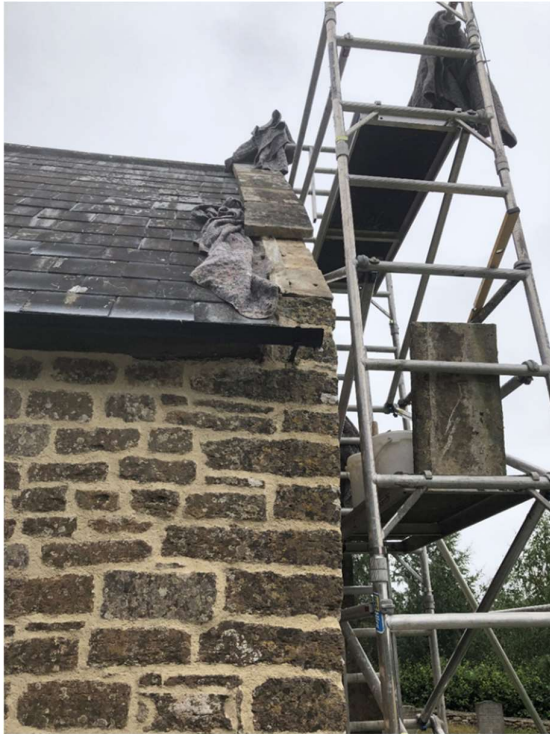
Figure 71 The east side copings being lifted

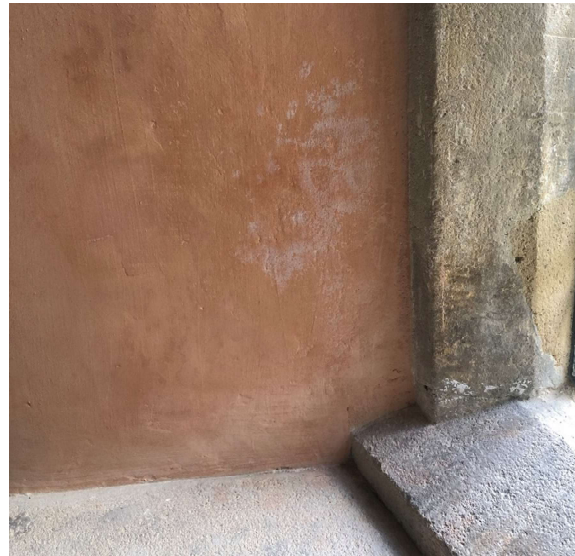
Figure 84 Salt formation on original lime plaster over the new limewash north corner of window; September 2022

As in 'The Condition Survey & Recommendations report 2020,' carried out by SSHC; a French drain was recommended to alleviate this problem, this solution would be recommended again.

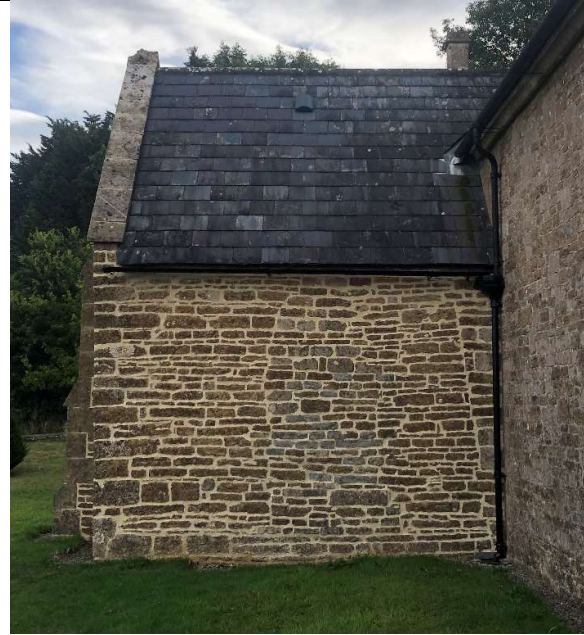
Figure 86 The current view of west wall of chapel, new pointing revealing historical interventions

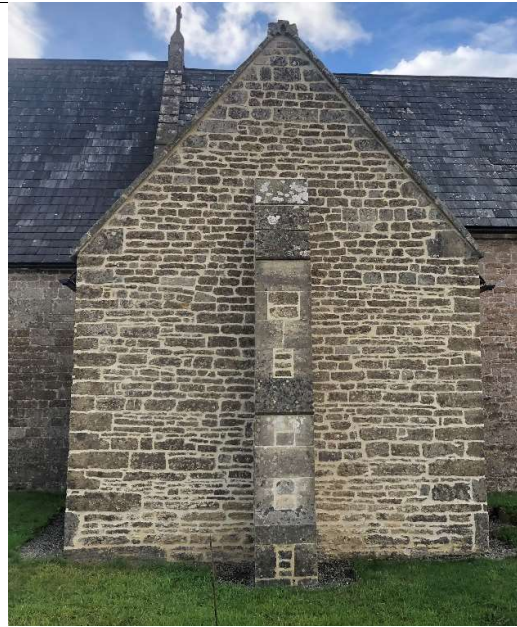
Figure 88 The current view of north wall of chapel, new pointing revealing historical interventions

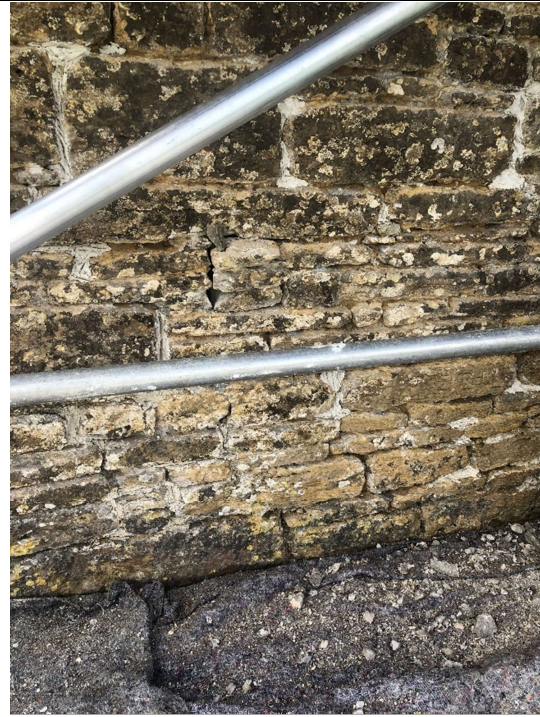
Figure 89 Exterior north-east lower putlog hole

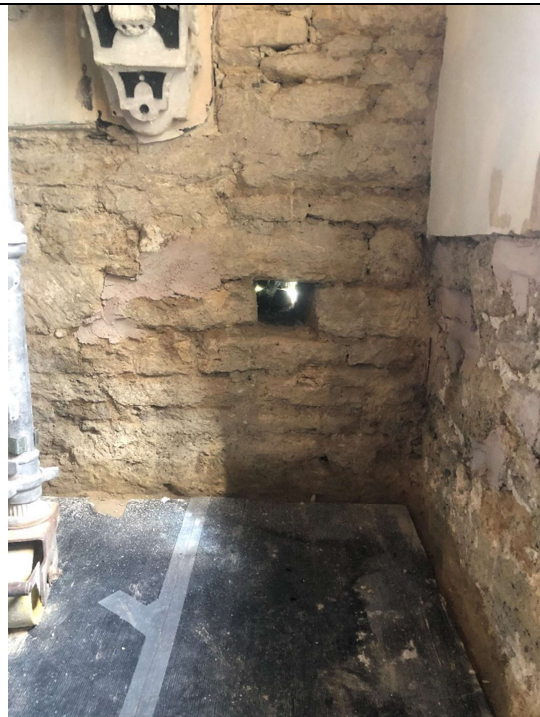
Figure 92 Interior north-east lower putlog hole
