ST. MARY'S CHURCH, THORNBURY, GLOS.

CONSERVATION TREATMENT REPORT OF THE WALL PAINTING  
FRAGMENT

ON THE SOUTH WALL OF THE NAVE.

JANUARY 2023

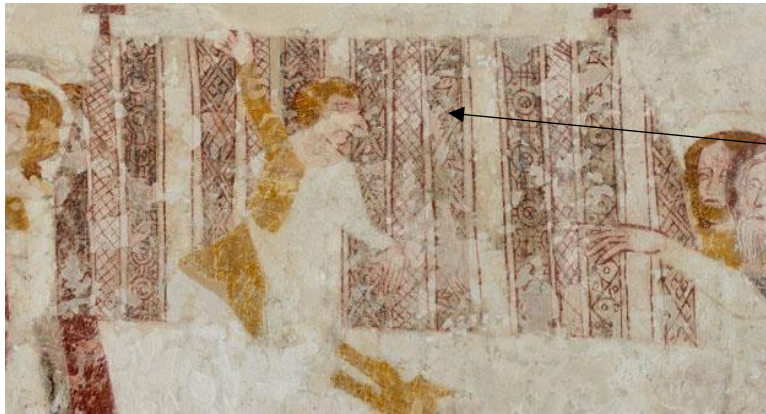
**Fig. 2**

*Chalgrove Church*

*Detail from wall painting of the burial of the virgin showing an elaborately patterned pall with diaper designs*

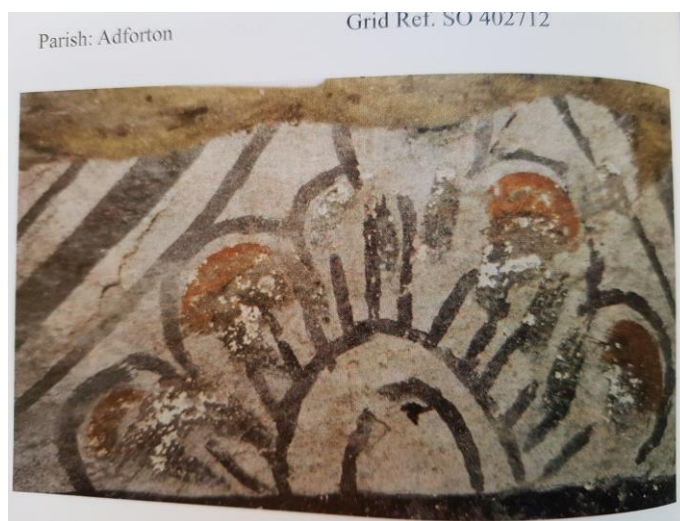
**Fig. 3.**

*Bank Farm, Adforton.*

*Typical 16<sup>th</sup> century half floral ray set within a diaper design<sup>3</sup>.*
