Nether Alderley Parish Hall, Nether Alderley

Design and Access Statement,
including a Heritage Impact Statement

August 2020

Report on
Structural Inspection
at
Nether Alderley
Parish Hall
for
Lloyd Evans Prichard
on behalf of
The PCC of St Marys
Nether Alderley

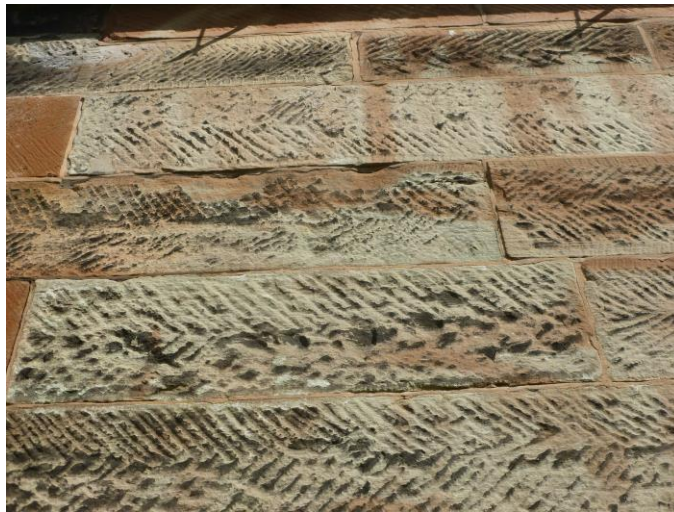
4. Figure 10 shows chevron pattern to the hall elevations; this is an evidence of the quality of craftsmanship applied to the building. This unusual detailing is not found to the other elements of the parish hall. The 19th century additions are considered to be of moderate significance.

Figure 10 : Chevron pattern to the hall masonry wall

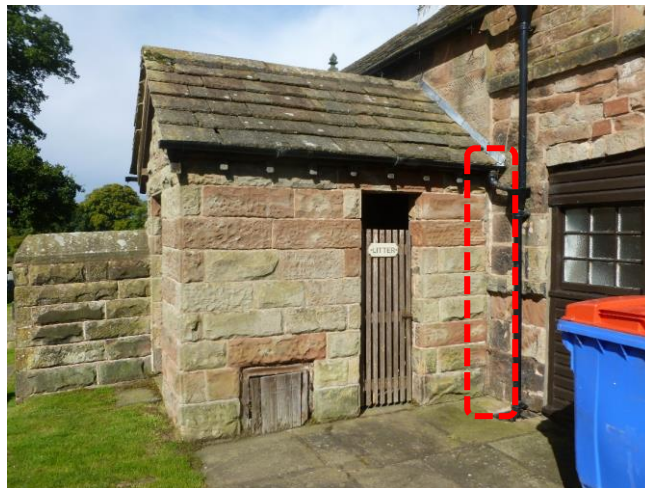
5. The fuel store block was built in 20th century and the exact date is unknown. It is deemed to be a negative addition to the building. It is connected to the 19th Hall and toilet block but has an uncomfortable relationship to them as it cuts across a window opening to the hall. It is not

keyed into the existing building and is moving away from them. Its removal will cause no harm or damage to the fabric of the earlier buildings.

Figure 11: Store Block. See figure 12 for details of highlighted area.

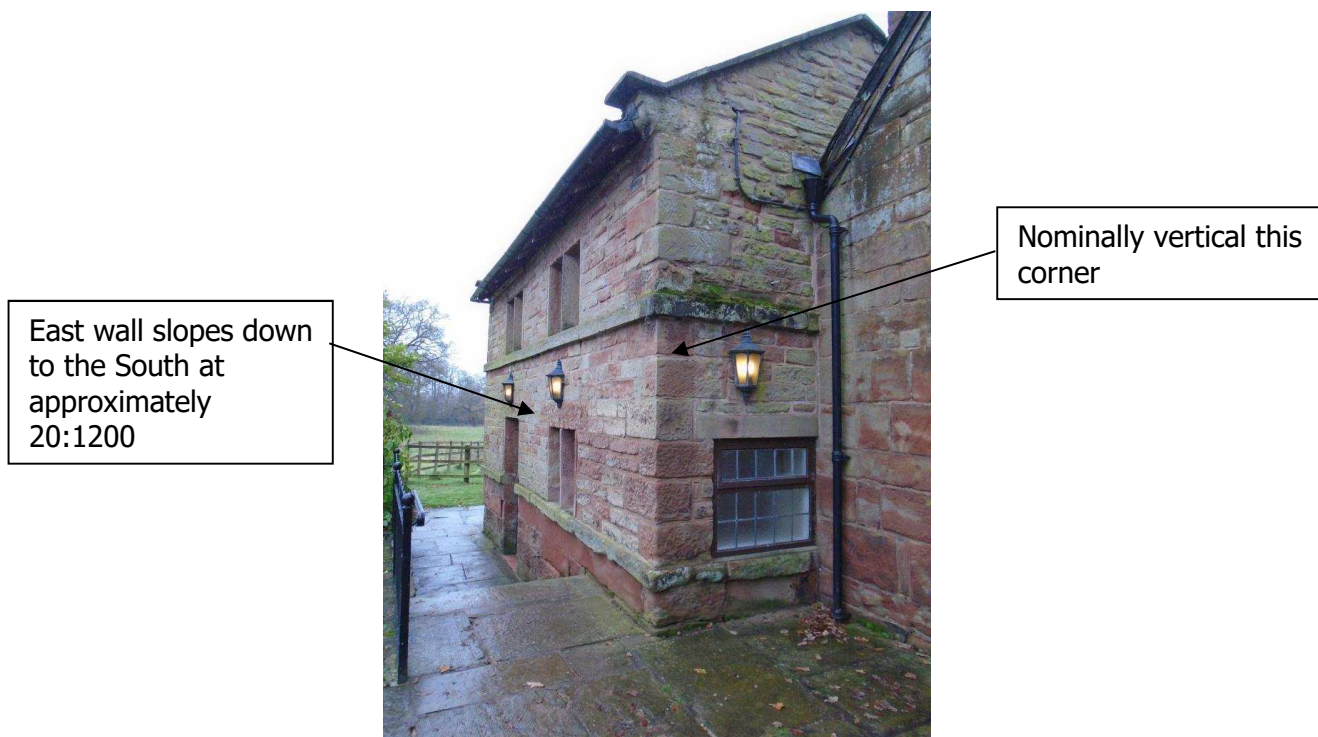
- 3.5 North East corner masonry is nominally vertical in both directions – gable pike wall appears nominally vertical.
- 3.6 Main East elevation appears to be as original with window and door openings formed with flat stone lintels approximately 300mm high and projecting cill / string courses approximately 150mm high. A number of relatively new stones (or stone face repairs) are present below the ground floor cill level and the pointing generally appears relatively recent.

Photograph 1
WC Block North East Corner

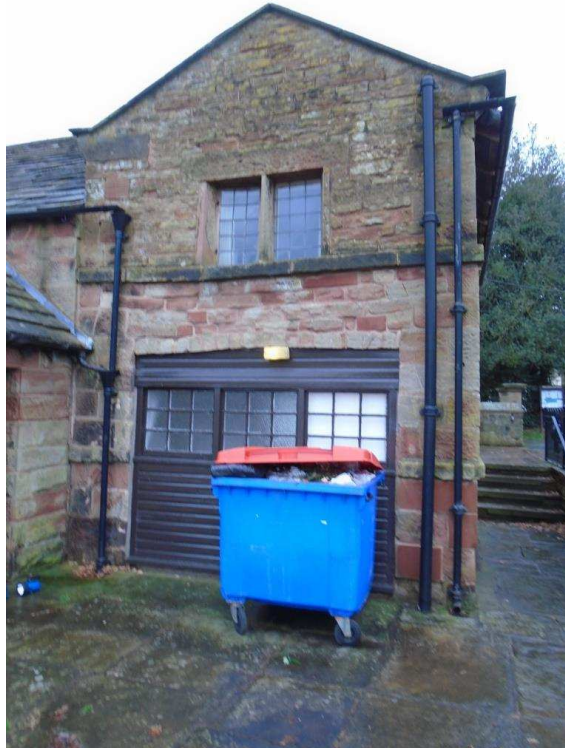
- 3.7 The South elevation appears to be mainly original above the first floor cill and there are a number of weather eroded sandstone facings. Much of the ground storey has a glazed timber infill panel (previous vehicle size opening) and the surrounding masonry appears to have been part repaired plus rebuilt above the opening up to the first floor cill.

- a) The wall plane tilts out at the top towards the South at approximately 20:1200.
 - b) The first floor cill / string course has a dip that is centred at the left hand side of the window opening. There is cracking and repaired cracking to the sides of the window opening.

Photograph 3
WC Block South Elevation
Glazed Timber Infill to Ground Floor

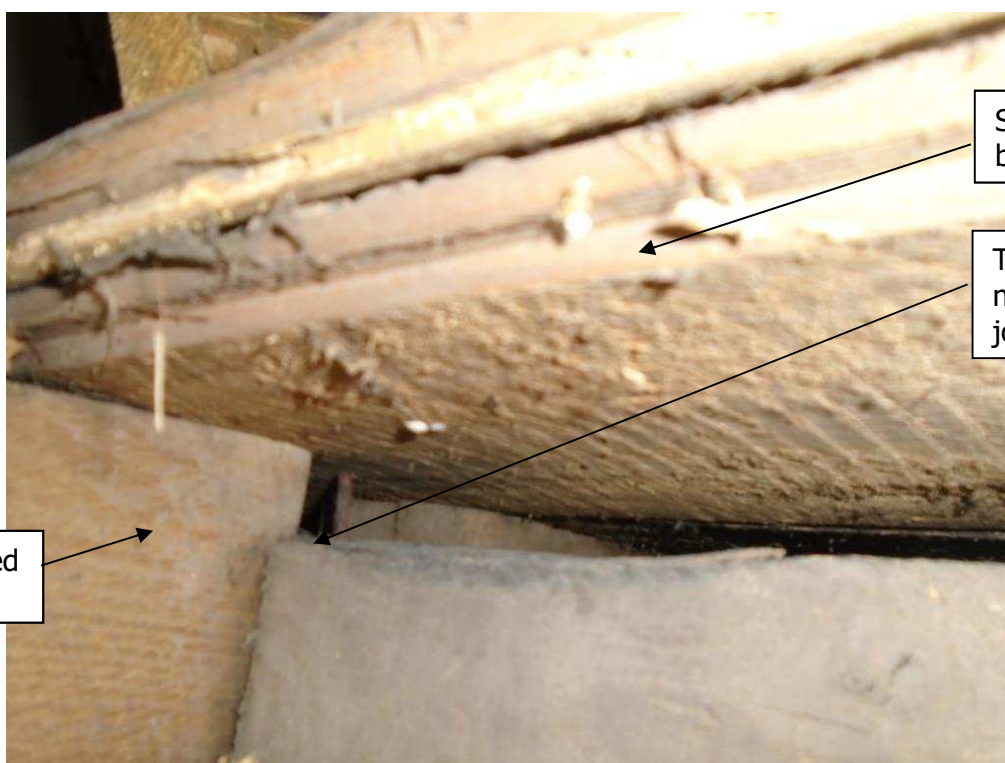
b) One small piece of floorboard was loose and could be lifted. This was close to a beam and showed the joist jointing arrangement. The floor timbers appeared to be in good condition mid span.

Softwood floor board

Top of oak beam notched for joists

Oak joist housed into oak beam

Photograph 10
WC Block – First Floor Construction

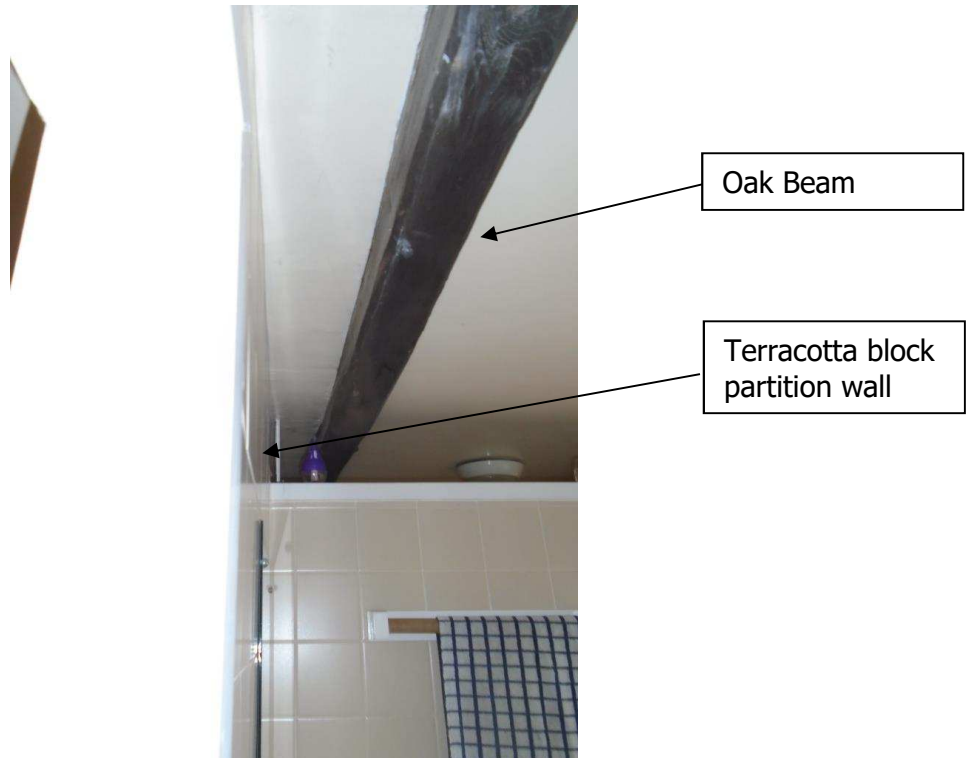
Photograph 11
WC Block – Ground Floor
Downstand of Oak Floor Beam

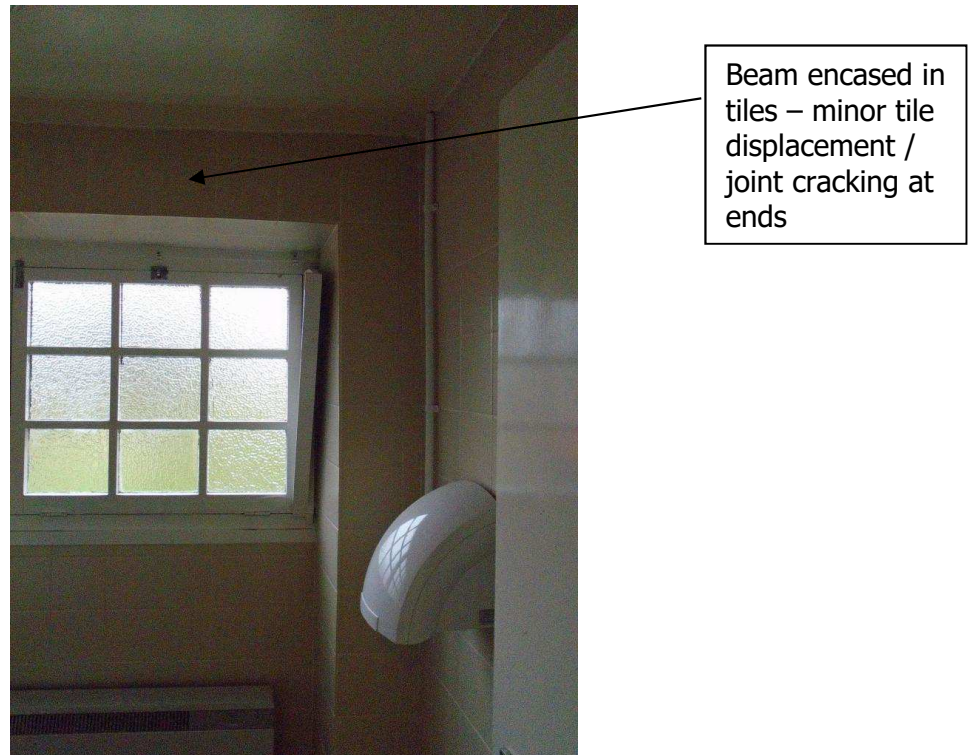
Photograph 12
WC Ground Floor – South End
Glazed Timber Frame Infill

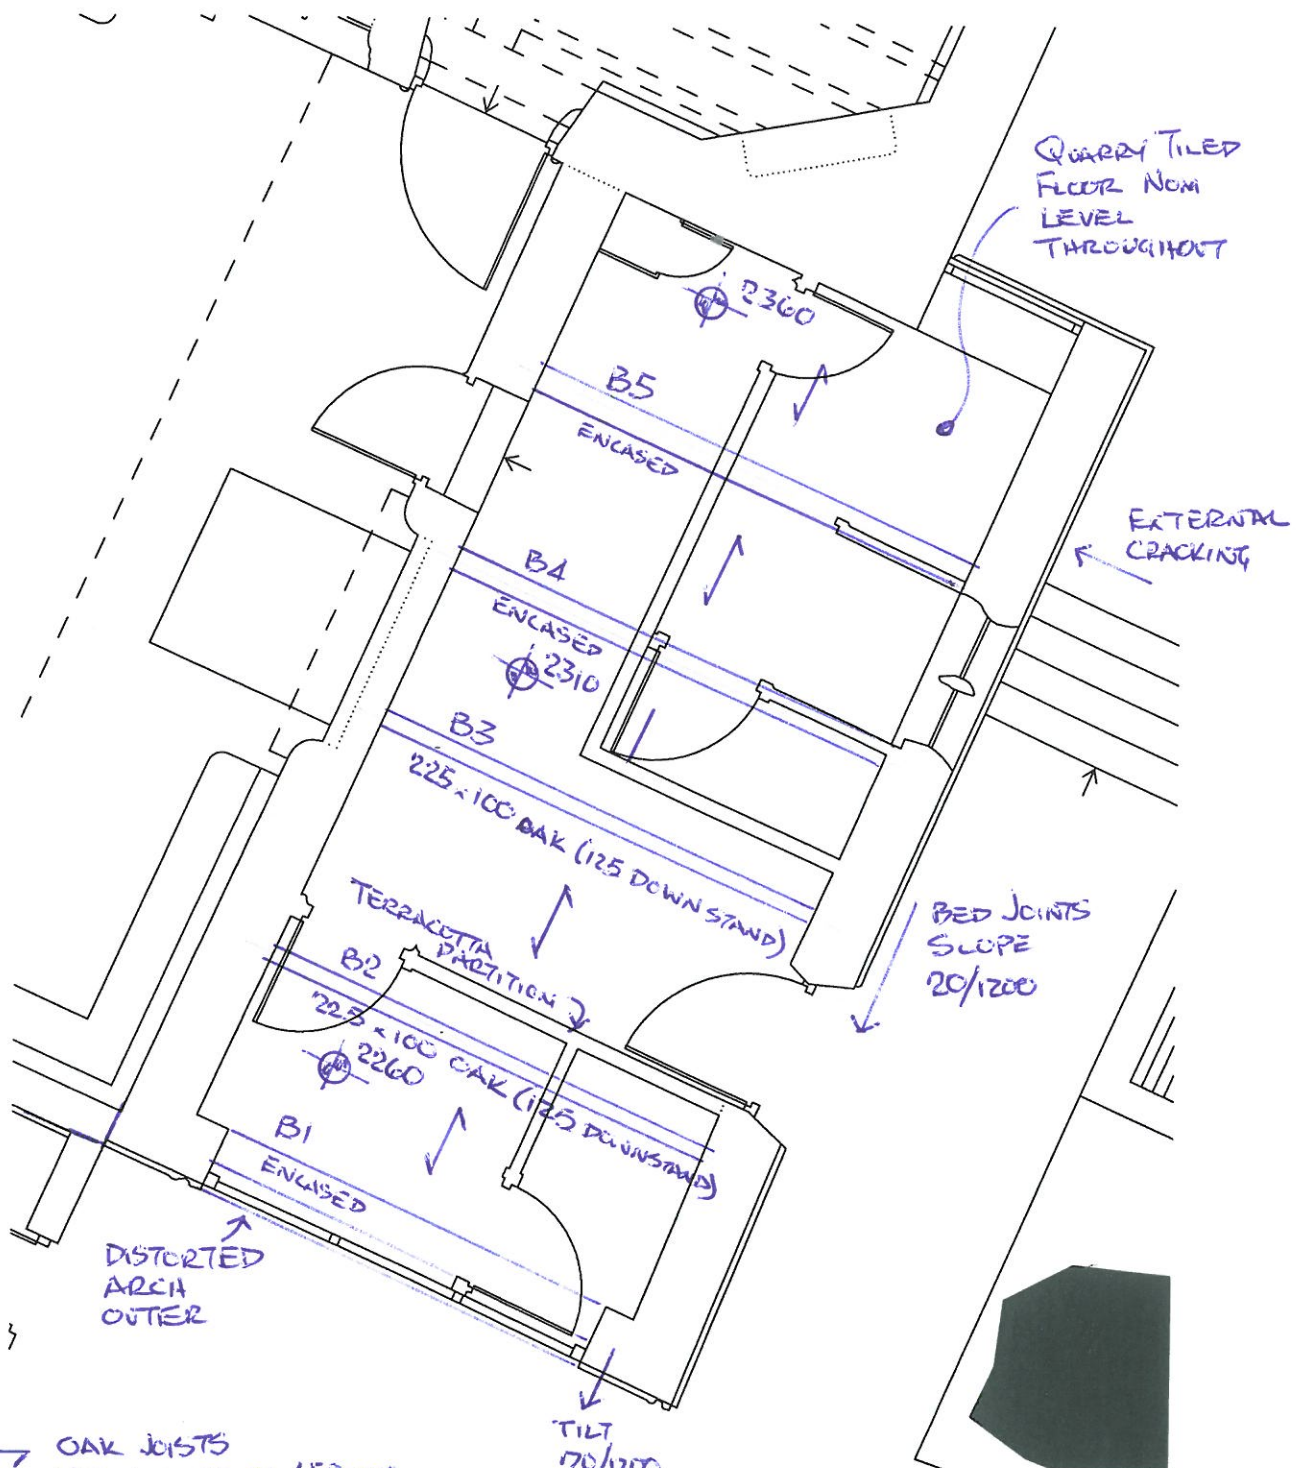
7975-SK02 – WC Block First Floor

← OAK JOISTS
NOM 100x50 @ 450c25
20mm softwood boards

⊕ 2260 FLOOR → CEILING HEIGHT
DIMINISHES TO SOUTH

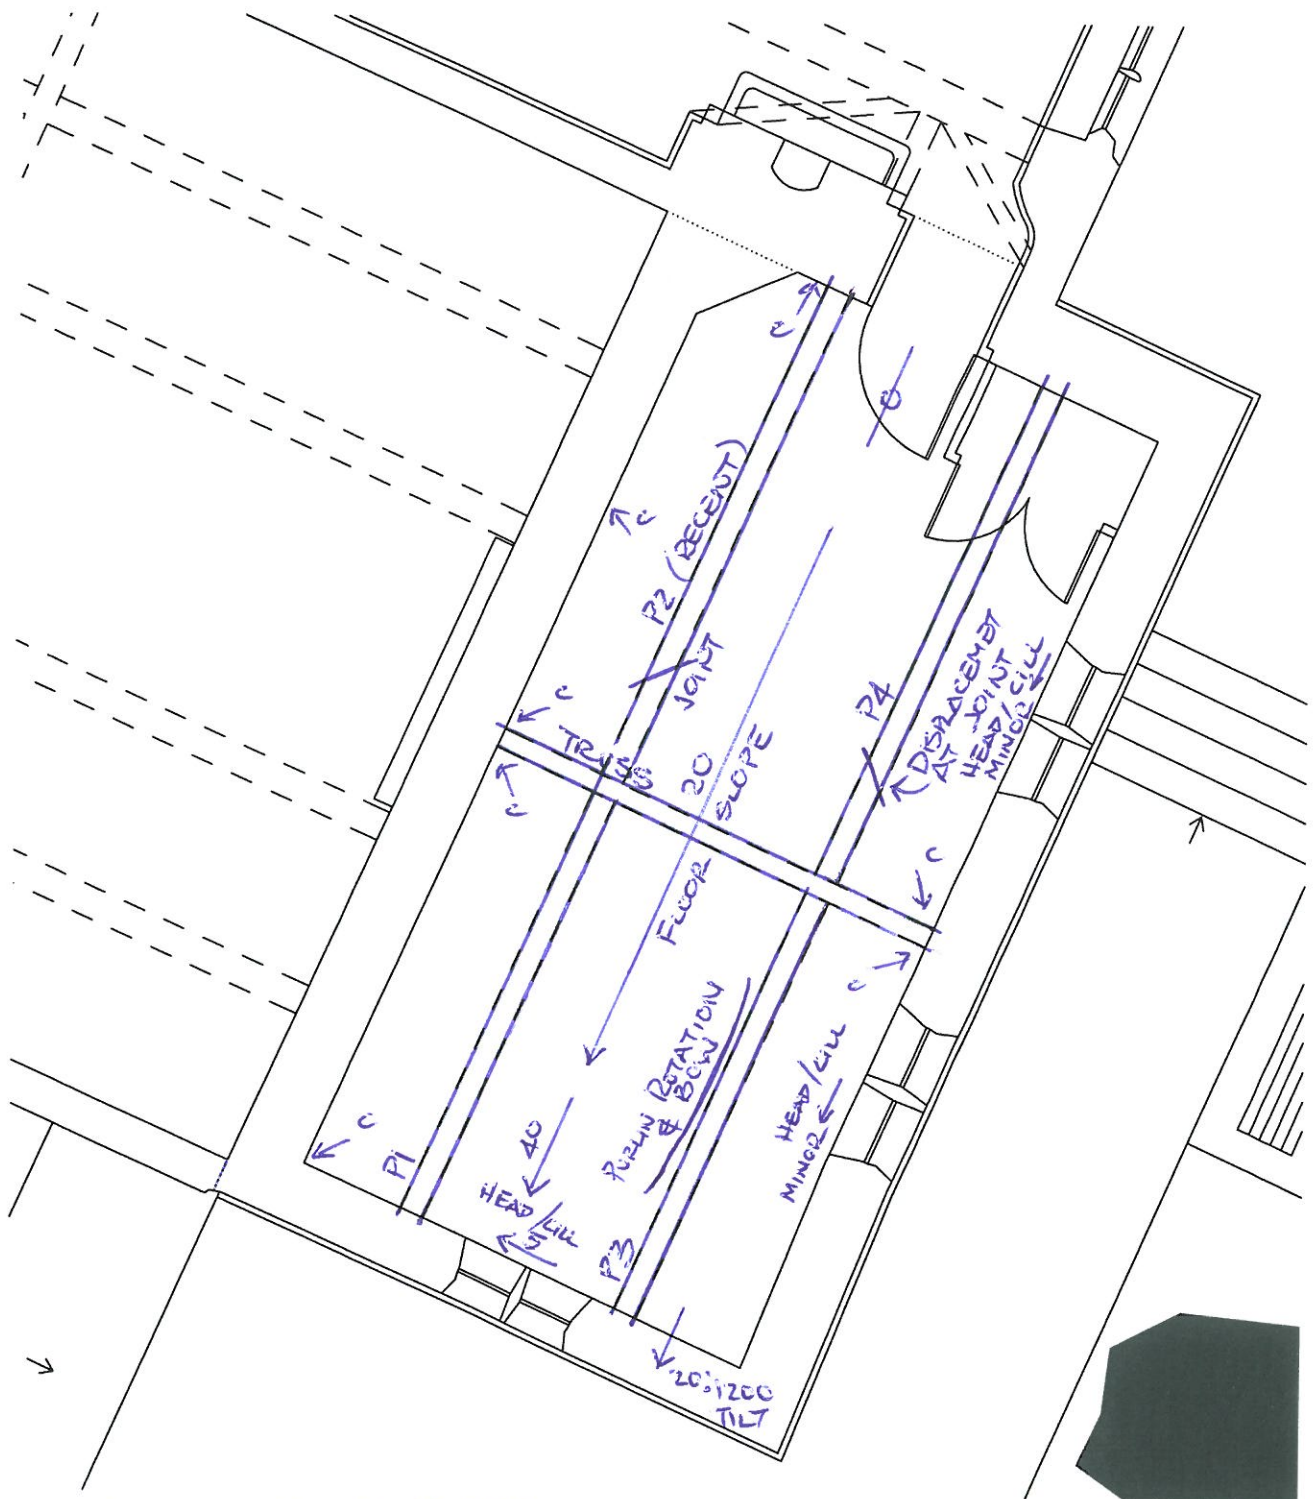
WC BLOCK - FIRST FLOOR

C → CRACKS TO WALL PLASTER

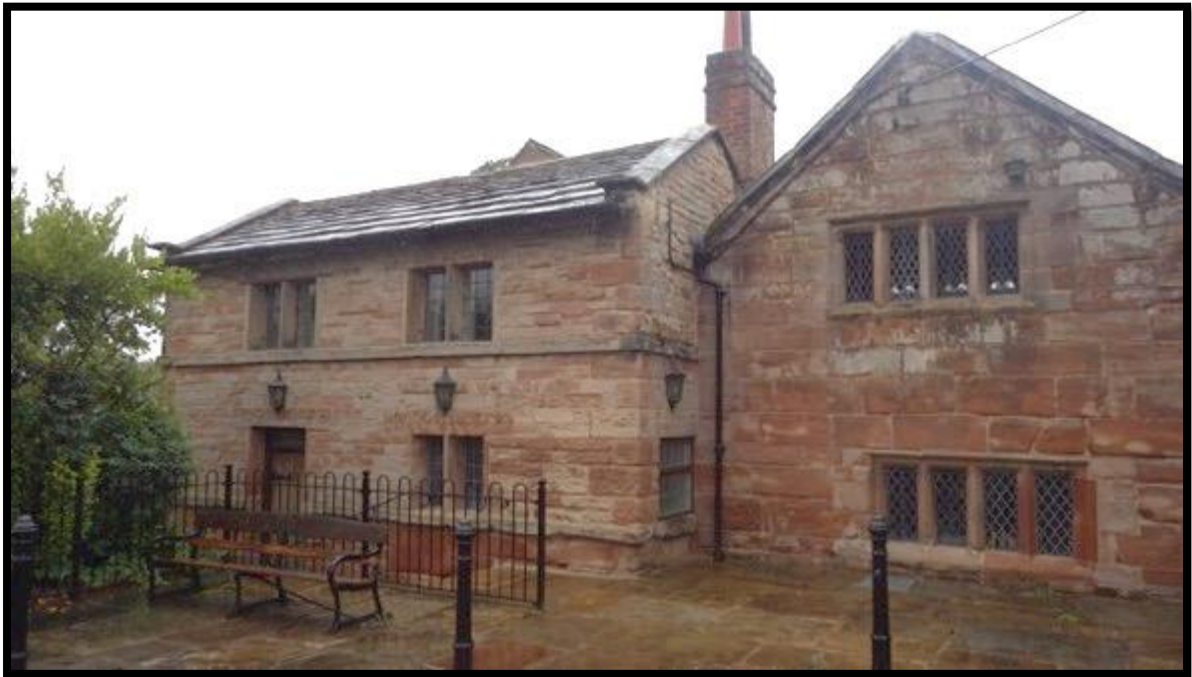
Fig 1. The target building is a church hall with several compartments to the building, all with pitched roofs. The building is well maintained.

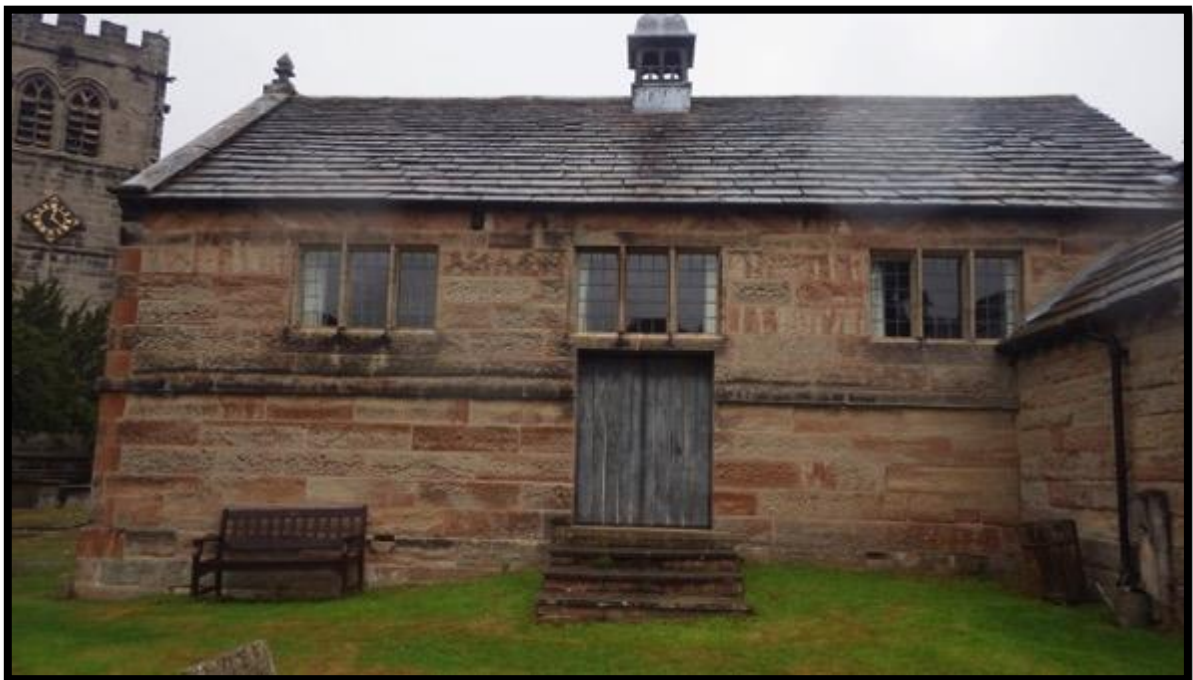
Fig 2. All sides of the building are well maintained with no obvious potential for bat activity.

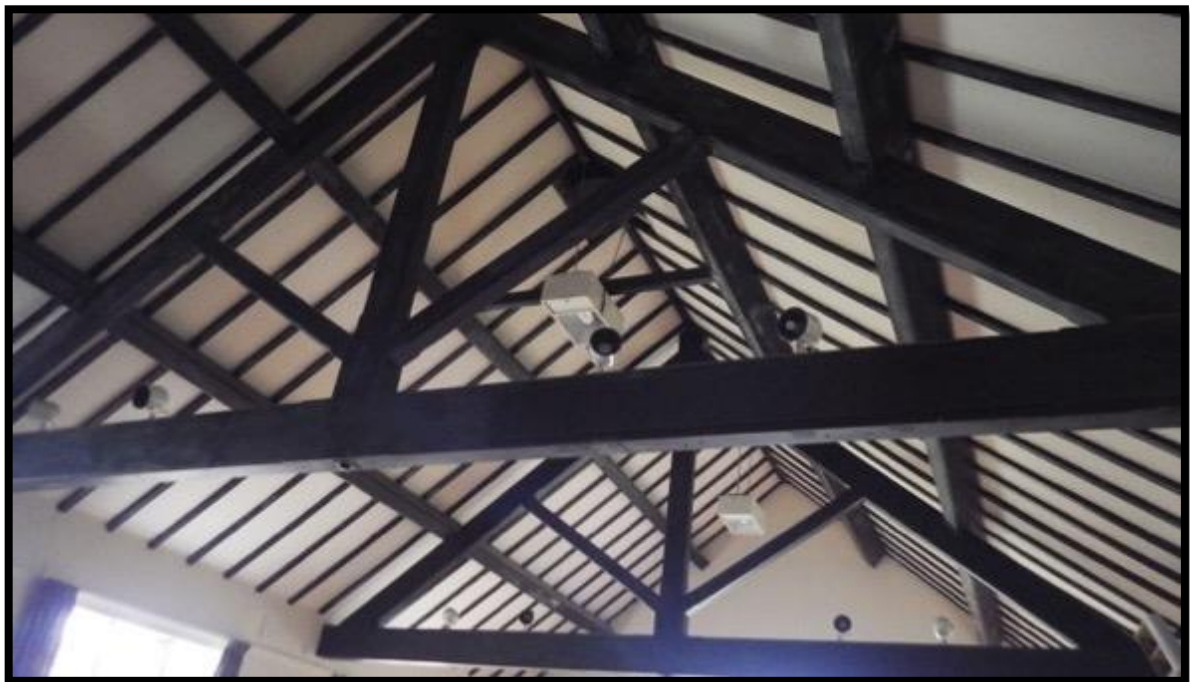
Fig 3. The underside of the pitched roof consists of wooden beams, seemingly very well maintained.

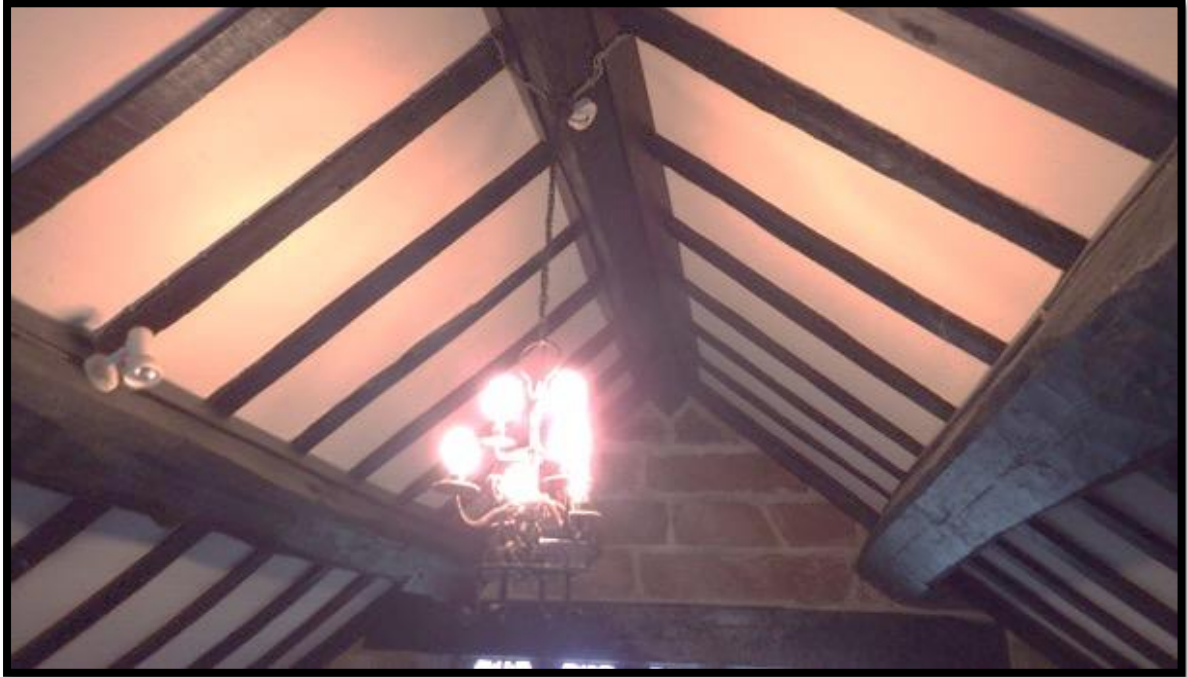
Fig 4. The underside of the pitched roof on the upper floor of the hall showing the vaulted ceiling following the profile of the roof.
