## St Michael the Archangel, Mere

Diocese of Salisbury

Preliminary inspection of medieval wall painting in trefoil niche, nave, south wall

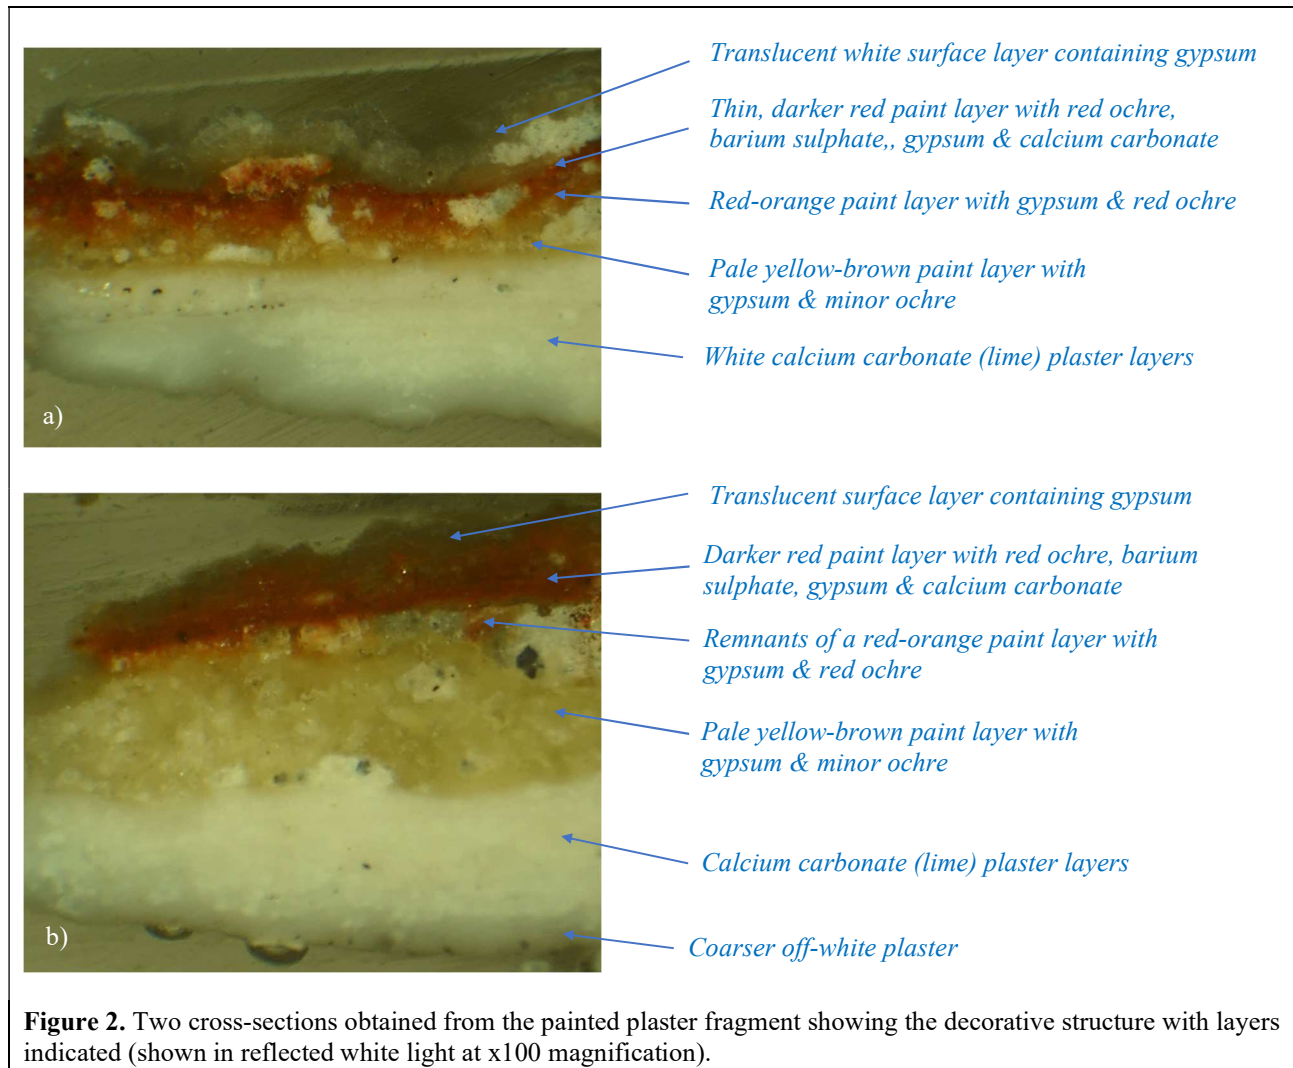
The black paint visible on the sample fragment appears to have been applied as a primary layer over the white plaster in some areas, with the edges of the pale yellow-brown paint observed to overlap this opaque paint (see Figure 1b). It is not clear whether the gypsum component identified in each decorative layer is original plaster material used in the fresco painting technique or whether it has developed from the degradation of a lime plaster more typically used for fresco layers.<sup>7,8</sup>
