CHURCH OF ST PETER  
DORCHESTER, DORSET  
GORDON MONUMENT

CONDITION ASSESSMENT  
&  
RELOCATION REPORT

MAY 2023

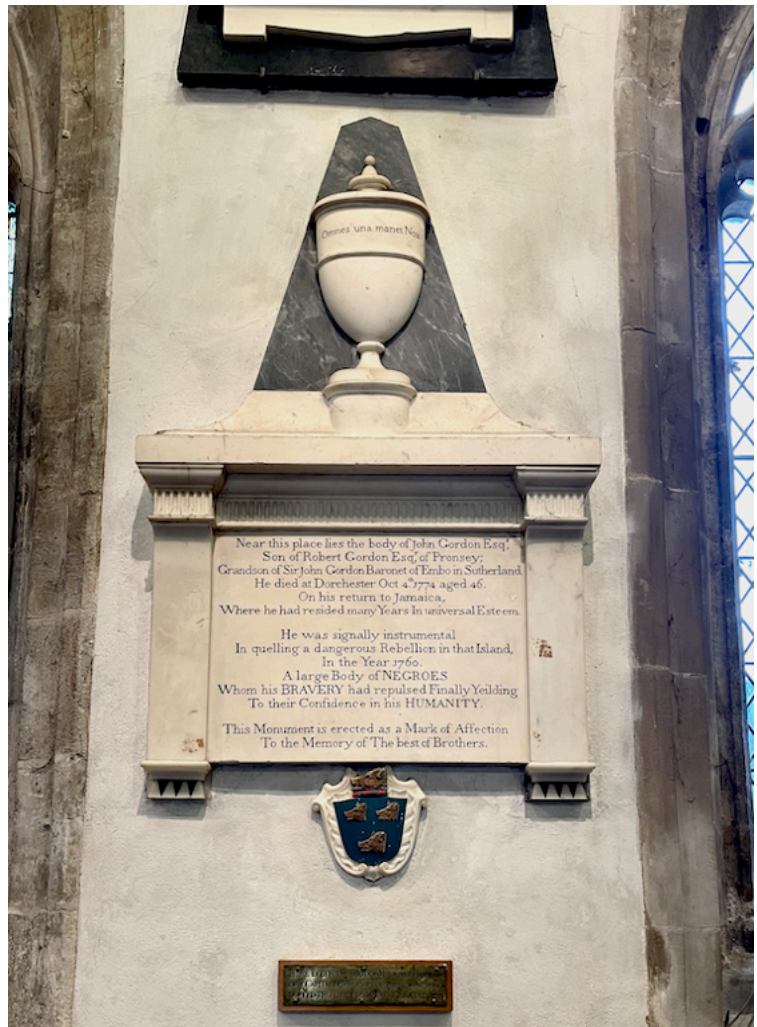
Figure 3 ~ Monument to John Gordon 1774, prior to dismantling.

SOILING ~ all areas are lightly soiled to varying degrees. Marks from parcel tape remain on the side shafts. An iron stain to the base of the urn, also mentioned in 1998, remains.

LOSSES ~ Past plaster repairs undertaken to missing upper /left dexter corner of inscription stone. No recent losses were noted.

STABILITY ~ The marble and monument are structurally sound and no movement was noted to the joints or perimeter. However, cracking/fractures of the 'shoulder' sections as noted in the Kelland report.

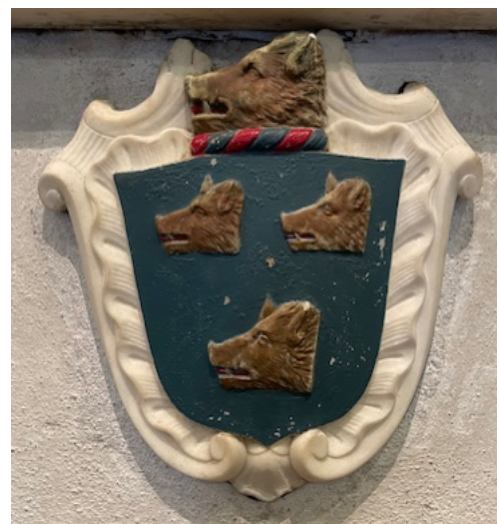
Figure 5 ~ Detail of shield.

POLYCHROMY ~ The lettering on the inscription and urn are legible. The blue polychromy of the shield is blistered and flaking due to salt damage, with some areas of loss. An earlier scheme of red and gold leaf may be noted beneath the existing. See figure 7.

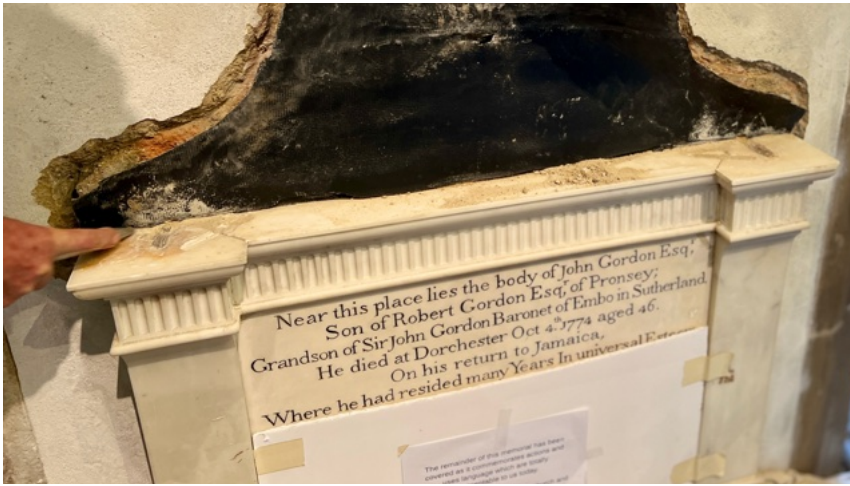
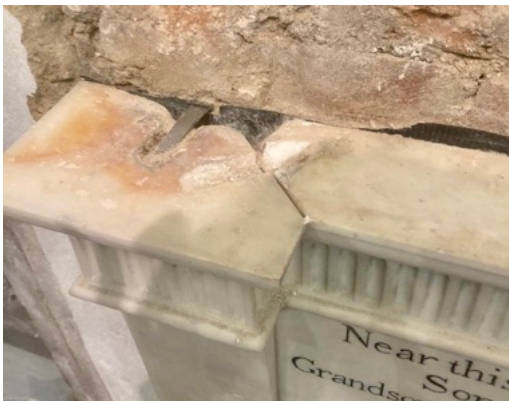
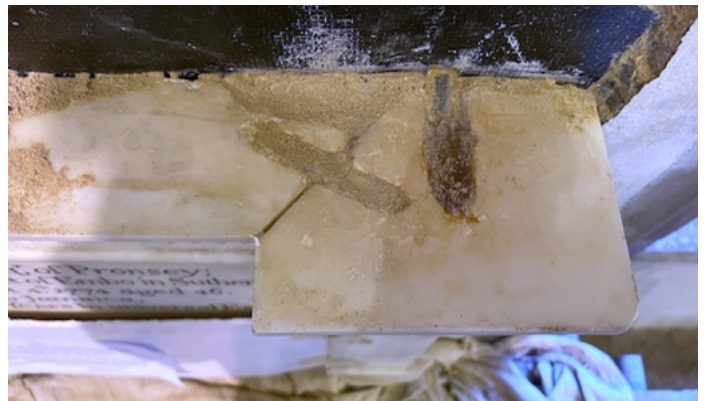
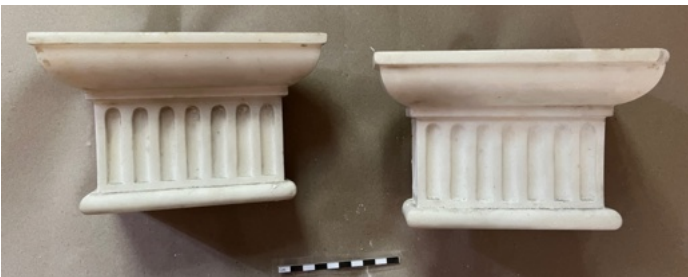
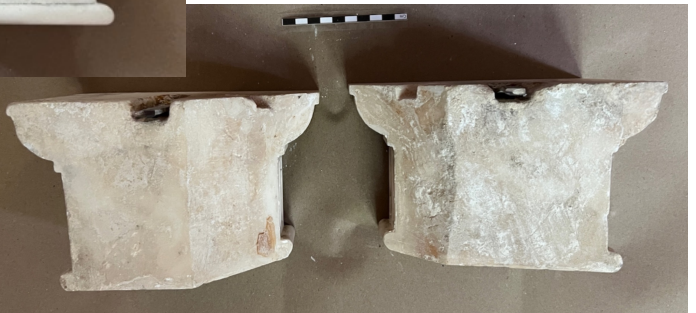
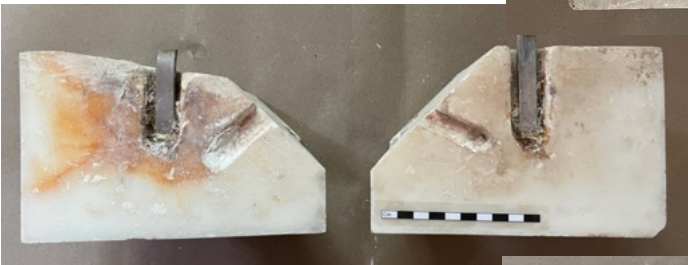
3 ~ CAPITALS, dexter and sinister

Figure 13 ~ Capitals flanking frieze in-situ, with details of: cramps to wall and to adjacent frieze element; front face; rear face; upper face; lower face.

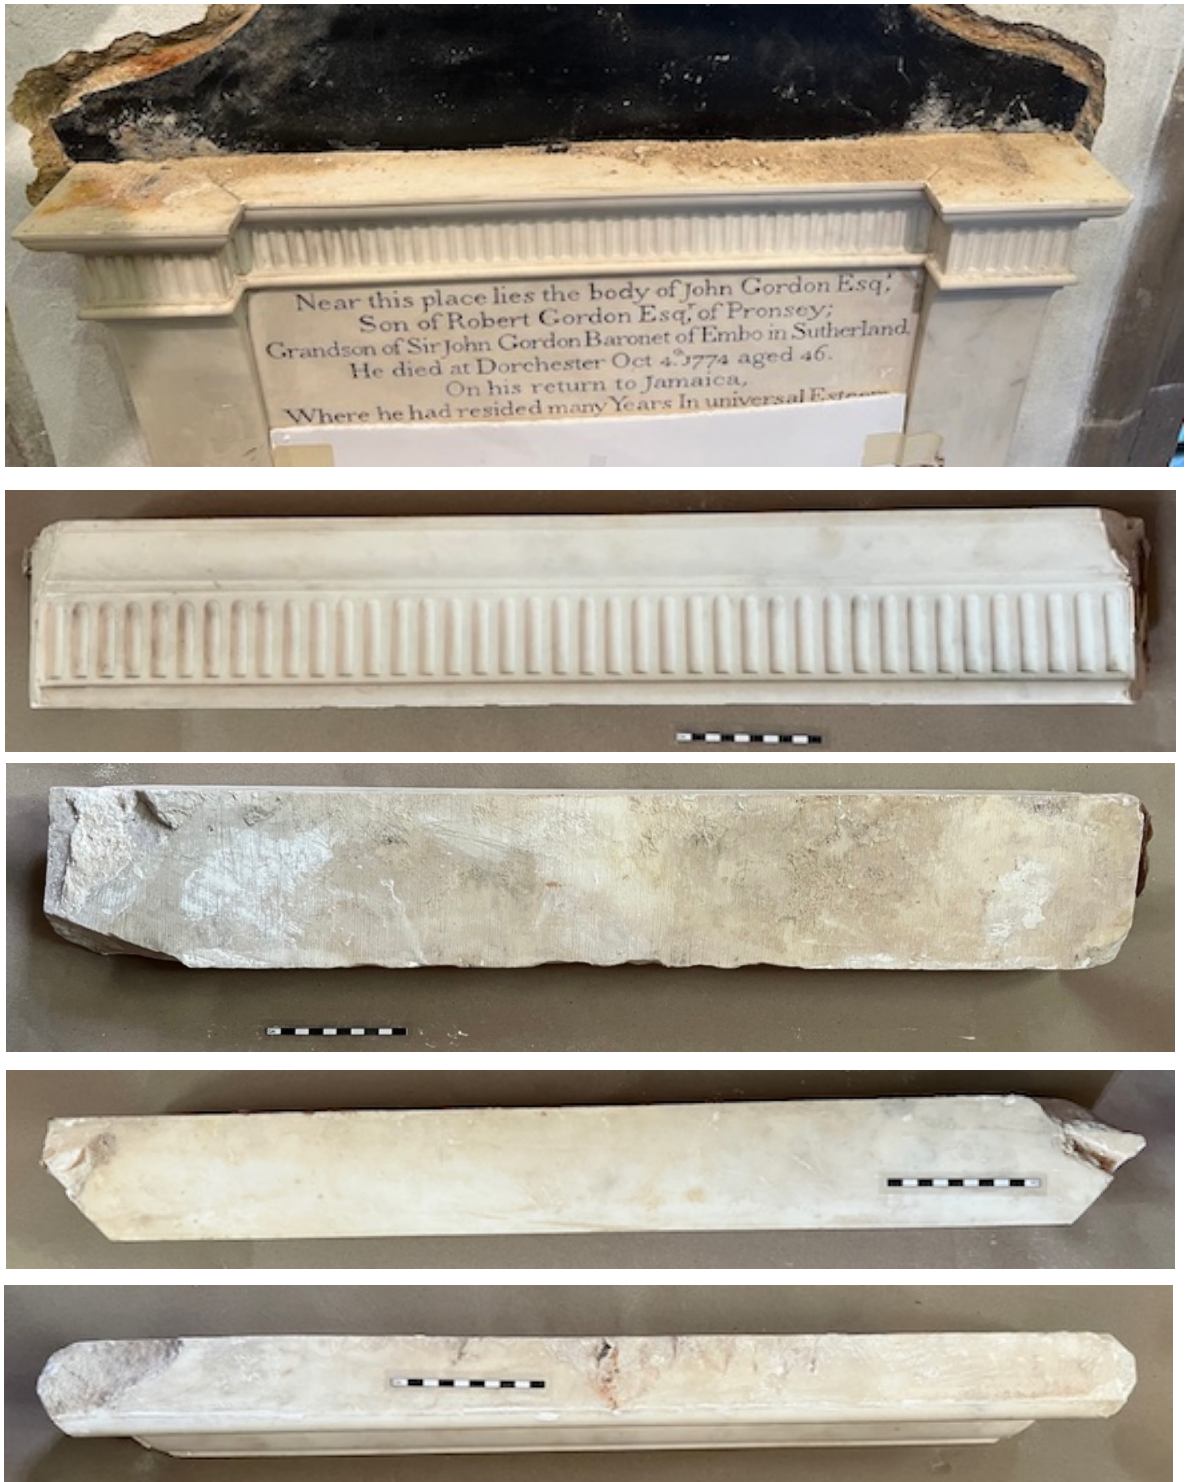
4 ~ FRIEZE

Figure 14 ~ Details of frieze element; insitu, front, rear, upper, lower and side.

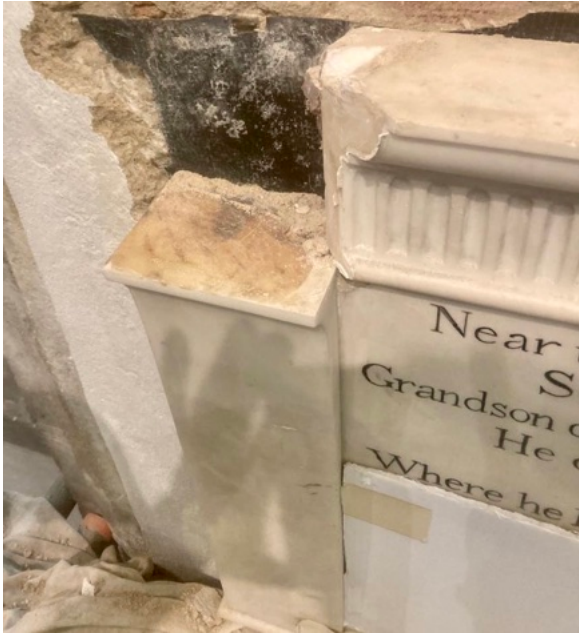
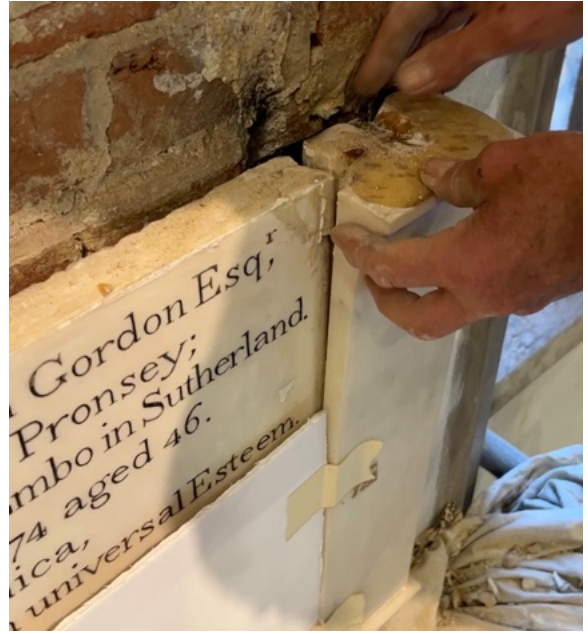
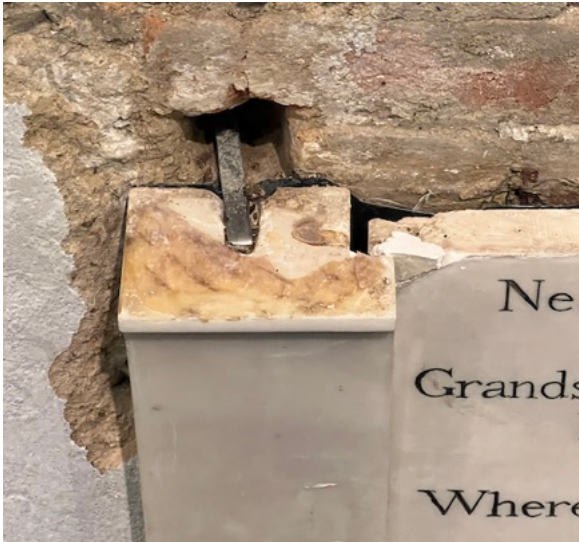
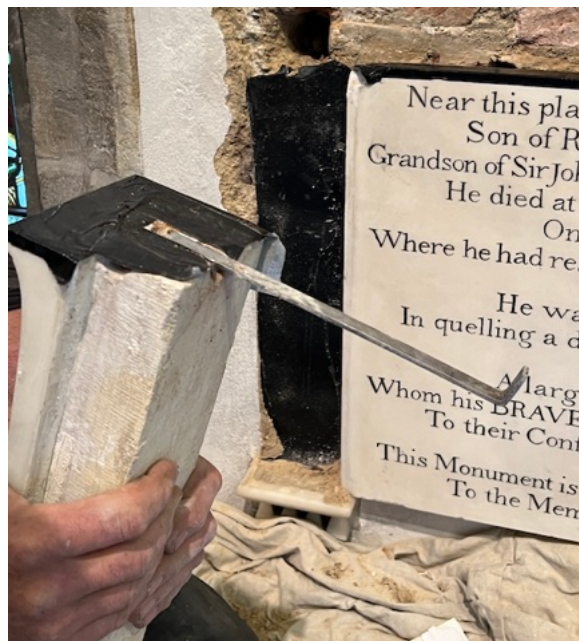
5 ~ PILASTERS, dexter and sinister

Figure 15 ~ Details of removal of pilasters and cramps.

- Stainless steel fixings were cut through whilst the elements were supported. Protections were applied to the marble to avoid scratching.
- Each section was lowered to the ground and placed on softening.

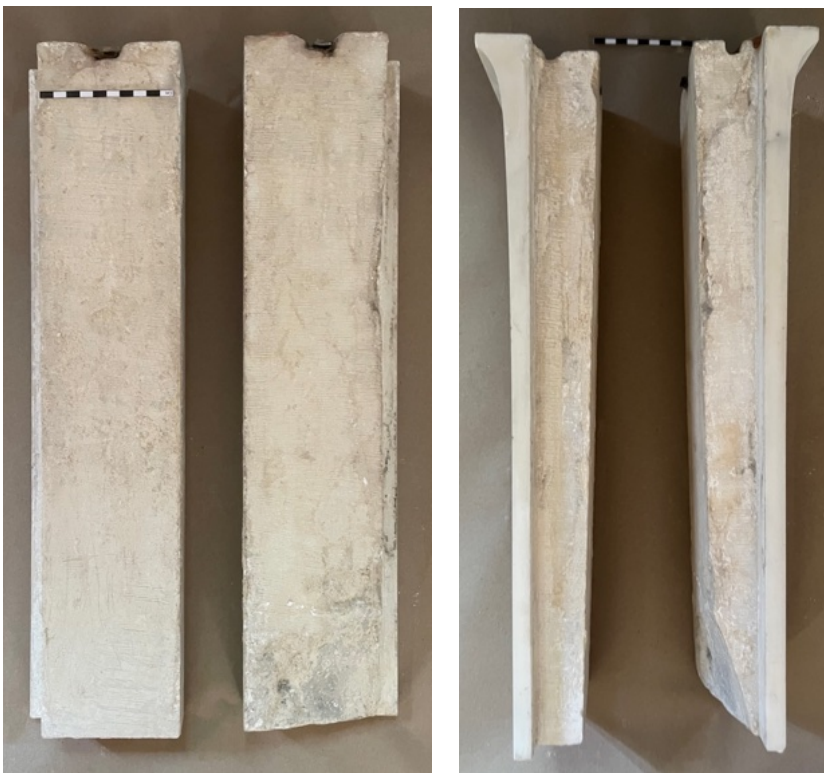
Figure 17 ~ Detail of rear and side faces of pilasters.

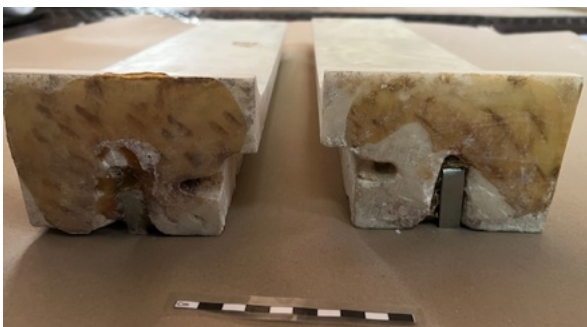
Figure 16 ~ Detail of clamp recess on upper face.

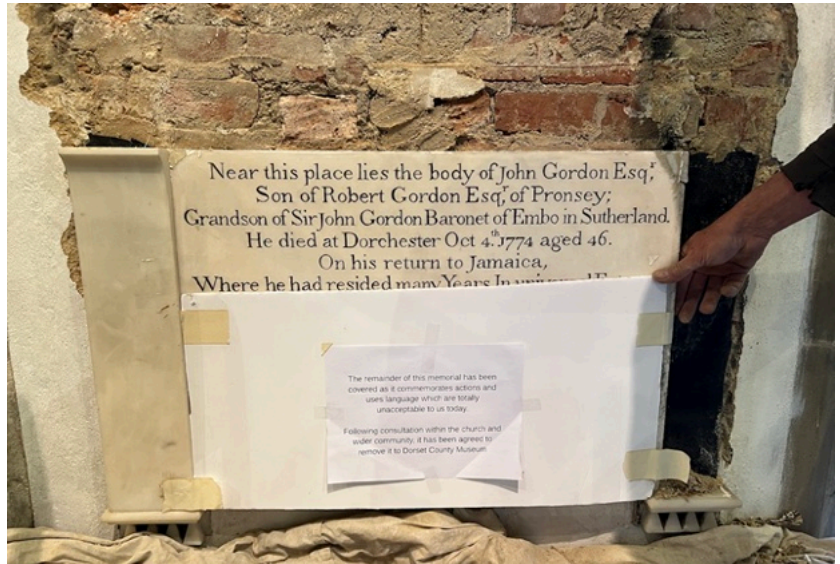
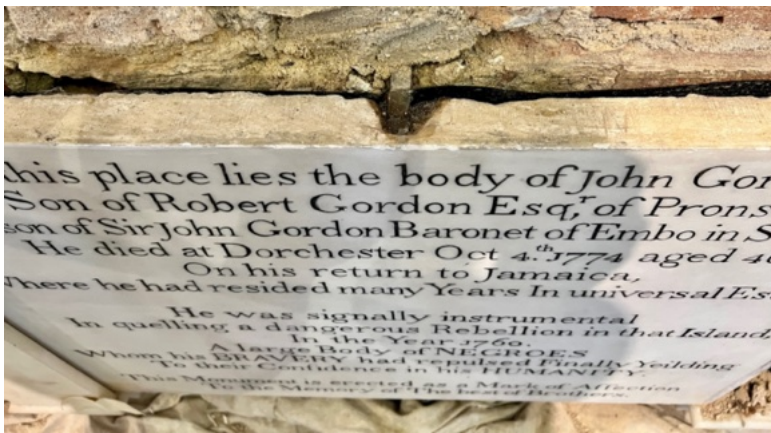
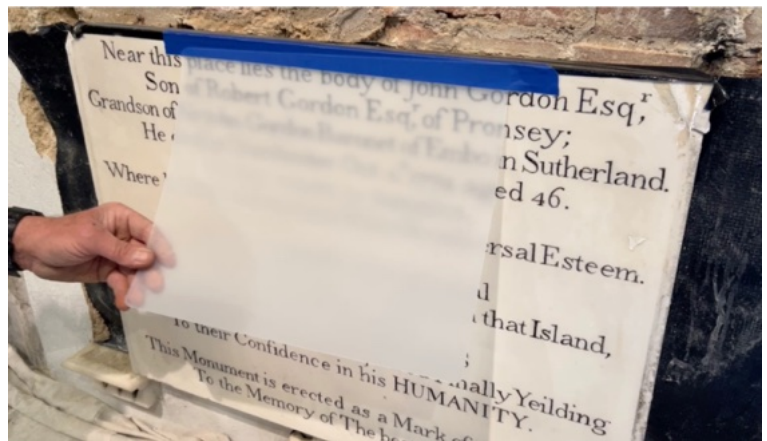
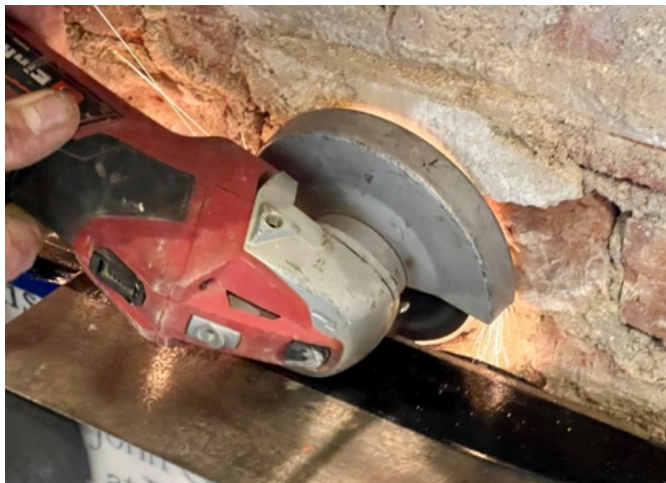
6 ~ INSCRIPTION TABLET

Figure 19 ~ Inscription panel. from top: in-situ; detail of retaining clamp; protections prior to cutting clamp; cutting clamp.

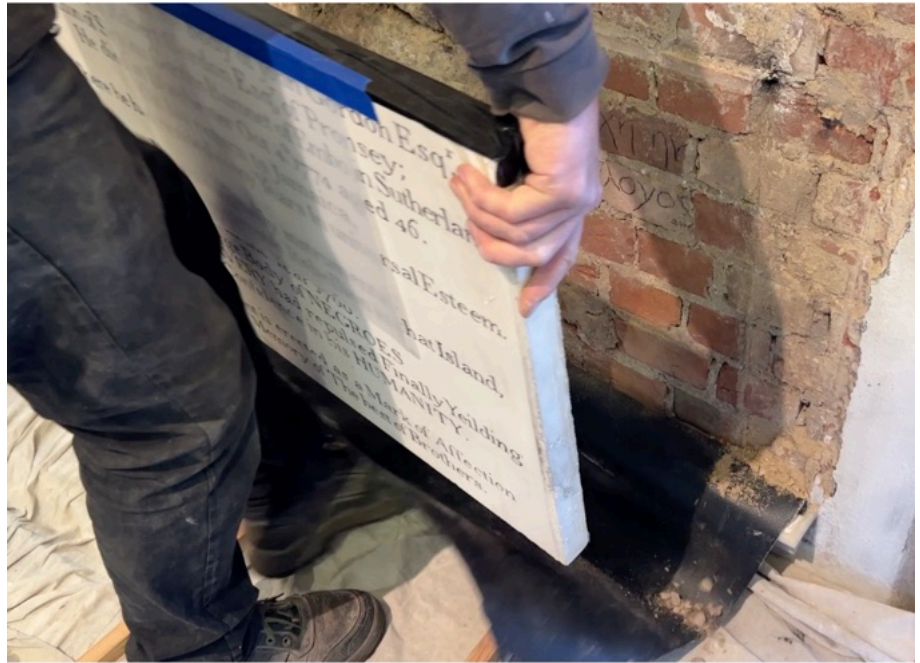
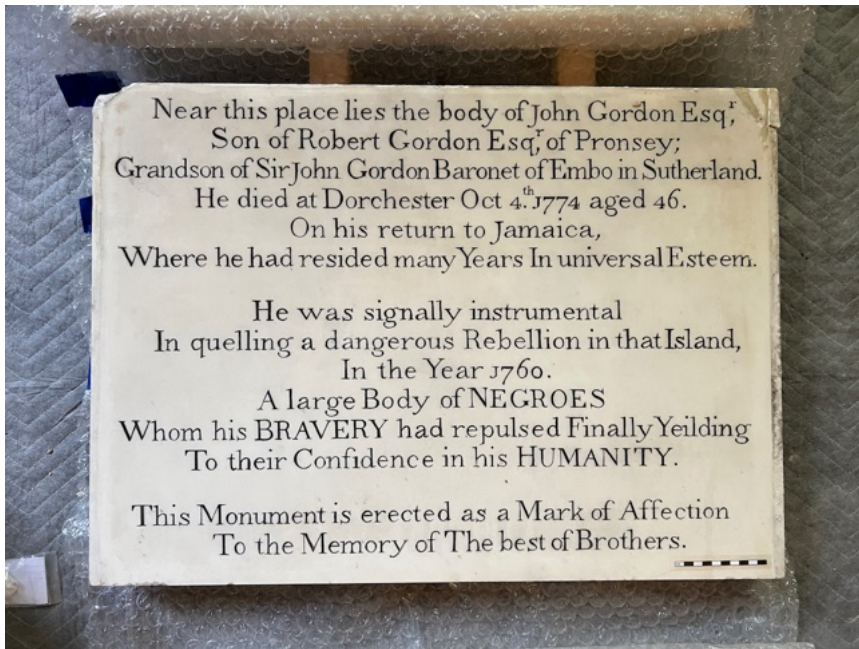
Figure 20 ~ From top: lifting off inscription panel, ex-situ; rear view (upside down).

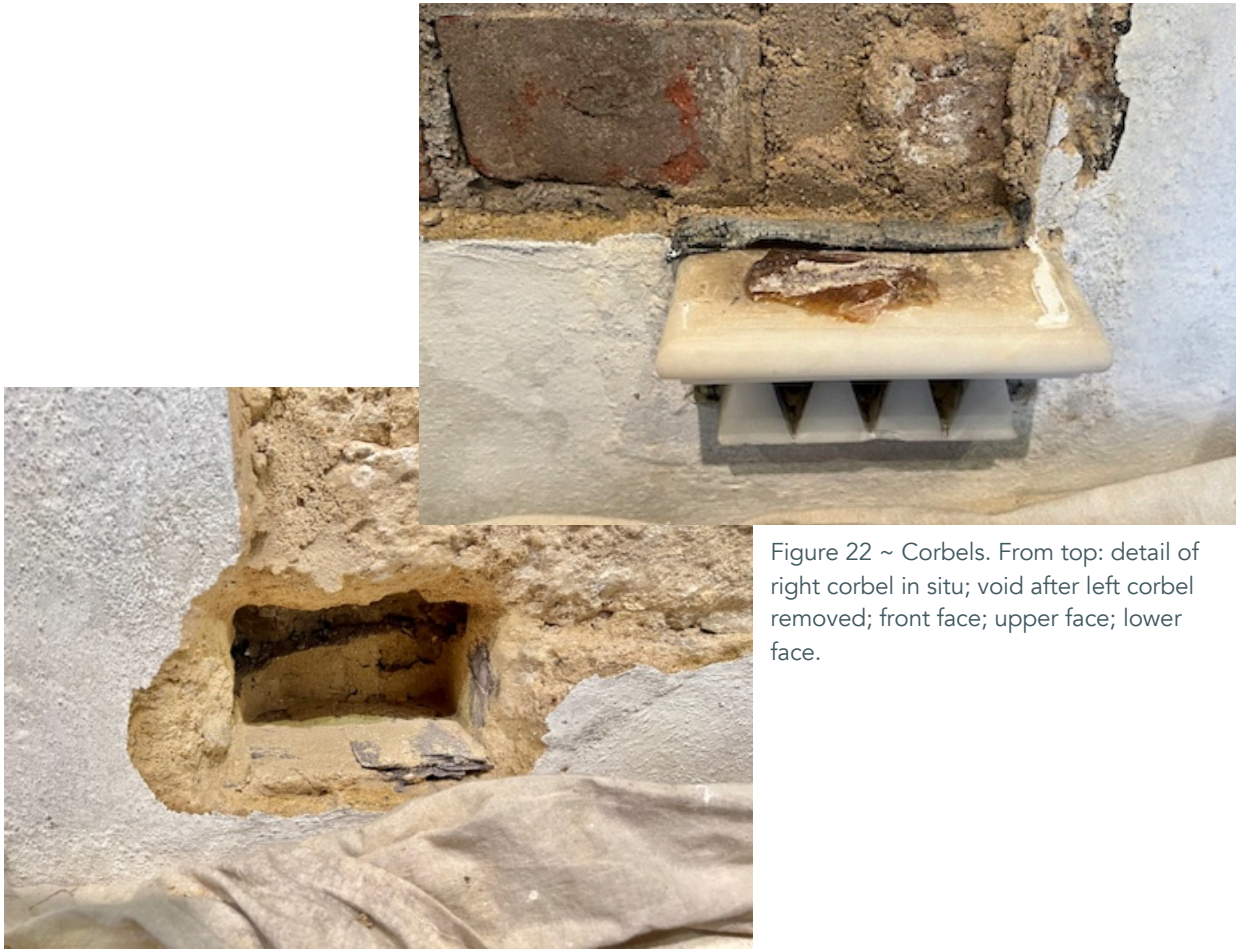
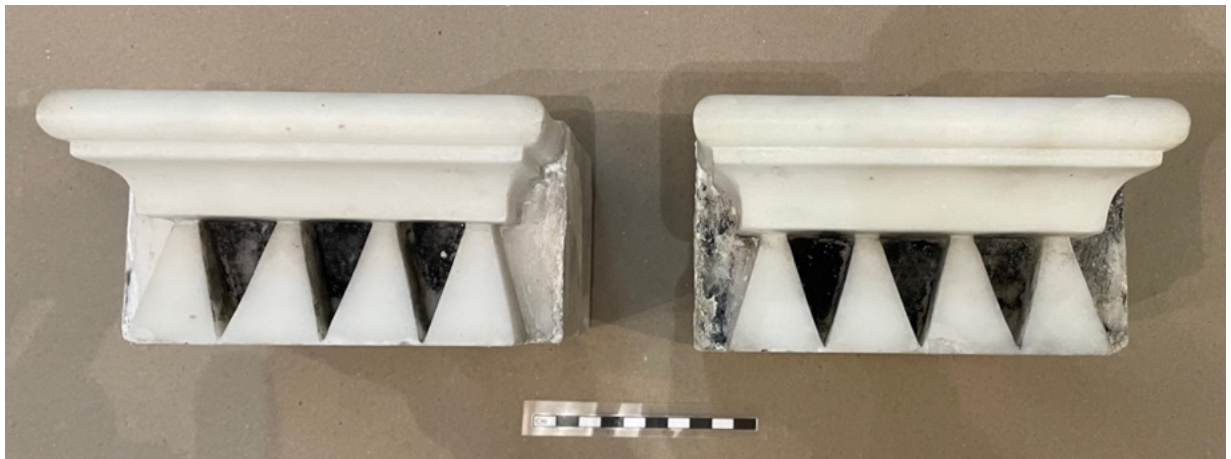
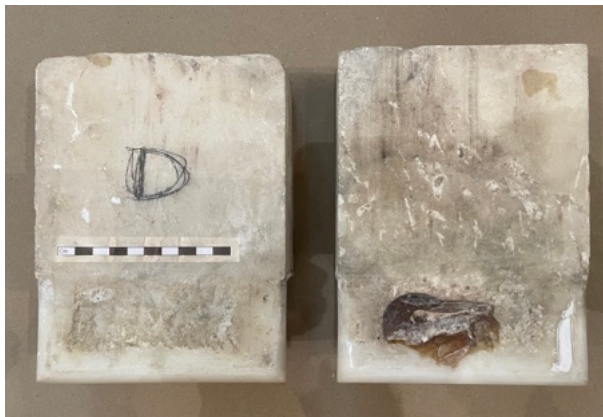
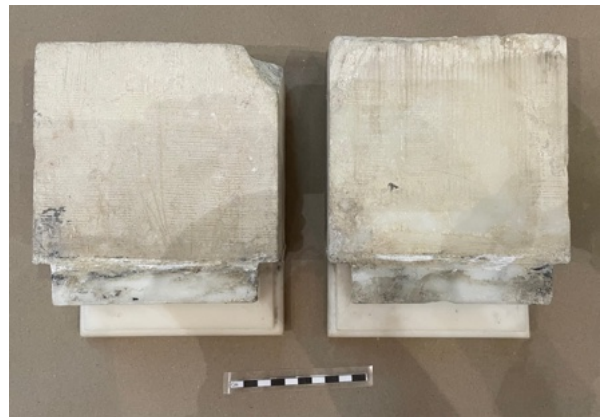
7 ~ CORBELS, dexter and sinister

Figure 22 ~ Corbels. From top: detail of right corbel in situ; void after left corbel removed; front face; upper face; lower face.

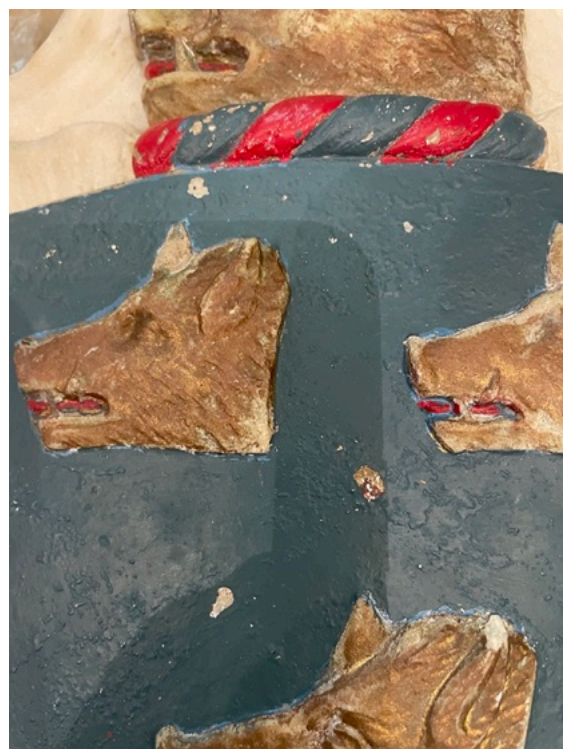
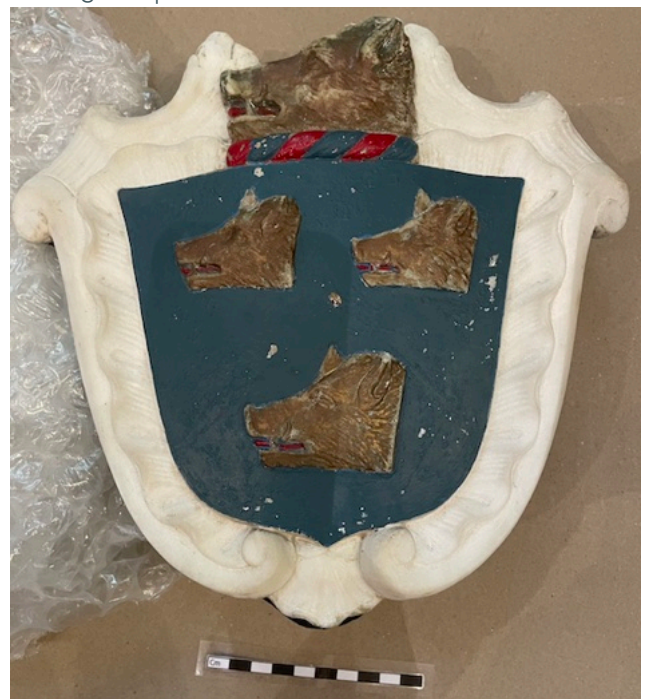
8 ~ COAT OF ARMS

Figure 23 ~ Details of cartouche with painted coat of arms. clockwise from top left: in-situ, dowels after removal; rear face; ex-situ; detail of painted surface and minor loss; locating cramp.

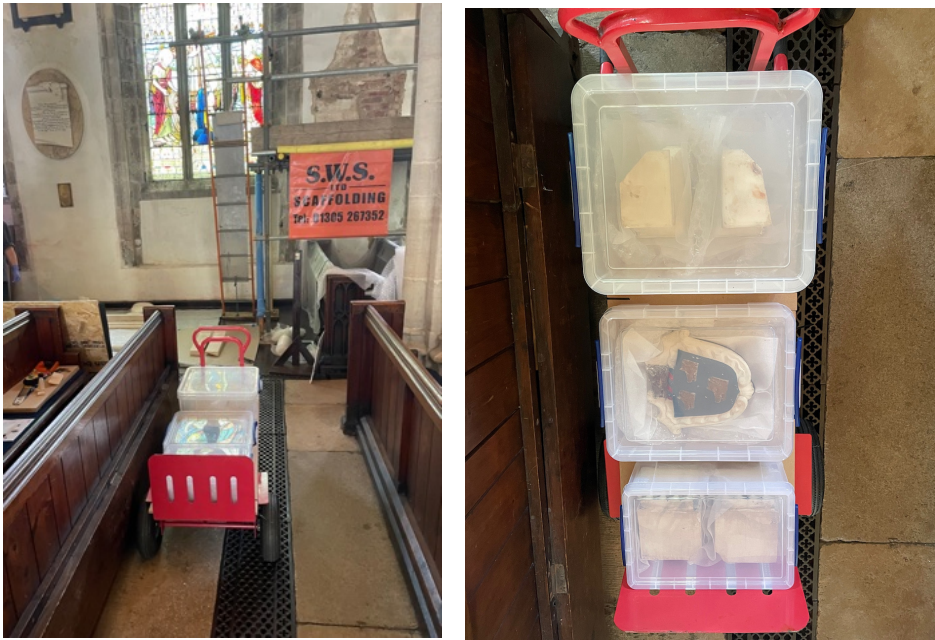
Figure 24 ~ Boxed elements on trolley to be transported to museum.

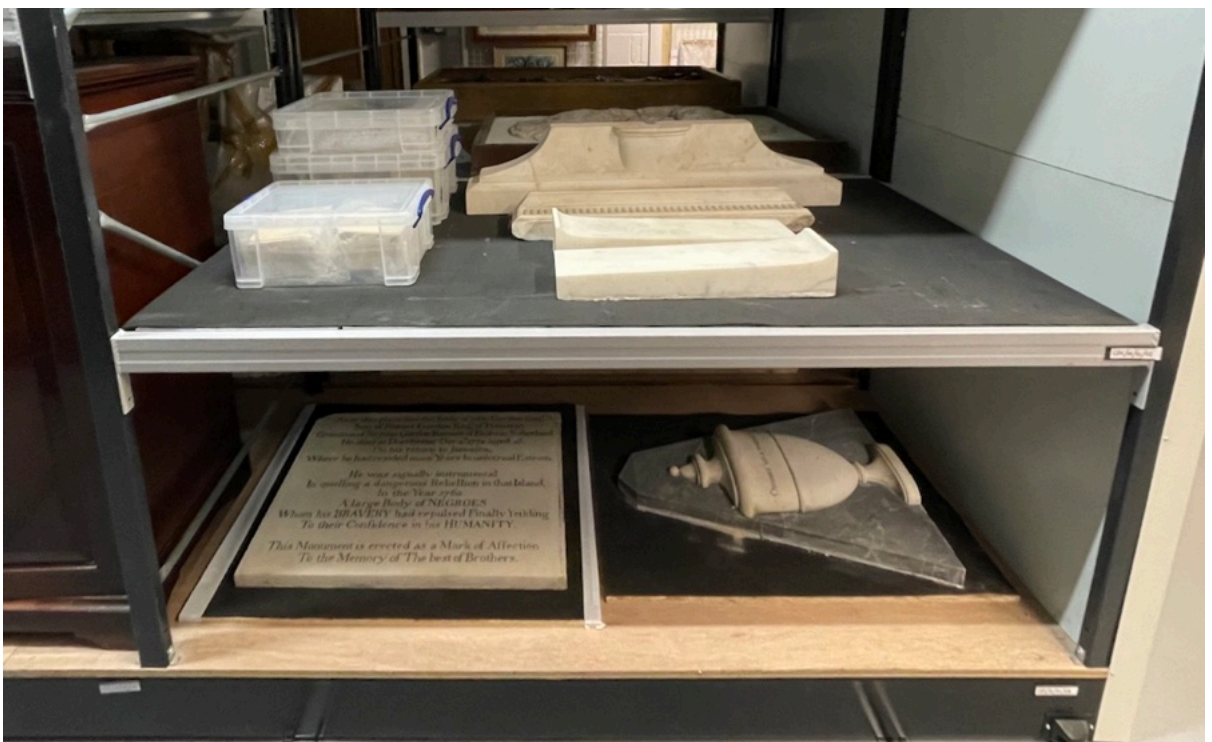
Figure 25 ~ On shelved storage within The Dorset Museum Discovery Centre.

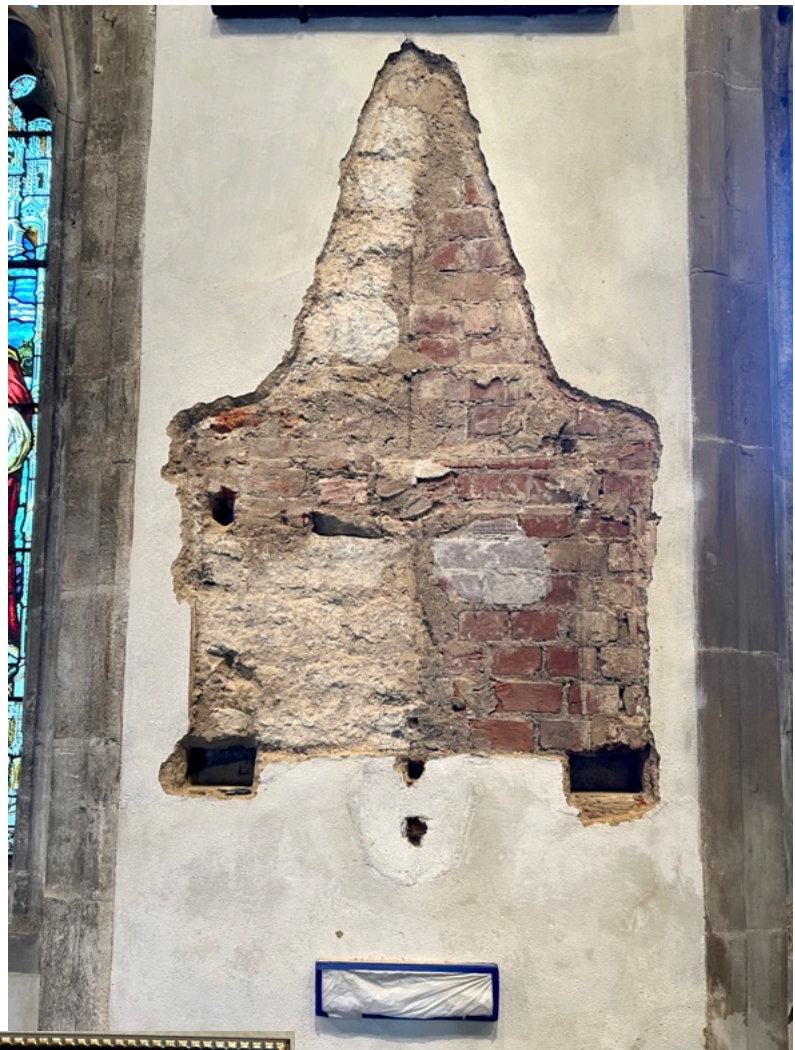
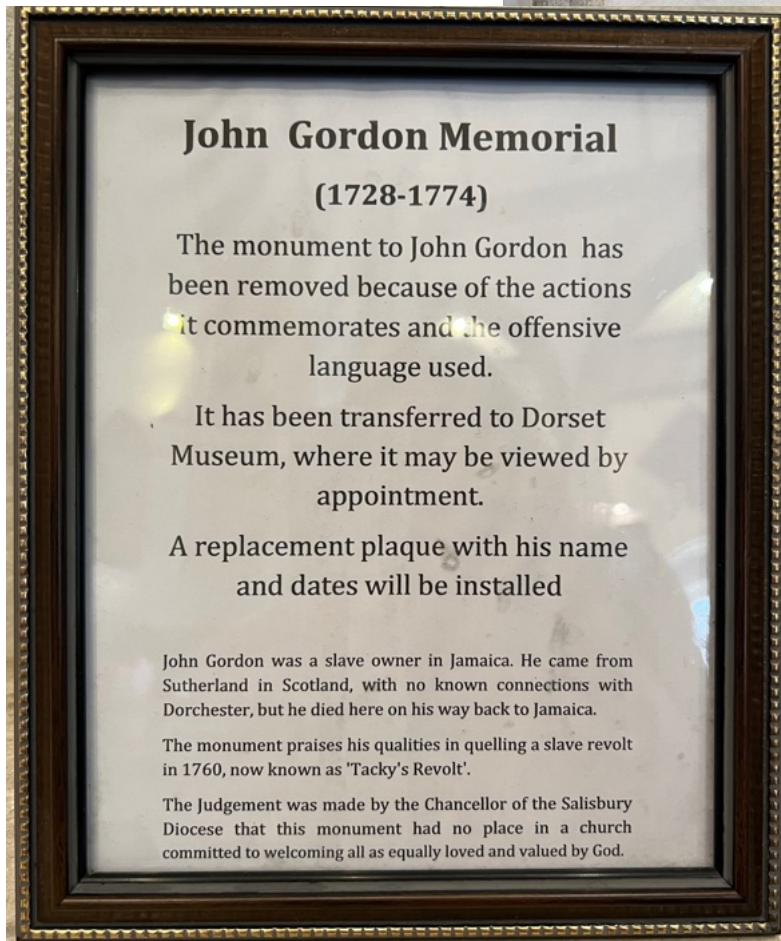
Figure 28 ~ Notice placed near by PCC, explaining reasons for monuments removal.
