## Conservation Records

**Location:** St Mary's Church, Stalisfield, Kent

**Panel:** 3 (inner)

**Window:** North window of the chancel, nII

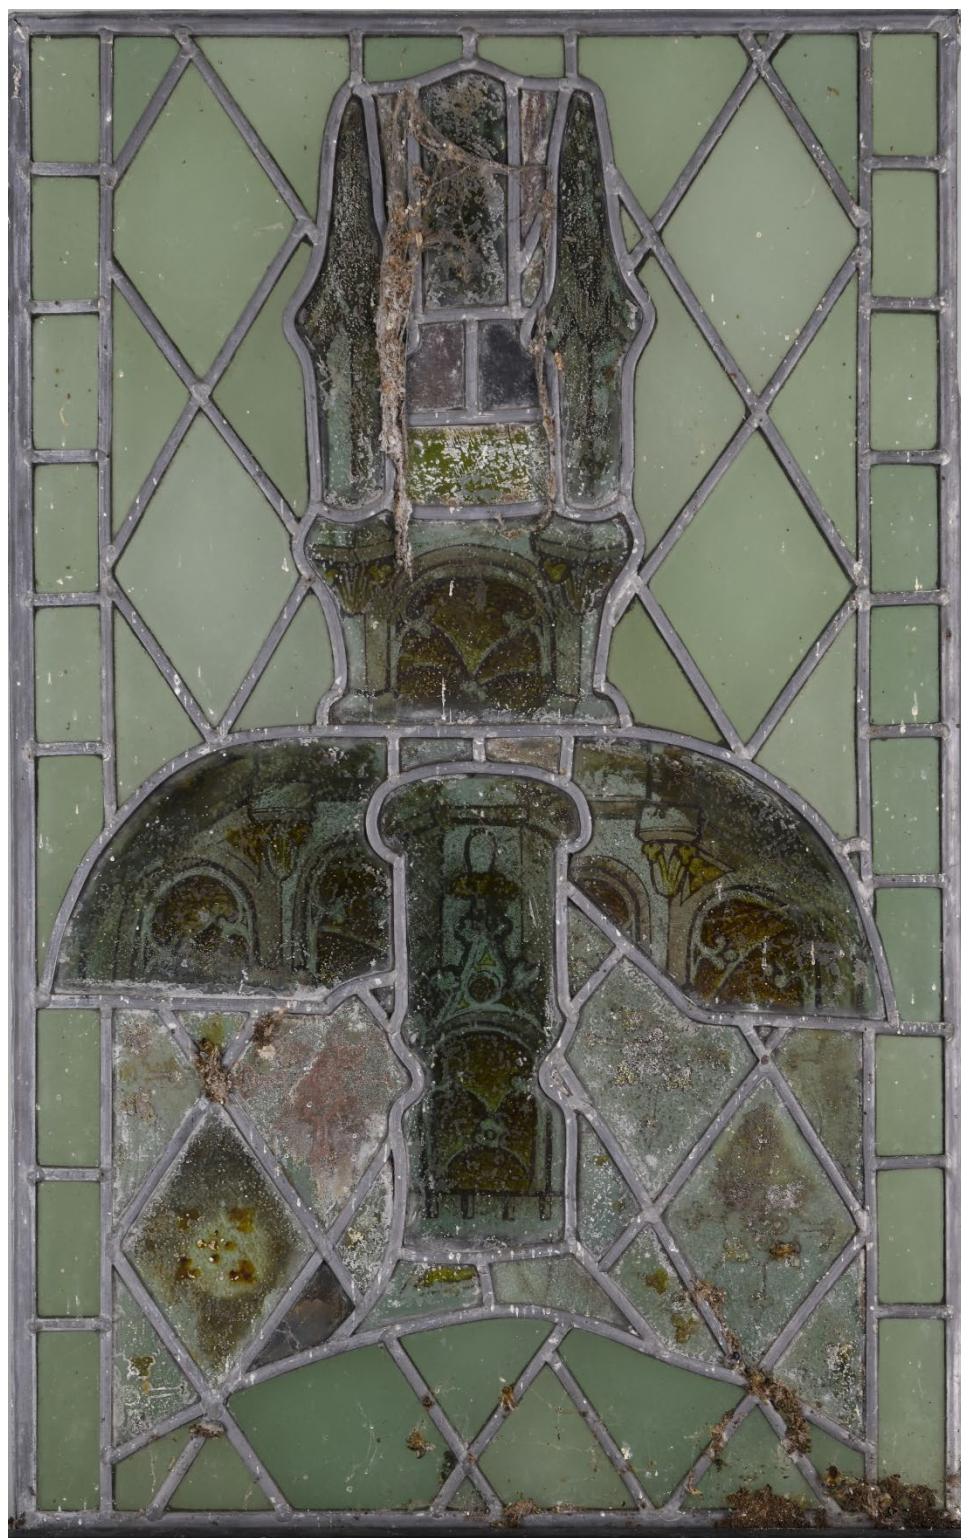
**Before Conservation**  
**External**

**External:** 15<sup>th</sup> century glass: Much fine pitting over the whole surface. Creamy-white and brown corrosion products within the pits.
