STRUCTURAL REPORT
St Andrews Church
Wollescote

The consultants were appointed by Rev. David Nichol, Rector of St Andrews Church, Wollescote on behalf of the PCC of St Andrews Church, Oakfield Road, Wollescote to carry out a report on the Church.

The report is to specifically comment on the current condition of the Church following the demolition of the Church Hall after this had suffered from significant subsidence. This Practice had previously prepared a report issued on 6th May 2019 and this records the details of the Church Hall and also the resultant cracking within the Church.

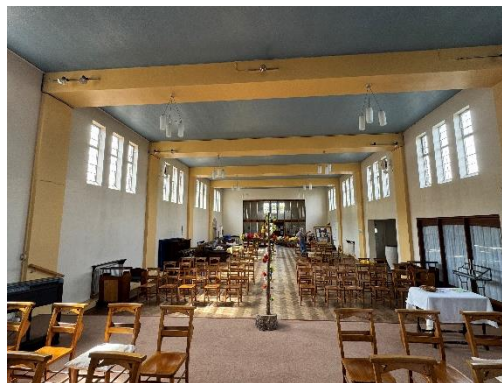
Photograph No.26

A general view of the Church looking from east to west is shown on photograph No.26.

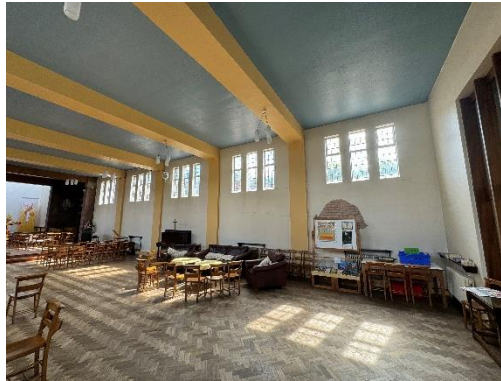
Photograph No.28

There is then the series of five bays, as noted externally, a general view of the southern wall being shown on photograph No.28.

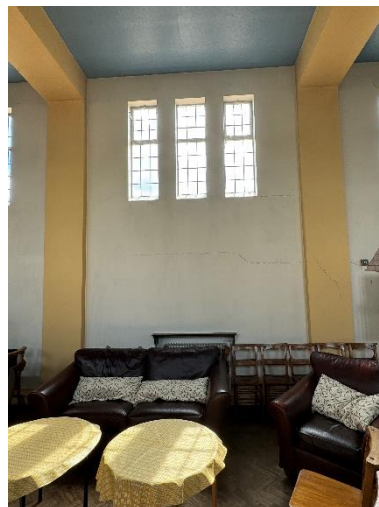
Photograph No.33

This is shown on photograph No.33.

The main items to note is there is a horizontal crack from the bottom right-hand corner of the window and also one below here, all as can be seen on photograph Nos.34 and 35.

The longer term works required will be to cut out and repair the cracking, which is as a result of the previous movement. The cracks internally and externally can all be cut out and repointed, and as they would appear to extend through the full thickness of the brick wall, installing helical remedial ties such as Helibar would be prudent to ensure that the bond is re-established in the brickwork prior to repointing. The plaster and decorations can then all be made good.

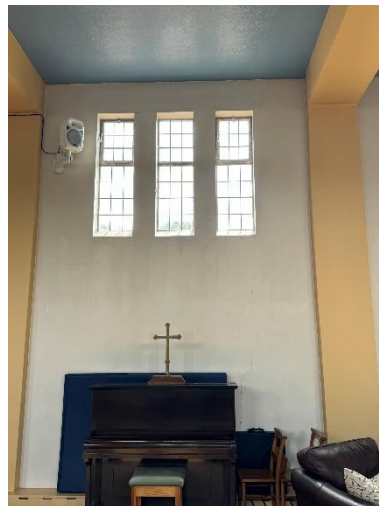
Photograph No.37

This is shown on photograph No.37.

There is a vertical crack which extends up towards the window and then a horizontal crack towards the bottom left-hand corner of the window, all as shown on photograph Nos.38 and 39.

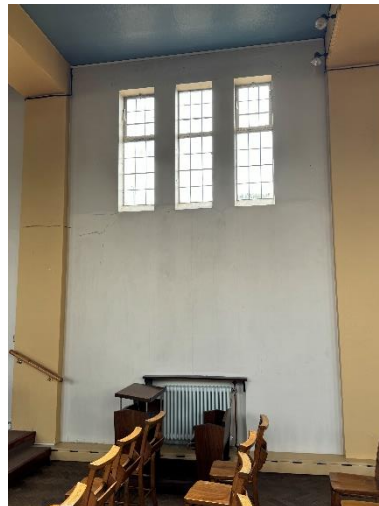
Photograph No.40

This is shown on photograph No.40.

There is again slight horizontal cracking from the bottom corner of the window which then extends across to the pier, and this is shown on photograph Nos.41 and 42.

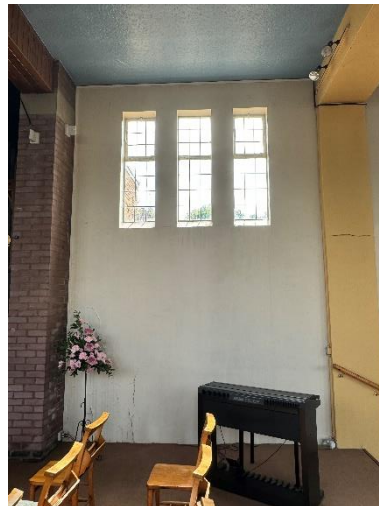
Photograph No.43

This is shown on photograph No.43.

There is no major cracking, but there is a disturbance to the decorations where the paint is peeling slightly, as shown on photograph No.44. Where the building then returns as noted externally, this houses the organ, as shown on photograph No.45 and from what could be seen there was no indication of any significant movement.
