Modbury church reordering

Site visit by Sue Spackman 25th September 2023

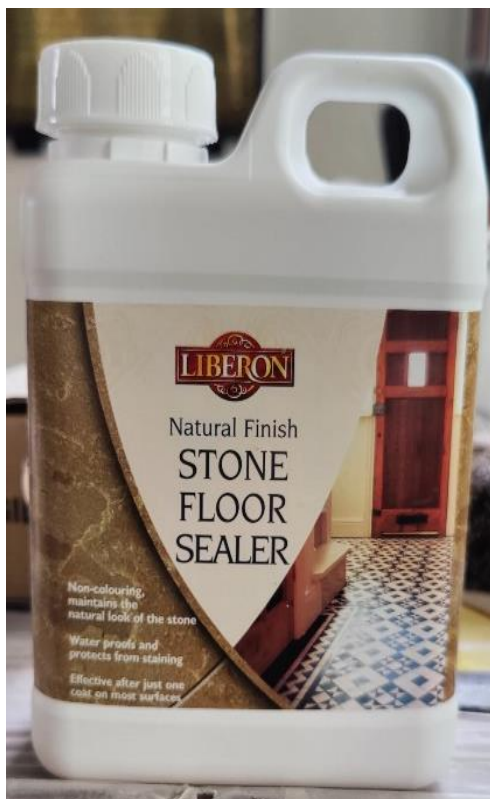
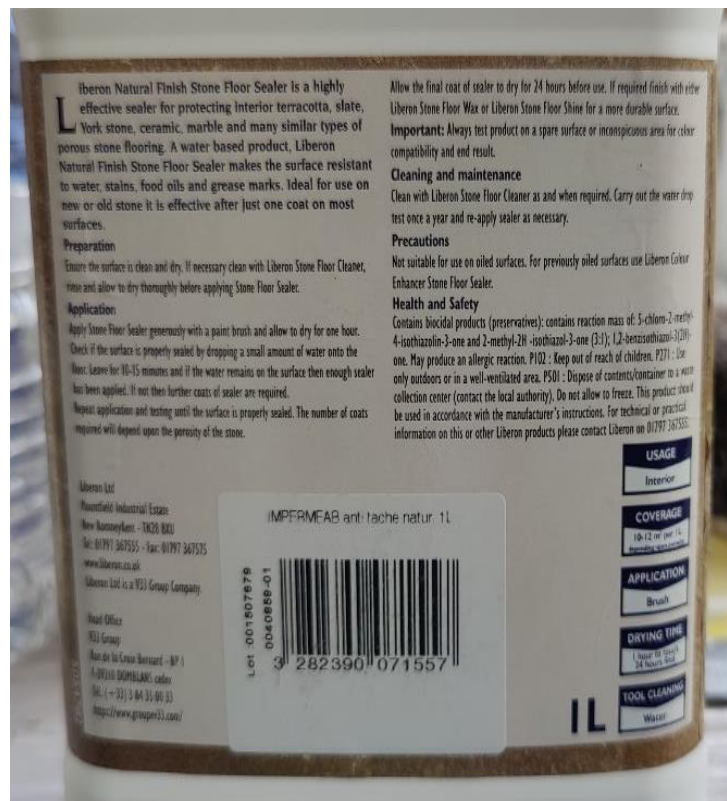
Stained Forest of Dean floor finish.

Forest of Dean sealed. No colour change

For these reasons they wish to amend the condition to allow a sealant on the stone. The sealant proposed is recognised by the stone industry as one of the better products and acceptable by the Forest of Dean quarry.

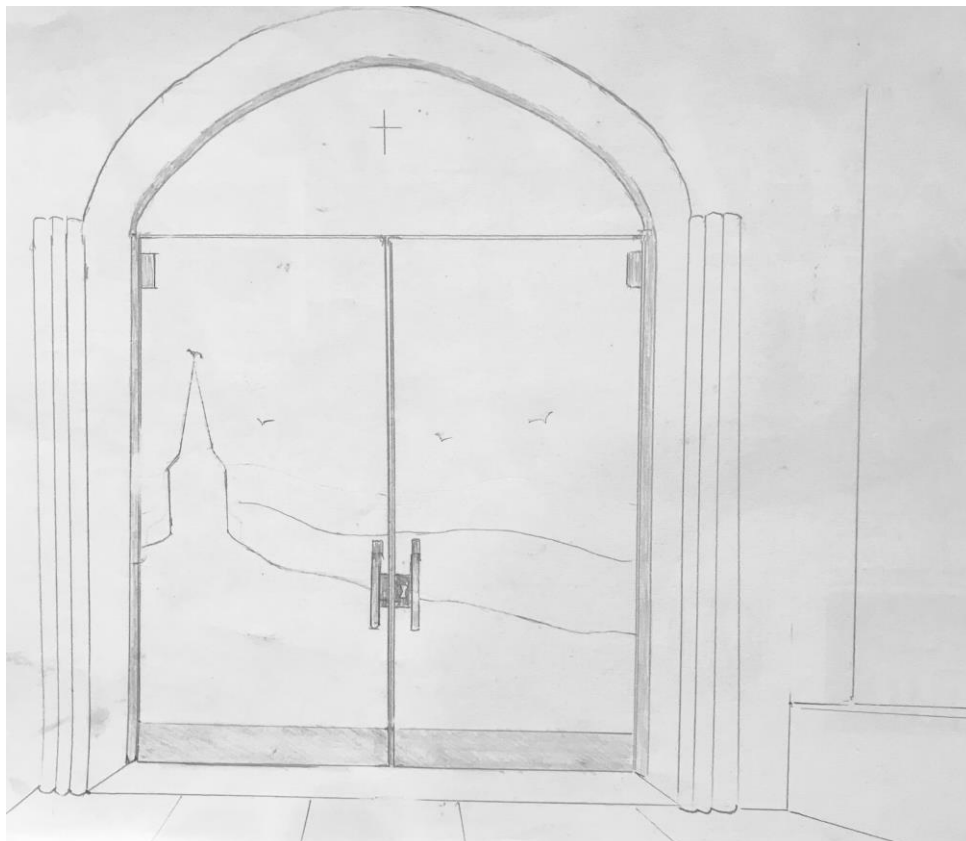
The fenestration will be a vinyl film. It was agreed at the meeting that a simple outline of the church and town would be better than a detailed one, which may over emphasise the door and not the space beyond. The PCC have taken this on board and propose something along the lines of the following.
