## St. Mary Magdalene, Stockland

### Condition Survey with recommendations for a conservation/restoration approach

08/11/24

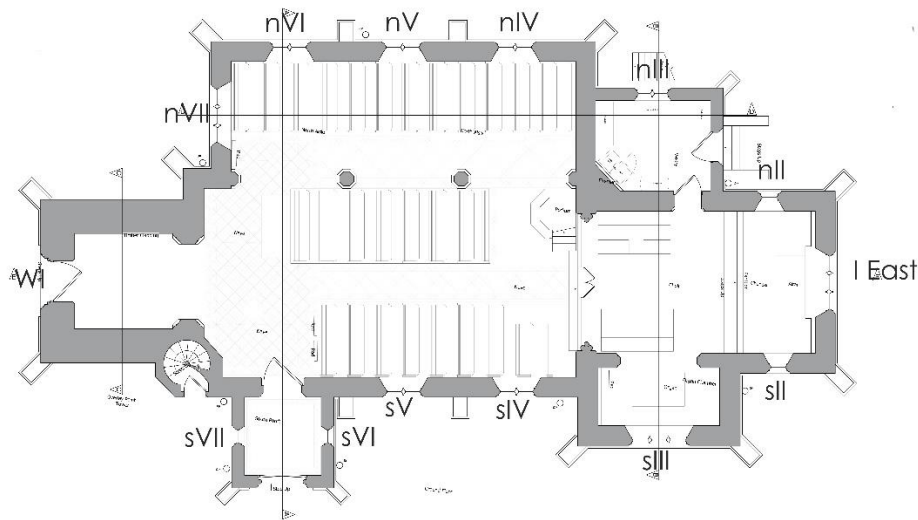
## East window I

A three-light window by Clayton & Bell circa 1860, with trefoil heads, three large quatrefoil traceries, and four subsidiary tracery elements. (Main lights 18 x 89 inches). The subject has scenes from the life of Christ in traceried niches, with censing angels in the traceries.

The glass is good quality, with no signs of deterioration.
