# St Mary Magdalene, Stockland Bristol

Addendum Report on the  
Condition of the  
Structural Fabric

Job Number: 10166

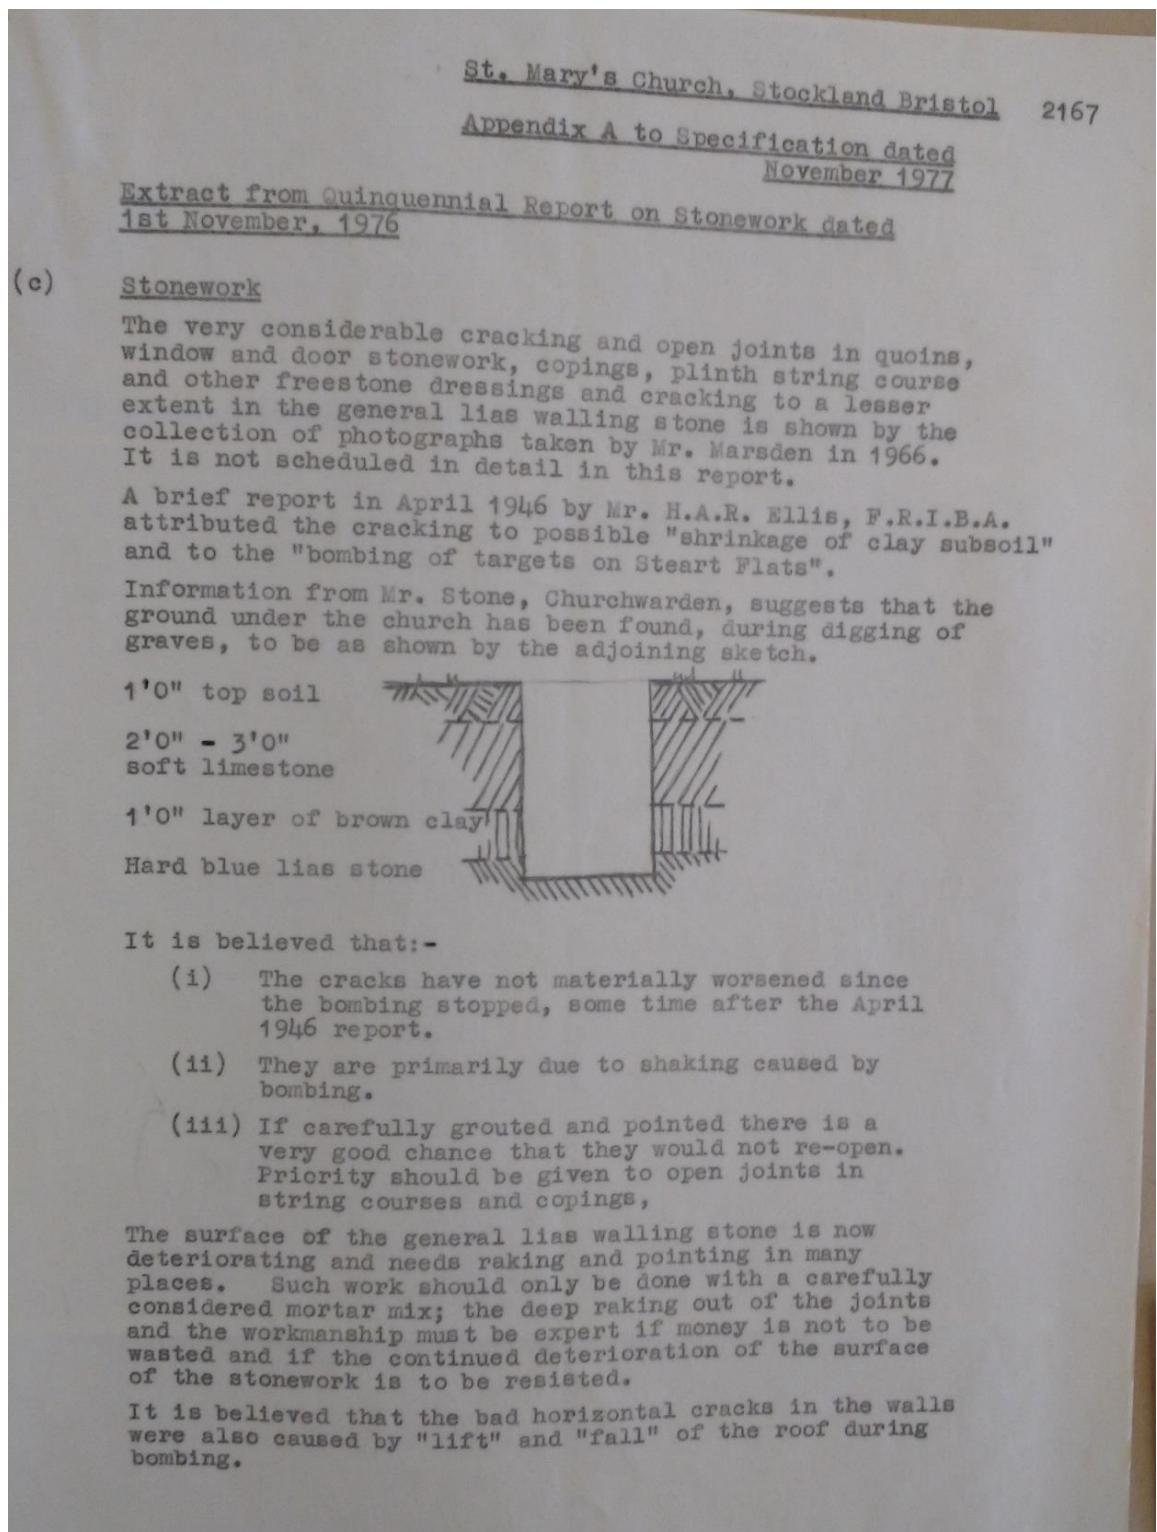
5.1.7 Marcus Chantrey has provided us with this historical note from church records from 1976.

5.1.8 The gravedigger reported that hard blue lias stone was encountered at some 1200mm below ground level, only 300mm below we were able to dig in our trial holes.

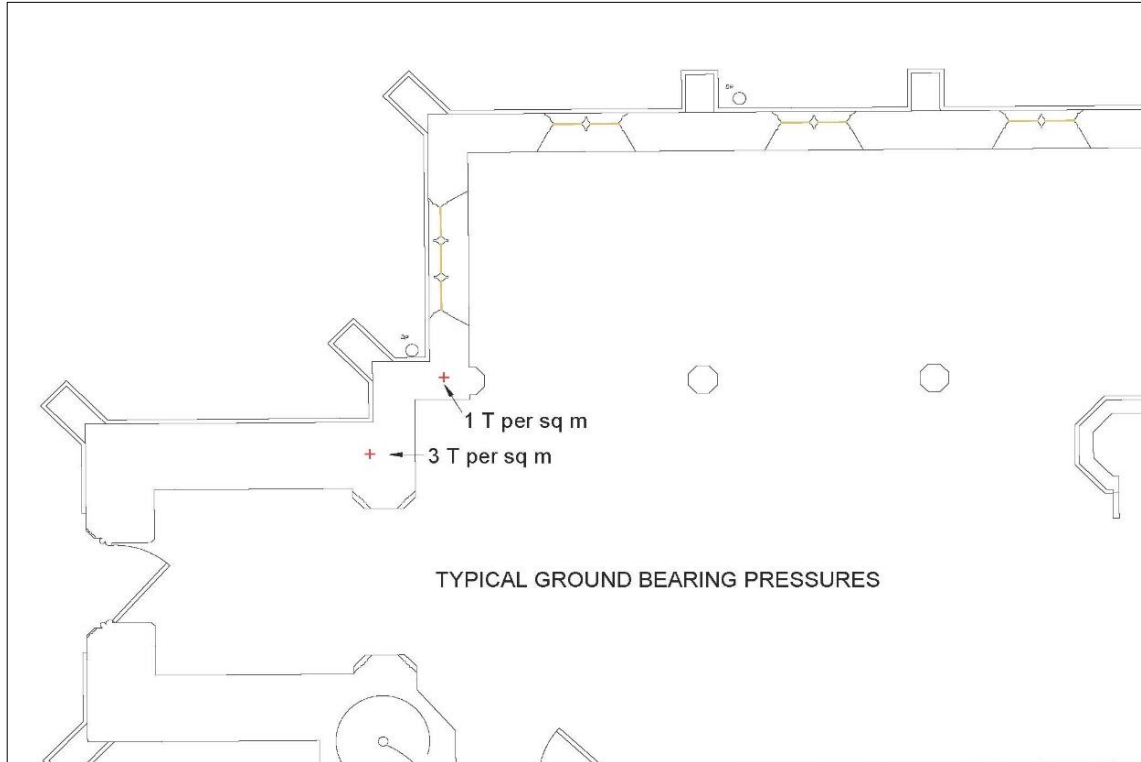
- 5.1.9 If foundation settlement was to be considered a factor in the fabric distortion, an area of the church should be examined where ground bearing pressures change within close proximity. For instance, the tall tower will be exerting something in the region of 3 tonnes per sq. metre bearing pressure on the material below the footings. The nave walls which immediately adjoin the tower will be exerting much less – a maximum of 1 tonne per sq. metre. If ground movement were a significant factor, then tearing of the fabric at the interface would be apparent. There are no signs of this.

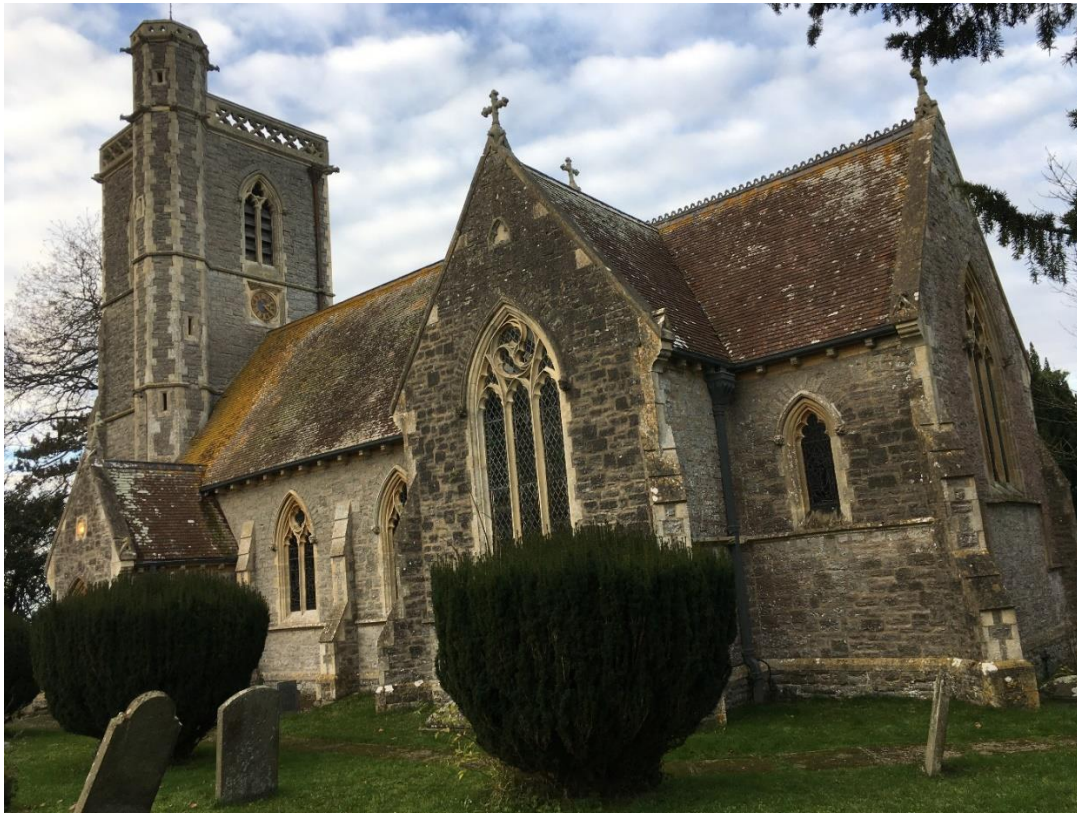
St Mary Magdalene as it stands now

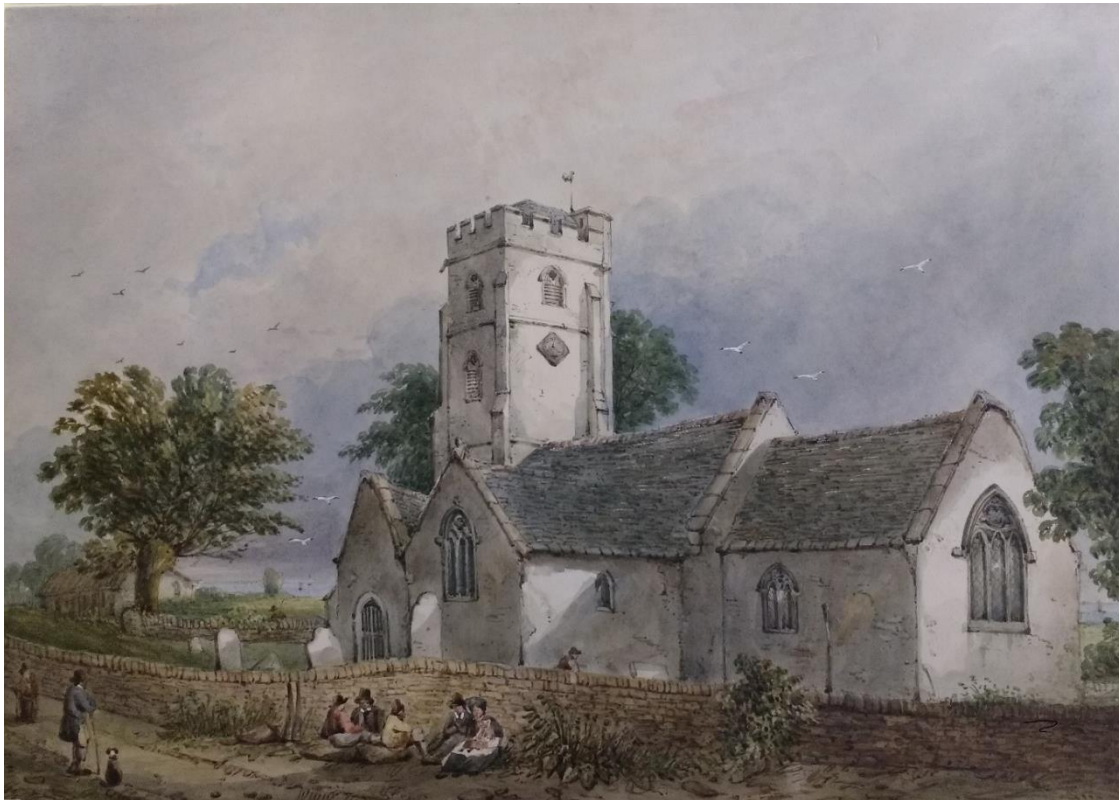
Original St Mary Magdalene before demolition as per print in vestry.
