# ST MARY MAGDALENE, STOCKLAND BRISTOL

CONDITION REPORT  
Selected Masonry, Windows and Tower Parapet  
St Mary Magdalene Church, Stockland Bristol TA5 2PZ

Client: PCC of St Mary Magdalene Church, Stockland Bristol  
Job No. 3401  
August 2024

Masonry Survey and Mortar Analysis  
St Mary Magdalene Church, Stockland Bristol  
CONDITION REPORT

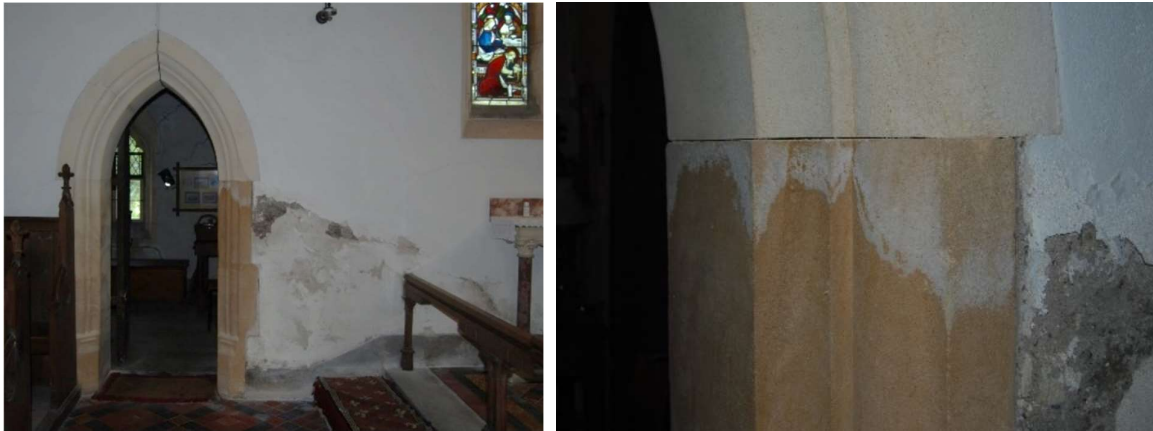
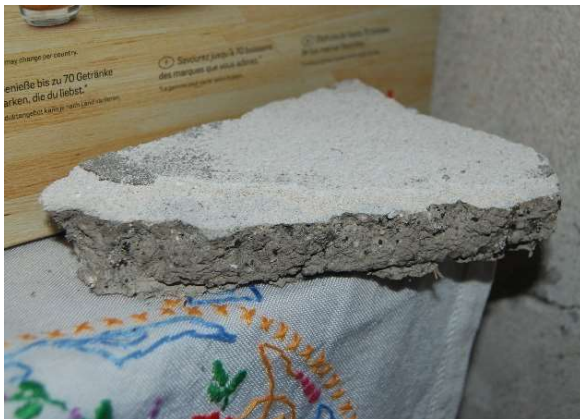
Figure 10 Fragment of mortar from the internal vestry wall.

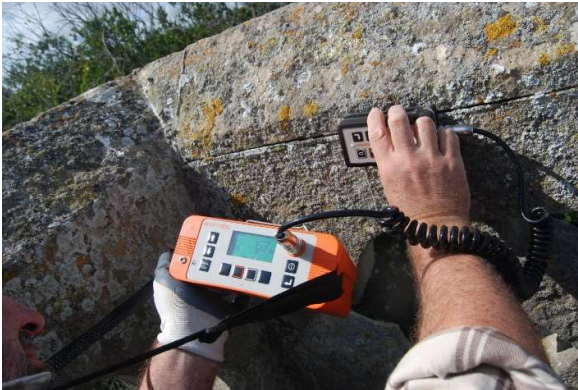
because of the level of corrosion. The visible fixing that was found in the broken section of masonry would suggest that this fixing method was used throughout the parapet, and this theory is supported by the discovery of a small 'slot' in the same position on the joint of all of the stones, indicated by a small mortar infill. It was not possible to confirm the presence of iron in all of these locations using the cover meter, however the rope access tower inspection may be able to provide further evidence. Lifting of the coping stone and opening of the joint was noted in the coping stone to the south west corner (west elevation) and ironwork was detected at a depth of 67mm (approximately) within this stone - this may have been picking up the vertical pin through the top of the stone.

Figure 15 Opening up of the coping stone joint in the south west corner (west elevation), and detection of iron fixing in this location.

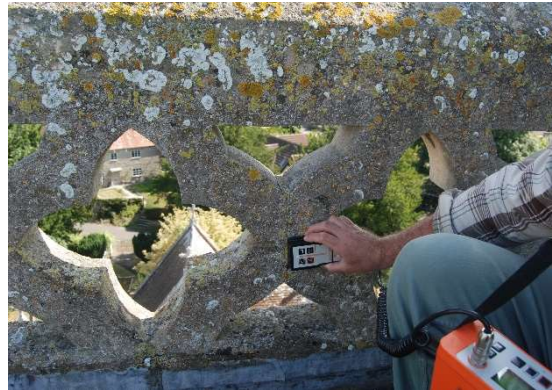
Figure 16 Example of an iron fixing detected at the centre of a panel on the east elevation. It is assumed that all panels contain similar central iron fixings.

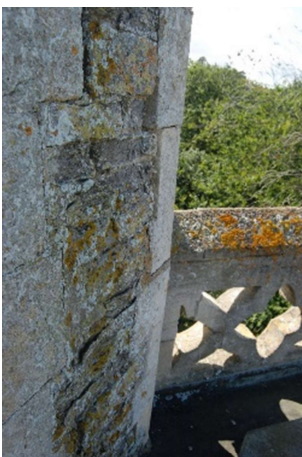
The visible upper section of the vice turret is in very poor condition, both in terms of the structure and the surface of the stone. The structural stability is of concern given the level of movement and lack of overall integrity. The blue lias is heavily delaminated and decayed, with large open joints and displacement throughout. The Bath Stone quoins/dressings appear loose, are displaced and are repointed in cement mortar. There is a large, notable crack to the door head, within which a large ferrous pin is visible. The iron ring that is noted in the structural survey is just visible on the south west side of the turret below parapet level.

Figure 24 Weathered blue lias surface to the vice turret on the north west side.

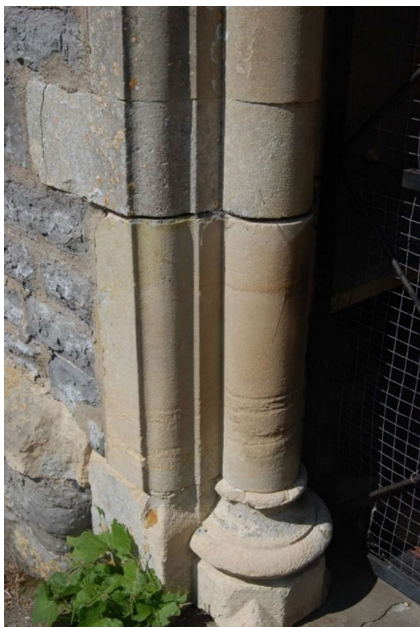
Figure 41 Displacement and open joints to lower west jamb

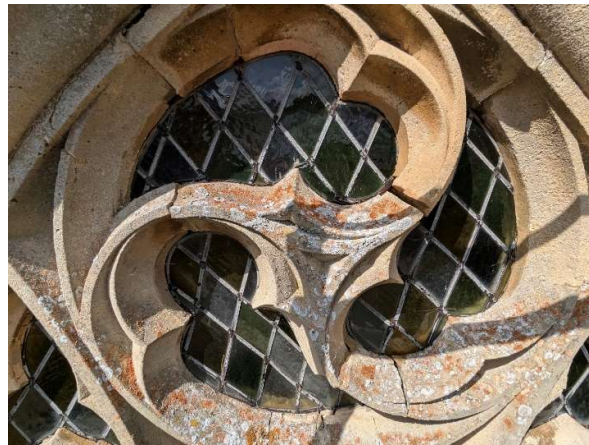
Figure 51 Extreme movement through the tracery head

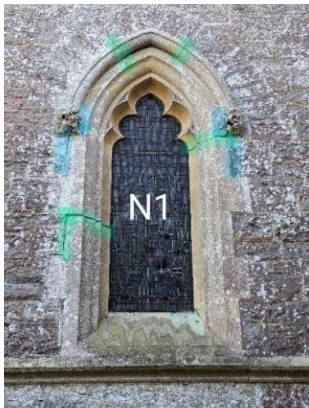
Figure 68 Chancel north window 1

The small window on the north chancel has open joint and displacement through the hood mould and jambs, with a particular shift on the east jamb at mid height.

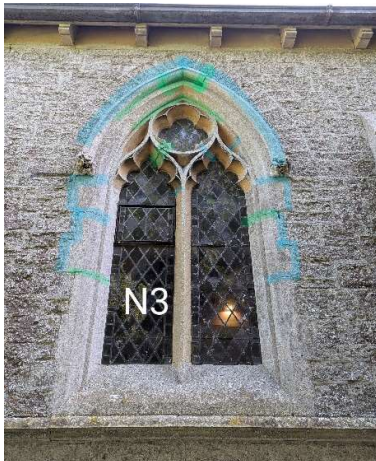
Figure 70 North aisle window 3

The first window to the west of the vestry on the north aisle has particularly pronounced movement through the hood mould key stone and in some areas of the tracery. The jambs remain in reasonable alignment but with open joints.

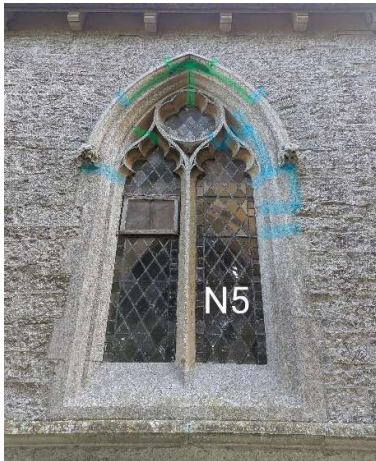
Figure 73 North aisle window 5

The opening of the central joint to the hood mould and voussoirs continues down through the upper section of the tracery. The jambs are not showing significant movement but have some open joints at the upper levels.
