# Rope Access Condition & Recommendation Report

**Rope Access Condition &  
Recommendation Report for  
St Mary Magdalene Church,  
Stockland Bristol –  
September 2024**

**Job number: 3535**

**Client: Marcus Chantrey**

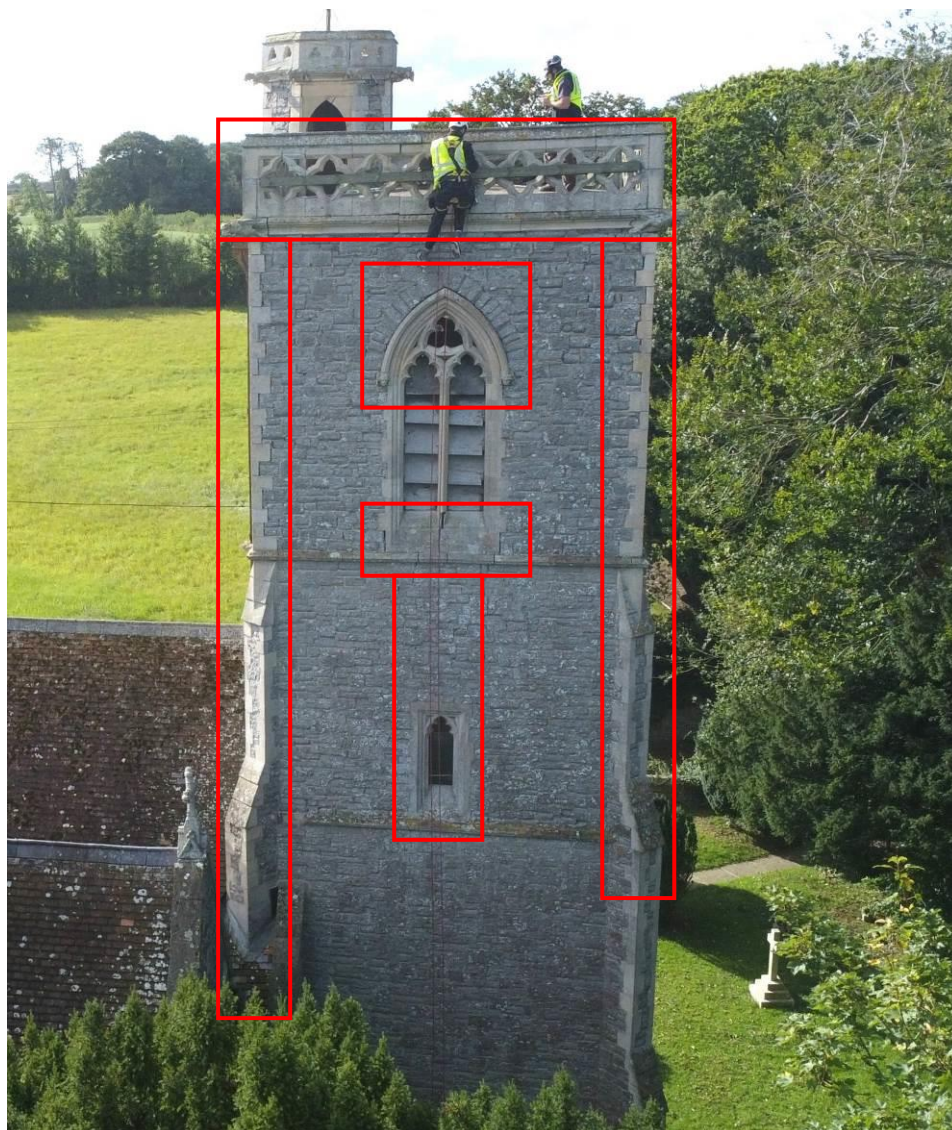
Figure 11 - DJI\_0191 Locations of Structural Issues in North Elevation

The parapet in the north elevation is in very poor condition, exacerbated by what is believed to be a rusting ring beam lifting or 'jacking' the masonry. This is combined with the upward force of the lias masonry swelling and/or the non-window vertical lines of the building effectively subsiding into the ground. The parapet is currently braced with a temporary timber structure, but it still leaves the parapet in a very precarious state and so requires completely rebuilding. If a rusting ring beam is present, it requires removing and re-fixing with a stainless-steel replacement specified by a structural engineer. Considering the ongoing deterioration of the lias masonry and the ground conditions, the structural engineer might wish to specify additional fixings to reinforce the parapet and make it more able to withstand further movement in the future. Numerous masonry fractures require pinning repairs and rusting iron fixings require removing and replacing with stainless steel replacements before reassembling the parapet. At least one section of the parapet panels will require a piecing-in repair.

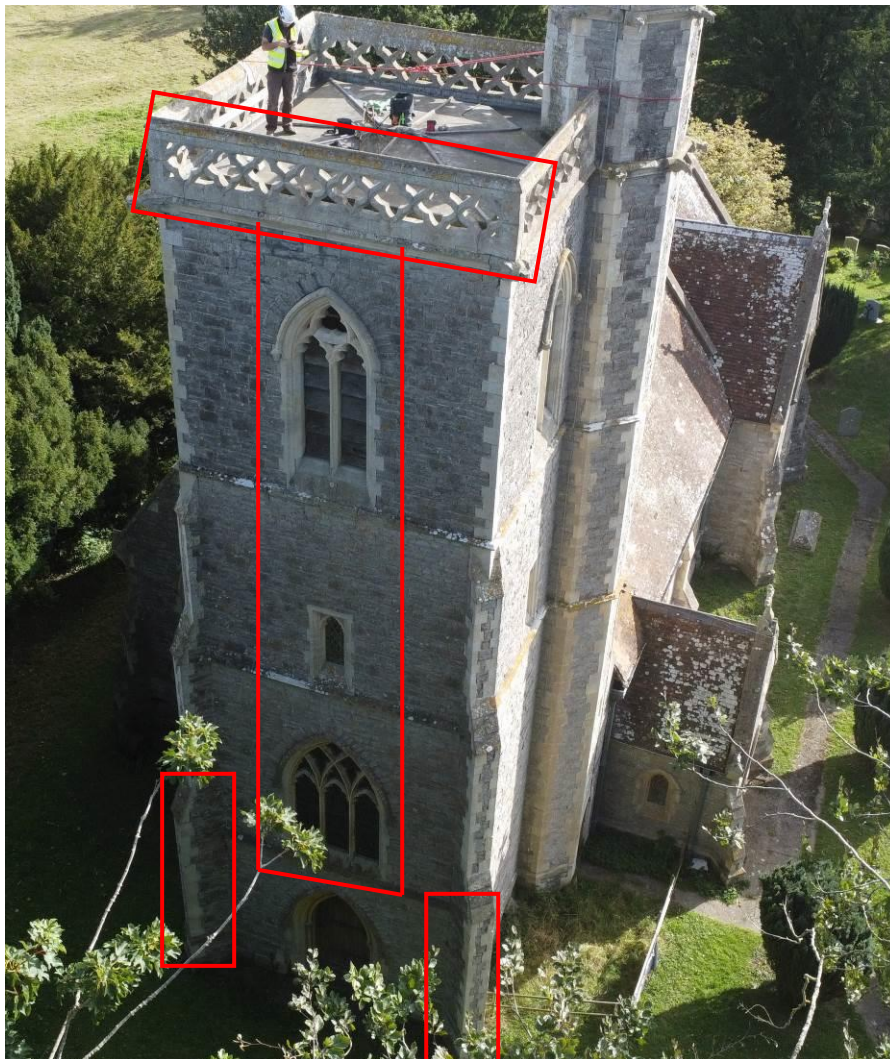
Figure 25 - DJI\_0198 Locations of Structural Issues in West Elevation

The cement pointing and associated masonry decay is in very poor condition, especially in the 2<sup>nd</sup> stage around the west window.

There are masonry fractures and open joints throughout the west window, west door and the 2<sup>nd</sup> and ground level buttresses to ground level. In essence, evidence of structural issues is visible through the whole height of the tower in the west elevation.

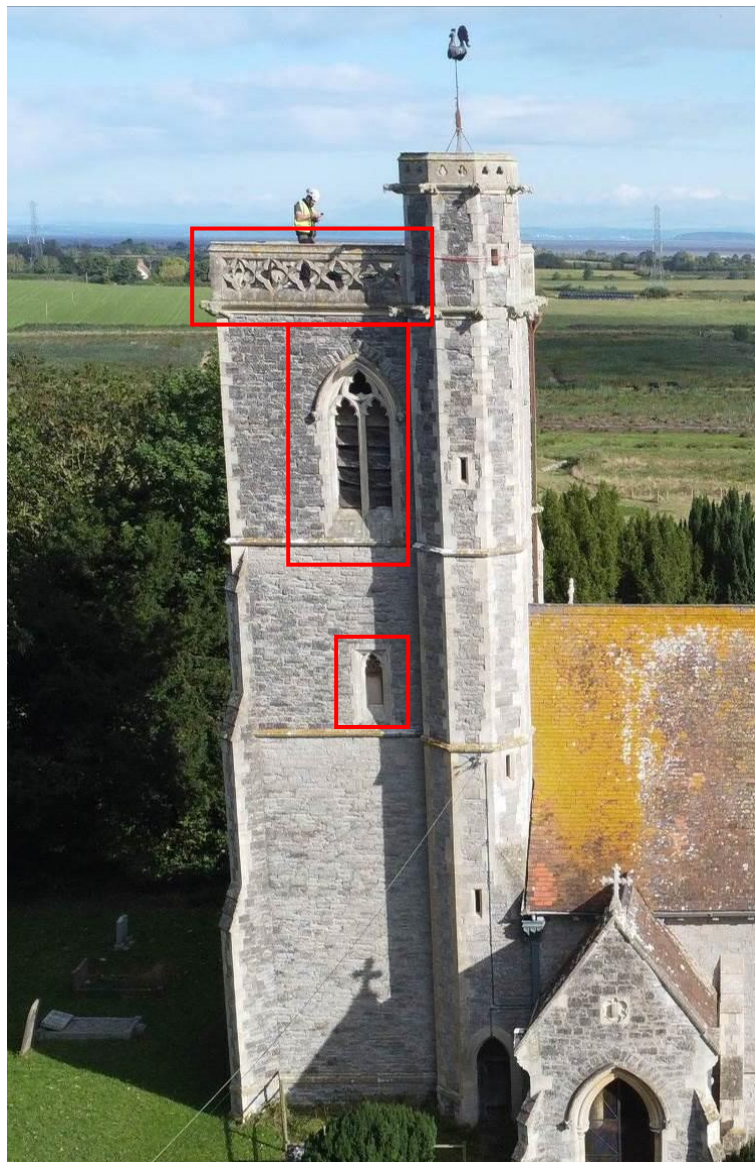
Figure 33 - DJI\_0196 Locations of Structural Issues in South Elevation

There are similar open joints around the belfry window hood, tracery, sill, string course and tower edge quoins. The string course is also slightly raised in the centre below the belfry window sill and associated fractures are visible in the string course and reveal bases. There does not appear to be an obvious open joint system below the belfry window string course but there are associated masonry fractures in the 3<sup>rd</sup> stage window header, sill and string course.

The cement pointing and associated masonry decay are in fair to poor condition throughout, but better than the north and west elevations.

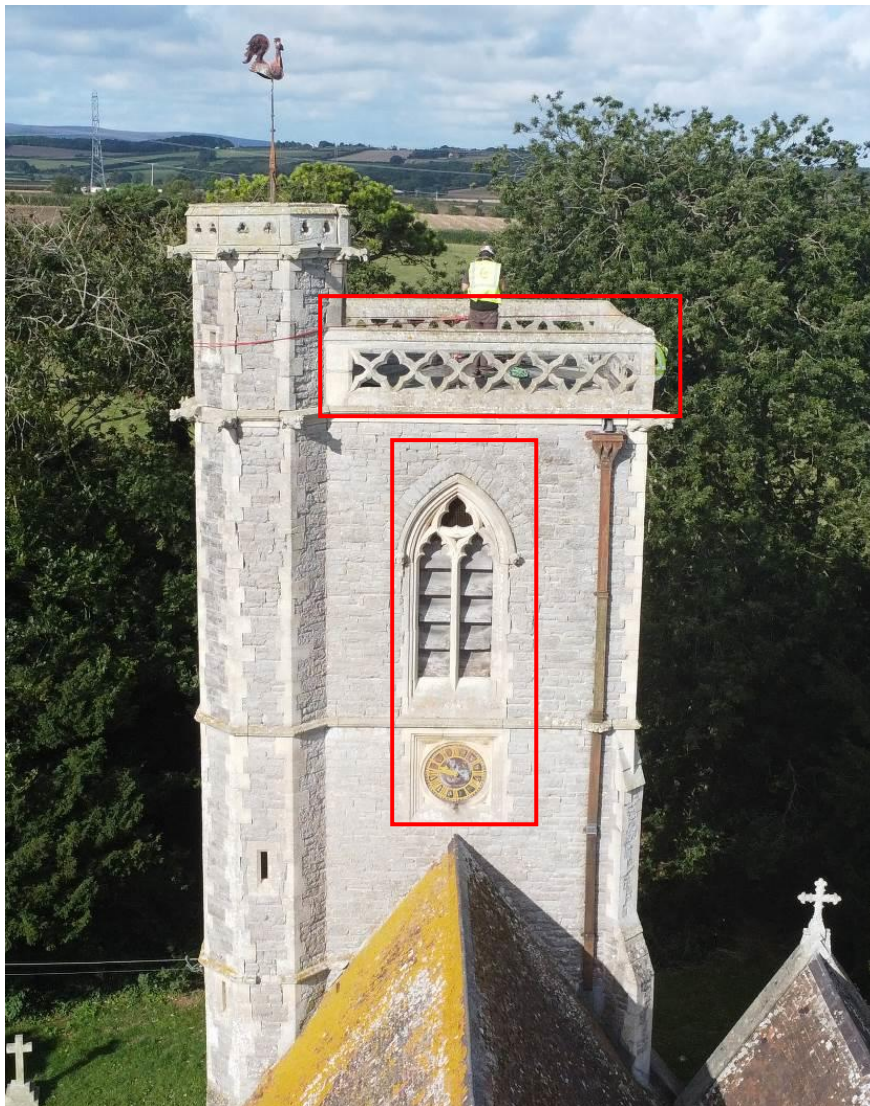
Figure 36 - DJI\_0193 Locations of Structural Issues in East Elevation

The walls are in fair condition compared to the north and west elevations, but the cement pointing does all however require removing and re-pointing with lime mortar. Deep-pack pointing is required in the open joints around the belfry window hood, tracery, sill and string course, but the quoins appear generally stable apart from isolated pieces and some open joints. There is an open joint and fracture system extending below the belfry window string course and through the clock face masonry, just above the ridge roof.

The tracery and mullions appear to have dropped as opposed to have risen when compared to other elevations. This is likely due to the structural movement interactions of the internal arch with the rest of the tower and nave below.

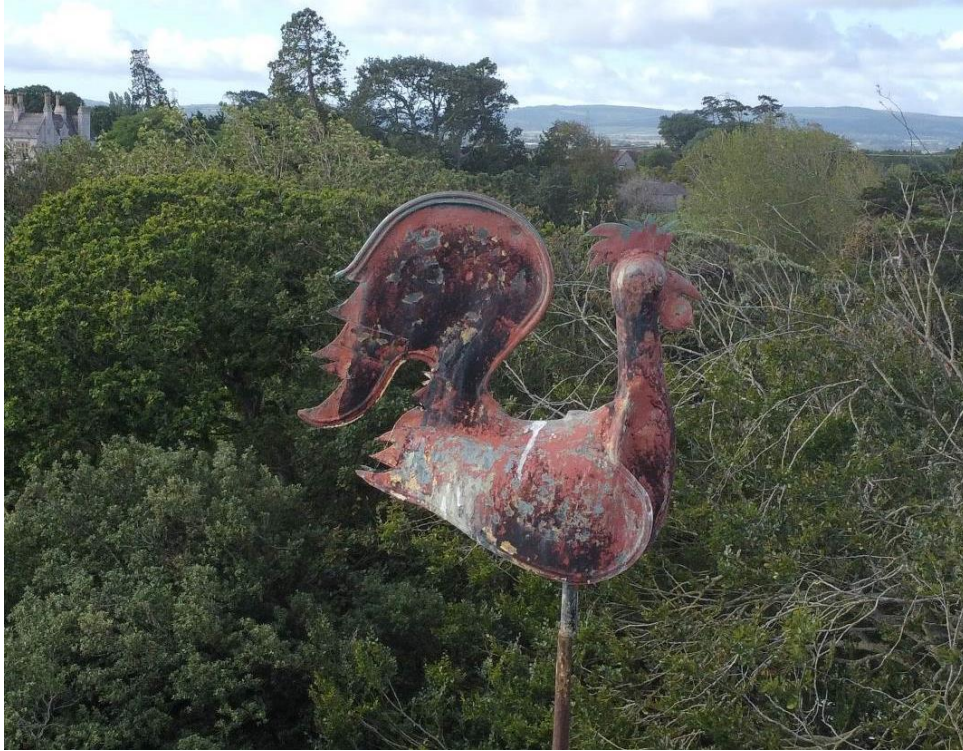
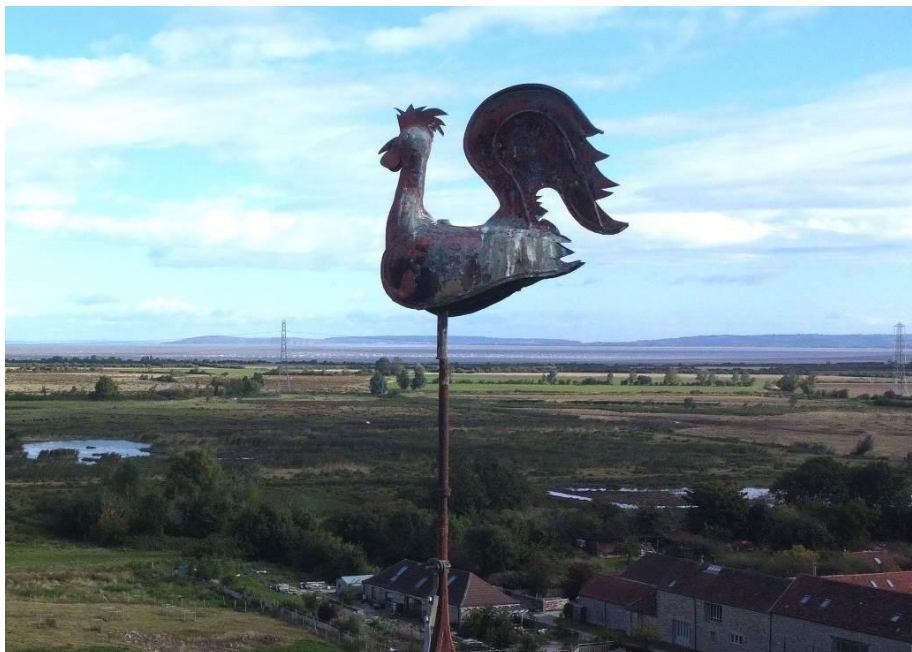
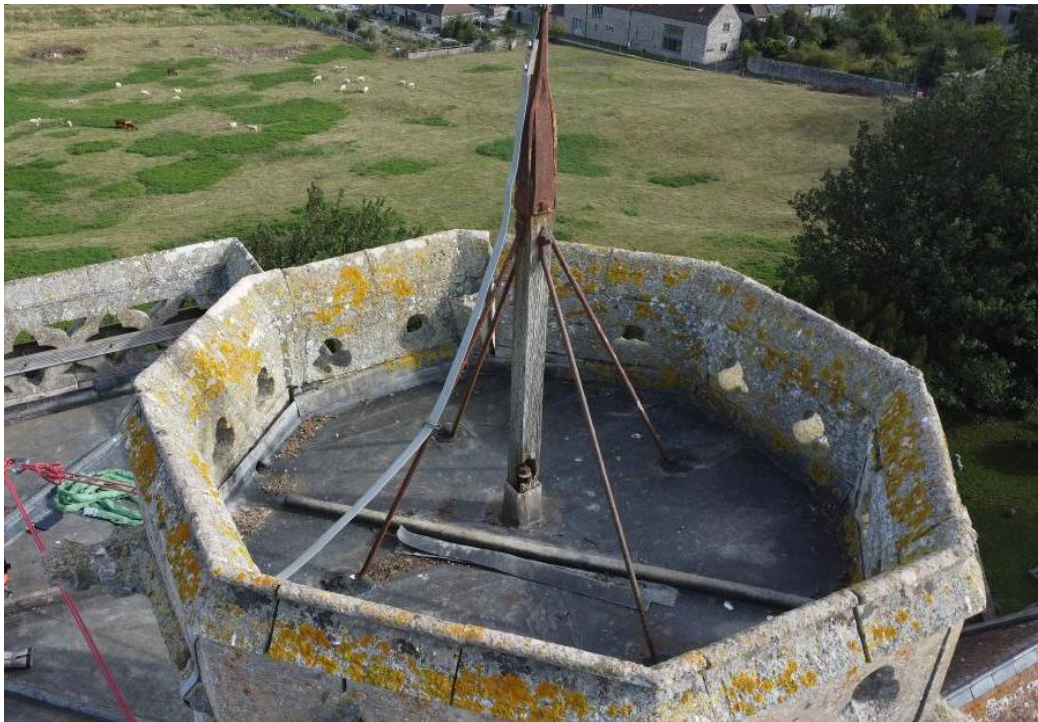
While the stair turret is dismantled and rebuilt, the weather vane can also be dismantled and repaired. The weather cock requires cleaning and regilding or re-painting while the iron fixings require cleaning, treating and re-painting. Although the metal frame stays appear structurally reusable, the central wooden pole is very rotten, severely compromised and requires replacing.
