CONDITION AND RECOMMENDATION REPORT  
Internal War Memorials and Commandment Boards  
St Mary Magdalene Church, Stockland Bristol TA5 2PZ

Client: PCC of St Mary Magdalene Church, Stockland Bristol  
Job No. 3417  
November 2024

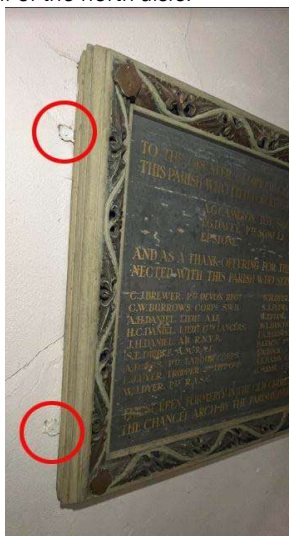
Figure 5 The memorial is attached to the wall with four brackets, two on each side.

Humidity can be present throughout the church environment, especially on outer walls. To prevent deterioration, it is best to avoid traditional display methods (see image 5) as old brackets can trap moisture by holding boards/memorials too close to the wall.
