# Final Conservation Report for The Monument to Evan Beavan Holy Trinity Church – Preston Wynne Hereford Diocese

## Final Conservation Report for the Memorial to Evan Beavan †1814

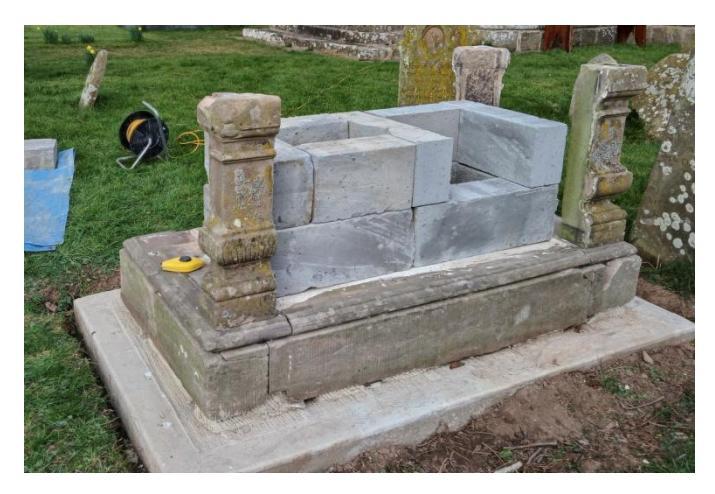
Three of the four pilasters in place to determine the finished height of the internal core, including all bed-joints in the block work.

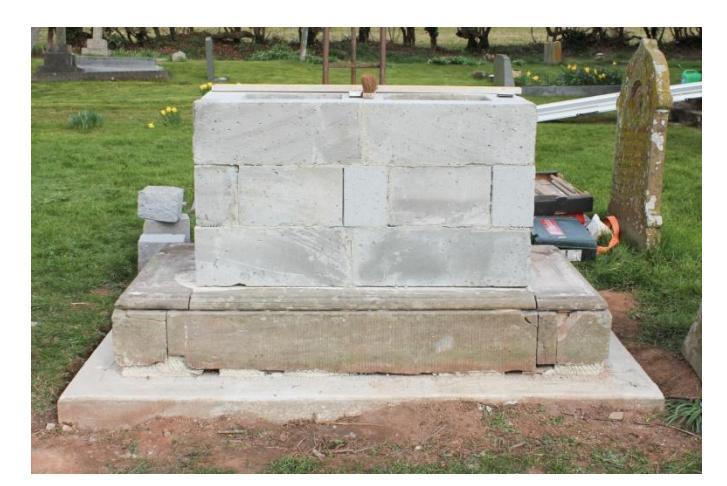
The core nearly completed, with a single course still to be applied to the top bed, to finish slightly higher than the top-bed of the fluted course, such that the core bears the majority of the lid weight.

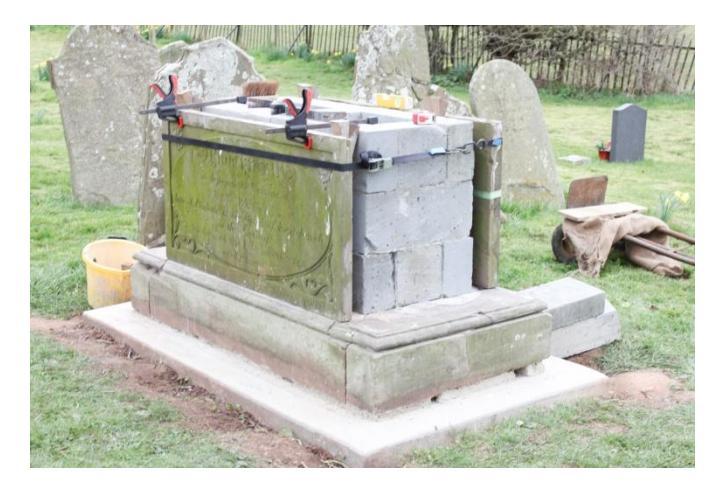
The long panels were secured first to allow positioning of the corner pilasters and short panels, which were by no means uniform, obviously being cut by different hands.

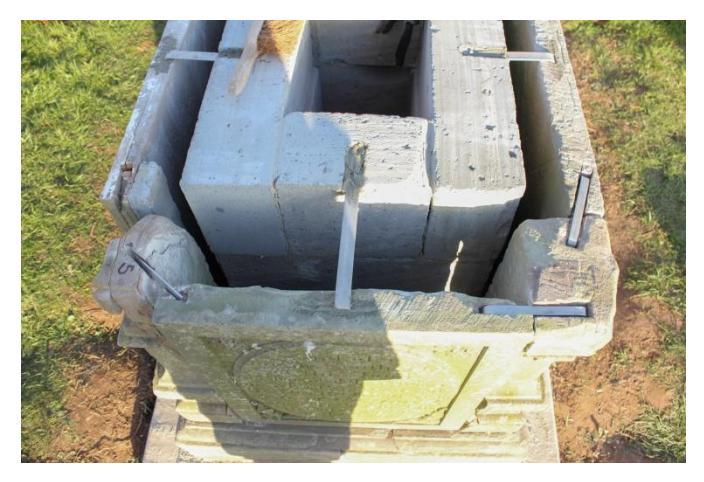
The internal depth of the pilasters (which were all different) dictated the internal dimensions of the supporting core. Bespoke stainless-steel fixings were used to secure the side panels back to the core and the pilasters back to neighbouring side panels.

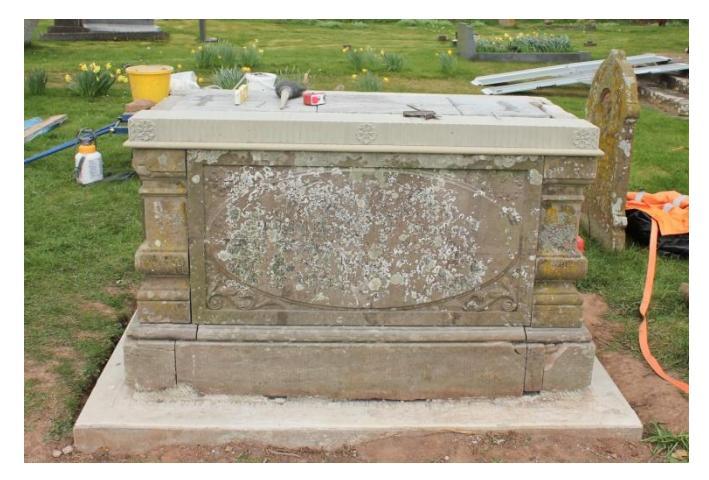
The thinner, albeit no less substantial fluted course in place and also secured back to the supporting core.

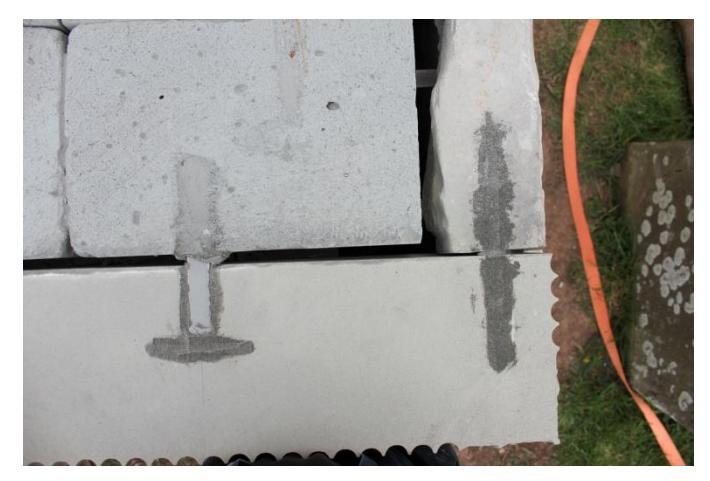
The top course of light-weight blocks of the core were cut/shaped to provide the largest surface area for the overlying lid.

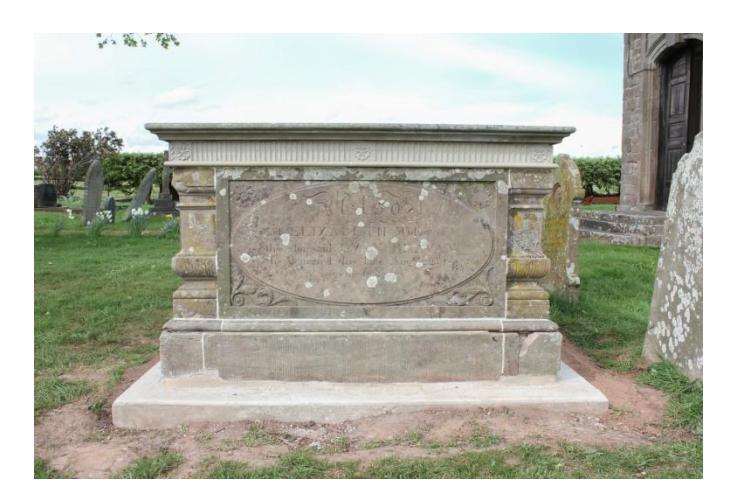
The lid in its final position after removal of excess material from the bottom-bed. The new fluted stone is the same geologically as the original material but much better quality and will tone-down in the short-medium term.

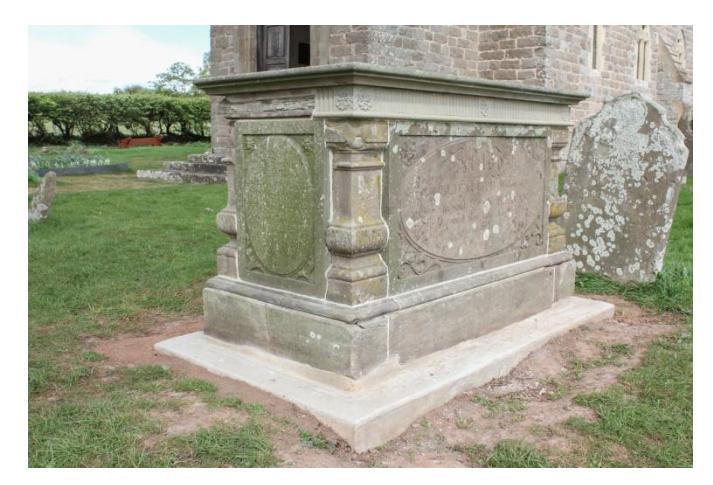
The newly carved section to the rear of the memorial.

- 3.3 The south, long-side, fluted block was replaced with a new piece of stone, which helps bear a little of the weight of the lid. It is formed in 2 separate pieces stuck together with an external grade resin. The upper fluting having been formed by a vertical milling machine (and not chiselled, adding shock into the stone) with the lower bull-nose moulding formed with a masonry router. The rose motifs at the corners and midway along its length where carved by hand, with the fluting also finished by hand so it didn't look so 'machine-cut'. Carving it by hand completely would have been much more laborious and therefore prohibitively expensive.
