# Bath Abbey

## The Tower Roof: Re-covering etc.

## Project summary

## BATH ABBEY, BATH: TOWER ROOF PROJECT

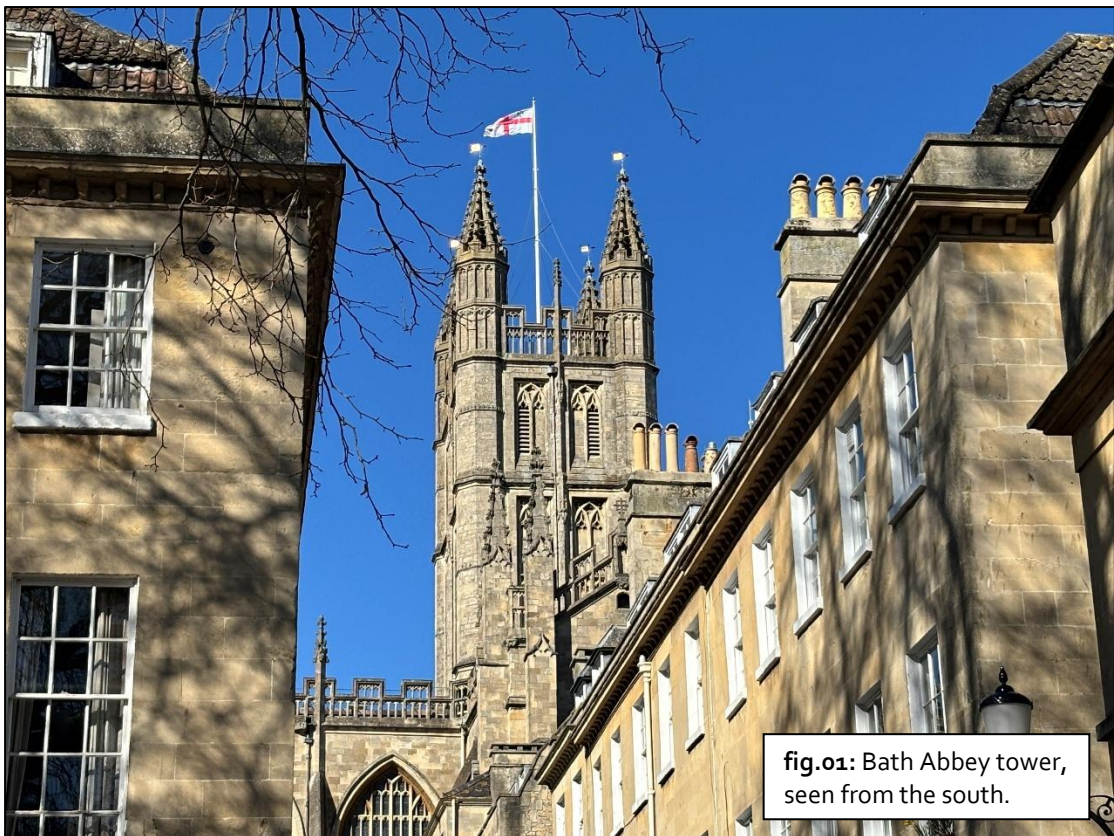
fig.01: Bath Abbey tower, seen from the south.

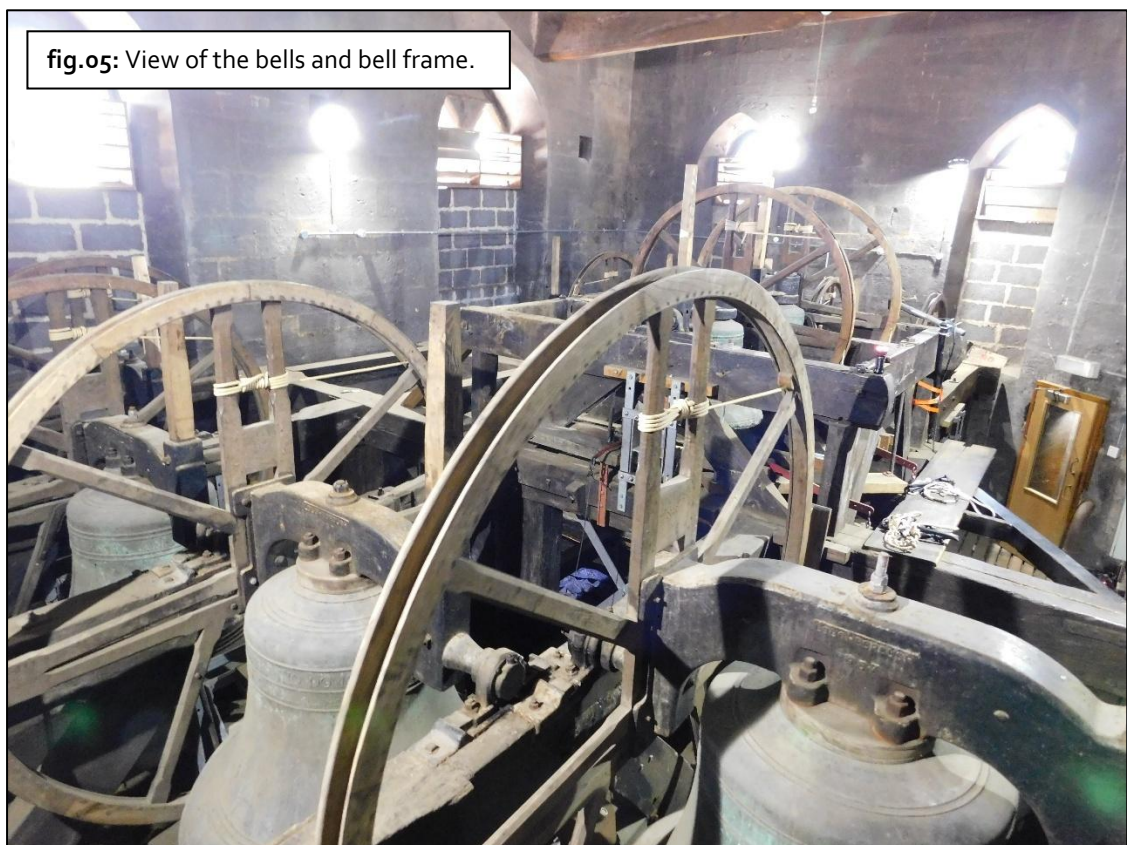
## 2.05 The bell frame

- b Whites of Appleton inspected the frame in June 2024 and their report <sup>7</sup> notes that modifications to the frame over the years, mainly to accommodate mechanisms related to the clock, have affected the structure. They attended to some repairs in 2004 and again in 2014, addressing problems caused by a water leak through the north-western corner of the roof, and deterioration where rot had set in in localised places. Repairs were generally achieved through the use of steel strengthening brackets etc.

- c Their report concludes as follows: '*...we do not consider it to be a particularly good example of this design of frame from this period, particularly as the bell frame is no longer in its original condition, having been adapted and repaired over the years, as well as considerable sections having been cut out for clock hammers. Bell frame movement is moderate and every effort has been made to strengthen it and in this respect it is currently sound and requires no maintenance works other than the routine tightening of the ironwork.*' These conclusions are echoed by Nicholson Engineering in their report. Necessary repair and maintenance of the bells and frame were carried out by Whites of Appleton in 2024, under list A of the Faculty Jurisdiction (Amendment) Rules 2019.
