## **BELFRY ROOF STRUCTURE BATH ABBEY, SOMERSET**

### **Historic Buildings Assessment**

ASE Project No: 240405  
ASE Report No: 2024181

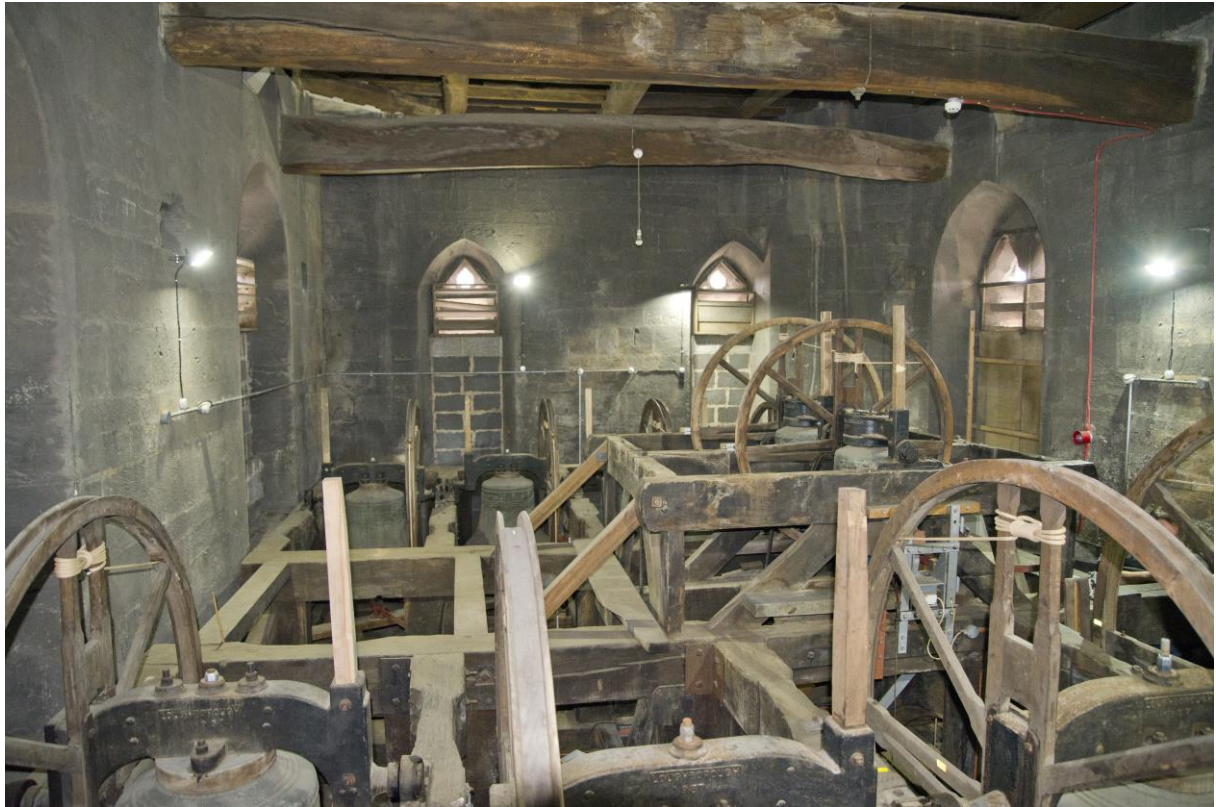
**Plate 3** – General view of the belfry, looking south

6.1 The belfry is of ashlar stone construction, pierced by pairs of louvred openings in each of its four walls (now partially infilled with modern concrete blocks; Plates 1-6). Large square putlog holes are present around the wall, at the level of the springing of each of these openings. The space is almost entirely occupied by the great bulk of the bell frame, with its ten bells. This is dateable to at least the late 17<sup>th</sup> century on the basis of a graffiti date of 1674 on a straight brace, and bears repeated episodes of apotropaic markings to deter malign spirits, including overlapping circles and Marian marks (Plate 7; Easton 2016). The core of the frame is probably of earlier date, however, conceivably original to the early 16<sup>th</sup> century tower, since here the braces are curved rather than straight (Plate 8).

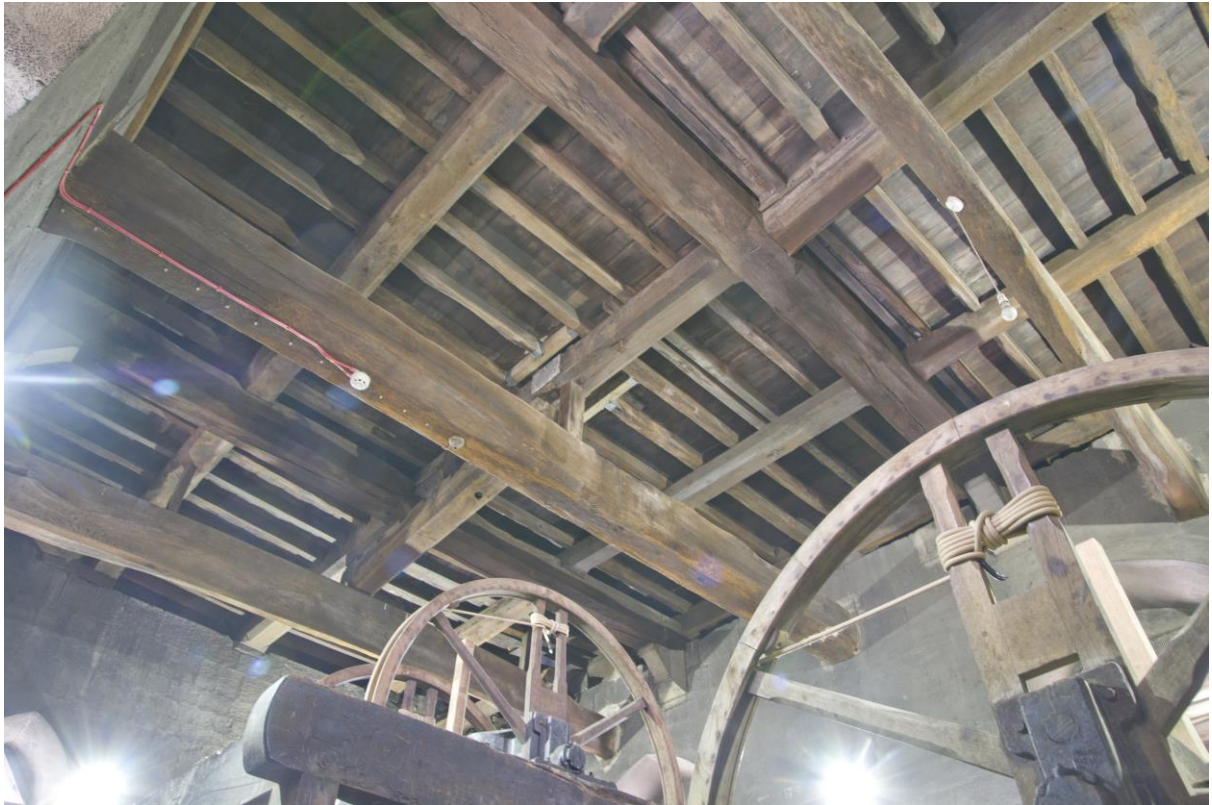
**Plate 9** – General view of the roof structure, looking north-east

6.2 The flat roof of the belfry is essentially constructed in a similar manner to a medieval or early post-medieval floor, comprising a pair of substantial cross beams which run the full 6.4m width of the rectangular structure, dividing it into three bays of c.3.0m apiece (Plate 9). Each of these bays is spanned by shorter axial beams, which in turn carry the smaller joists (c.1.3-1.4m apiece) that bear the sarking boards of the lead roof above. Diagonal dragon ties are present at wall-plate level to the north-west and south-east corners; the other two corners are occupied by the newel stair and a redundant pulley system relating to the abbey clock. A further three cross beams are present at a lower level to the roof, and do not form a part of its structure.

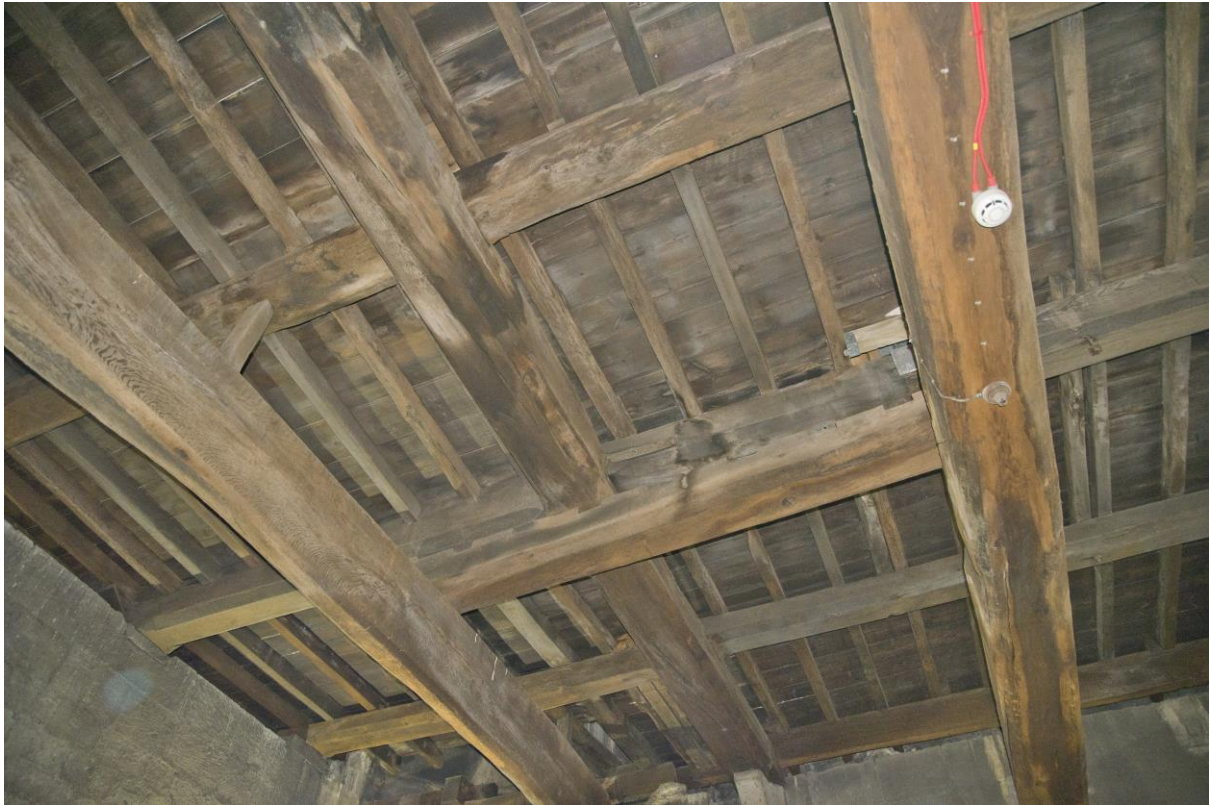
**Plate 13** – General view of the roof structure, looking east

- 6.4 The northern of the two cross beams still appears to be of oak, but it bears a combination of step-and-runout and simple runout stops to its chamfers, and is markedly crisper and straighter than its southern counterpart, suggestive of machine sawing (Plate 13). On the evidence of the corbels, it is likely that it dates to the late 19<sup>th</sup> century restoration of the church under George Gilbert Scott.

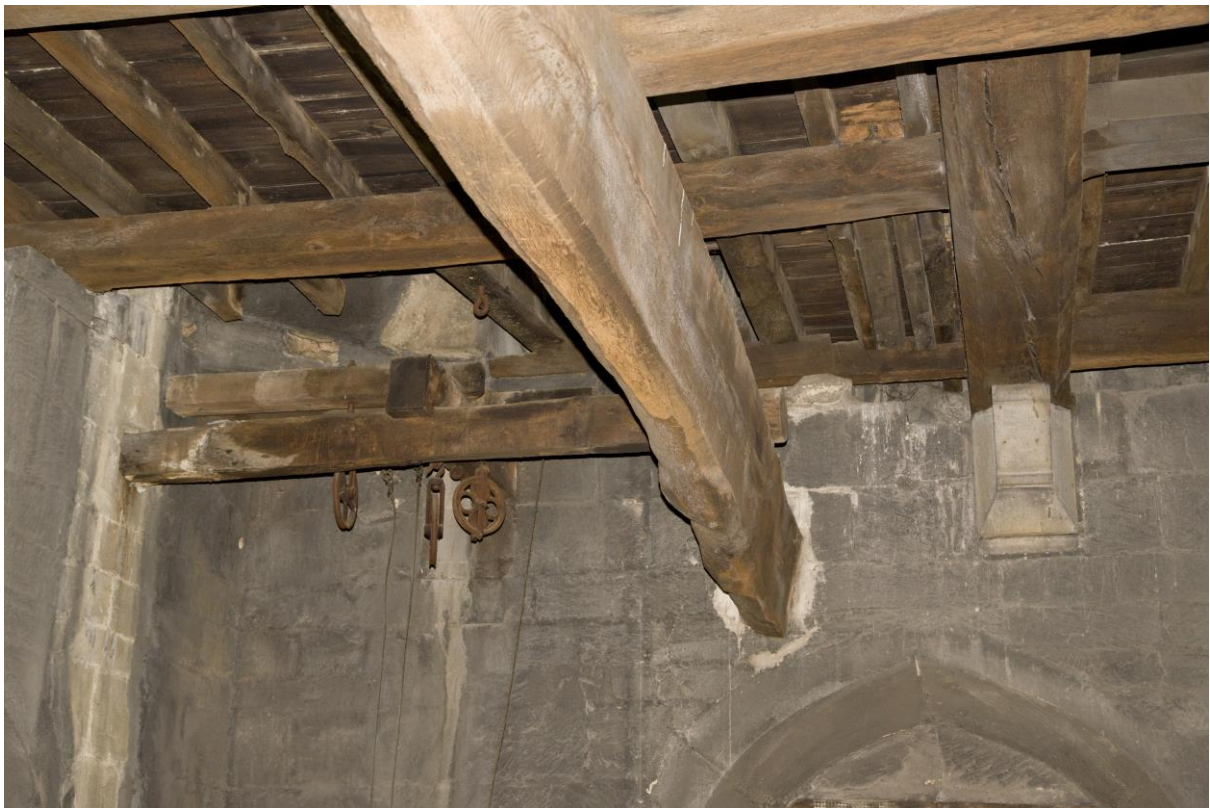
**Plate 20** – North-east corner of the roof, showing lower cross-beam and 19<sup>th</sup> century clock structure. View looking east

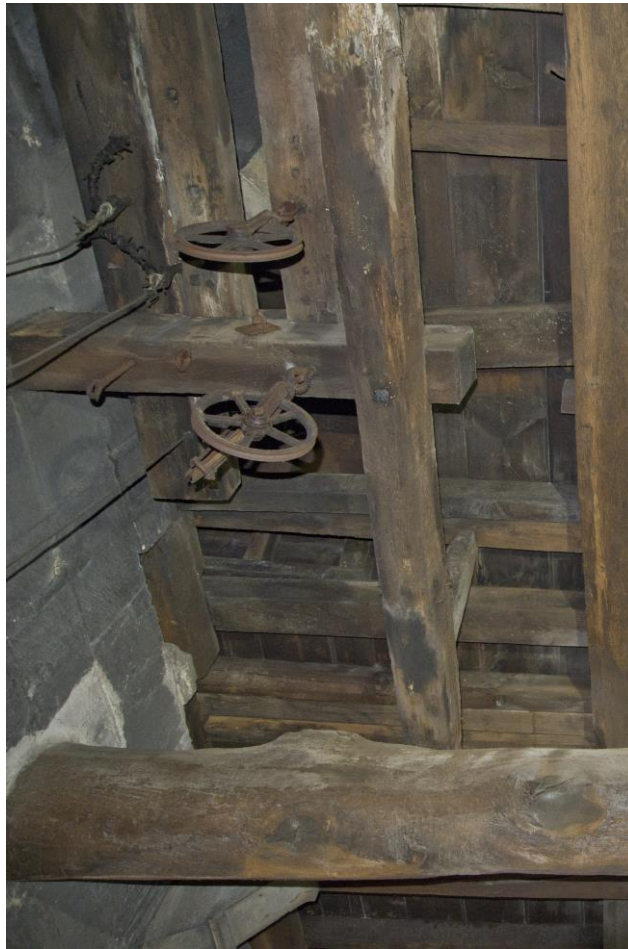
**Plate 21** – North-east corner of the roof, 19<sup>th</sup> century clock structure. View looking south
