THE CATHEDRAL STUDIOS

St Mary the Virgin Church Hastingleigh

nVI

Final Report on the conservation of the historic stained glass

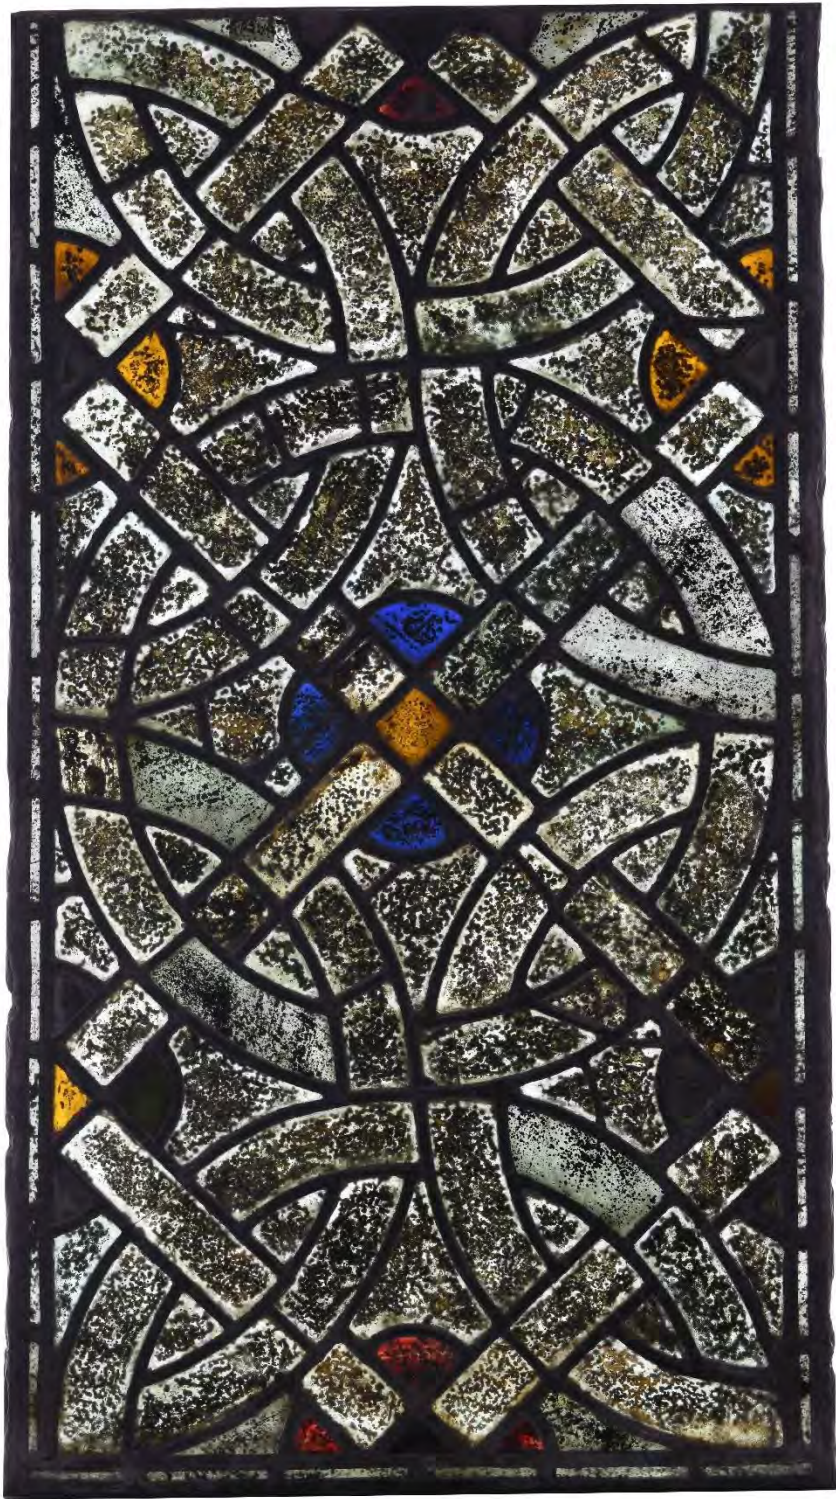
Location: St Mary the Virgin, Hastingsleigh	Window: nVI
	Panel: 1a
Before Conservation Internal	Image Information: Digital, Studio darkroom, transmitted light

1a has twenty-eight border glass pieces and ten glass pieces in the main body of the panel that are modern replacements painted to mimic age, dirt, and corrosion. Three replacement pieces of coloured glass are stopgaps made of possibly re-used Victorian glass.

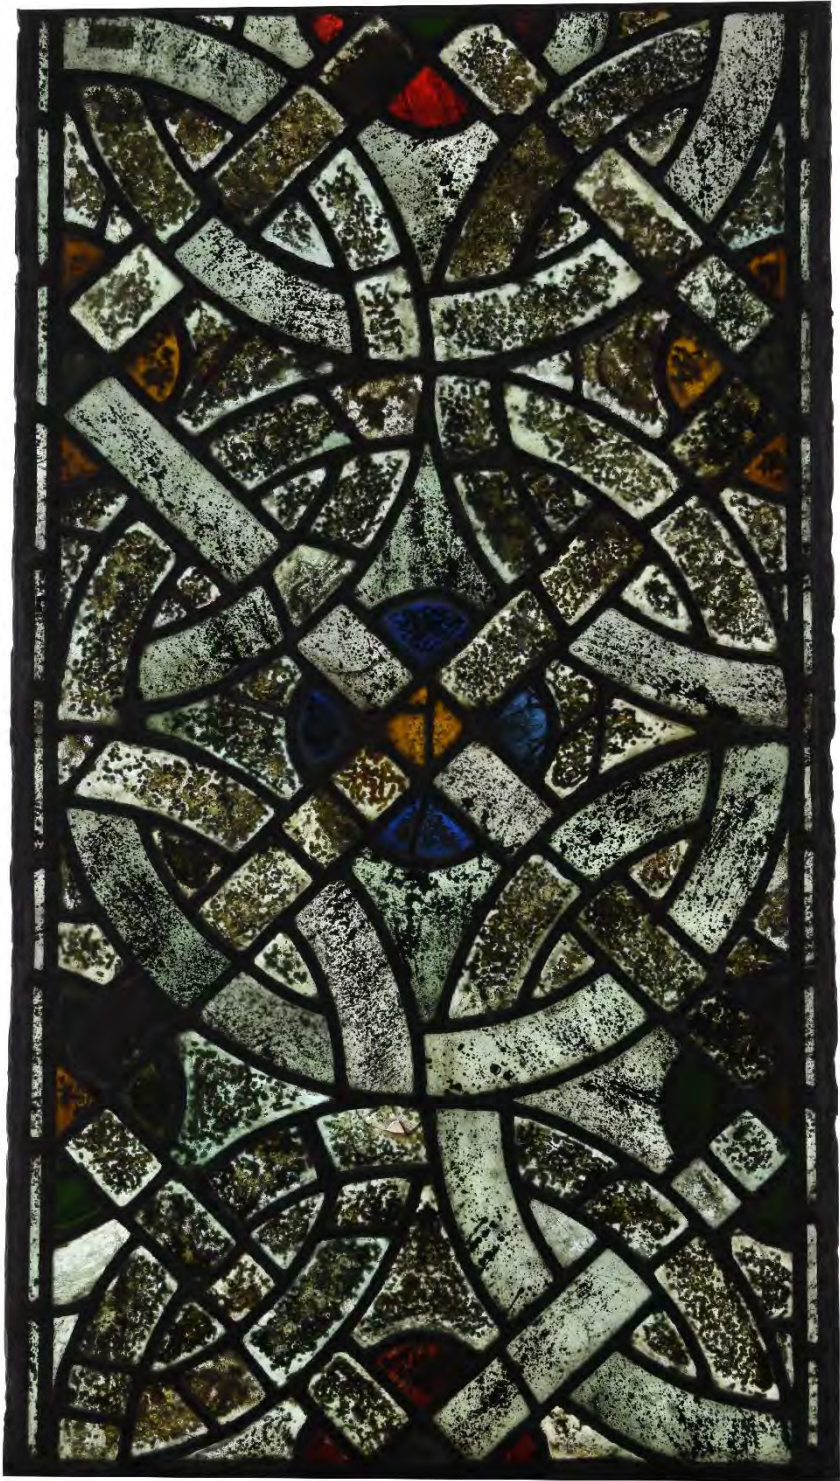
Location: St Mary the Virgin, Hastingsleigh	Window: nVI
	Panel: 2a
Before Conservation Internal	Image Information: Digital, Studio darkroom, transmitted light

2a has clear silicone used in two places to fill holes in the glass. One is at the top of the panel, and the other is lower down and secures a complex set of cracks. This was likely added in situ from the exterior.

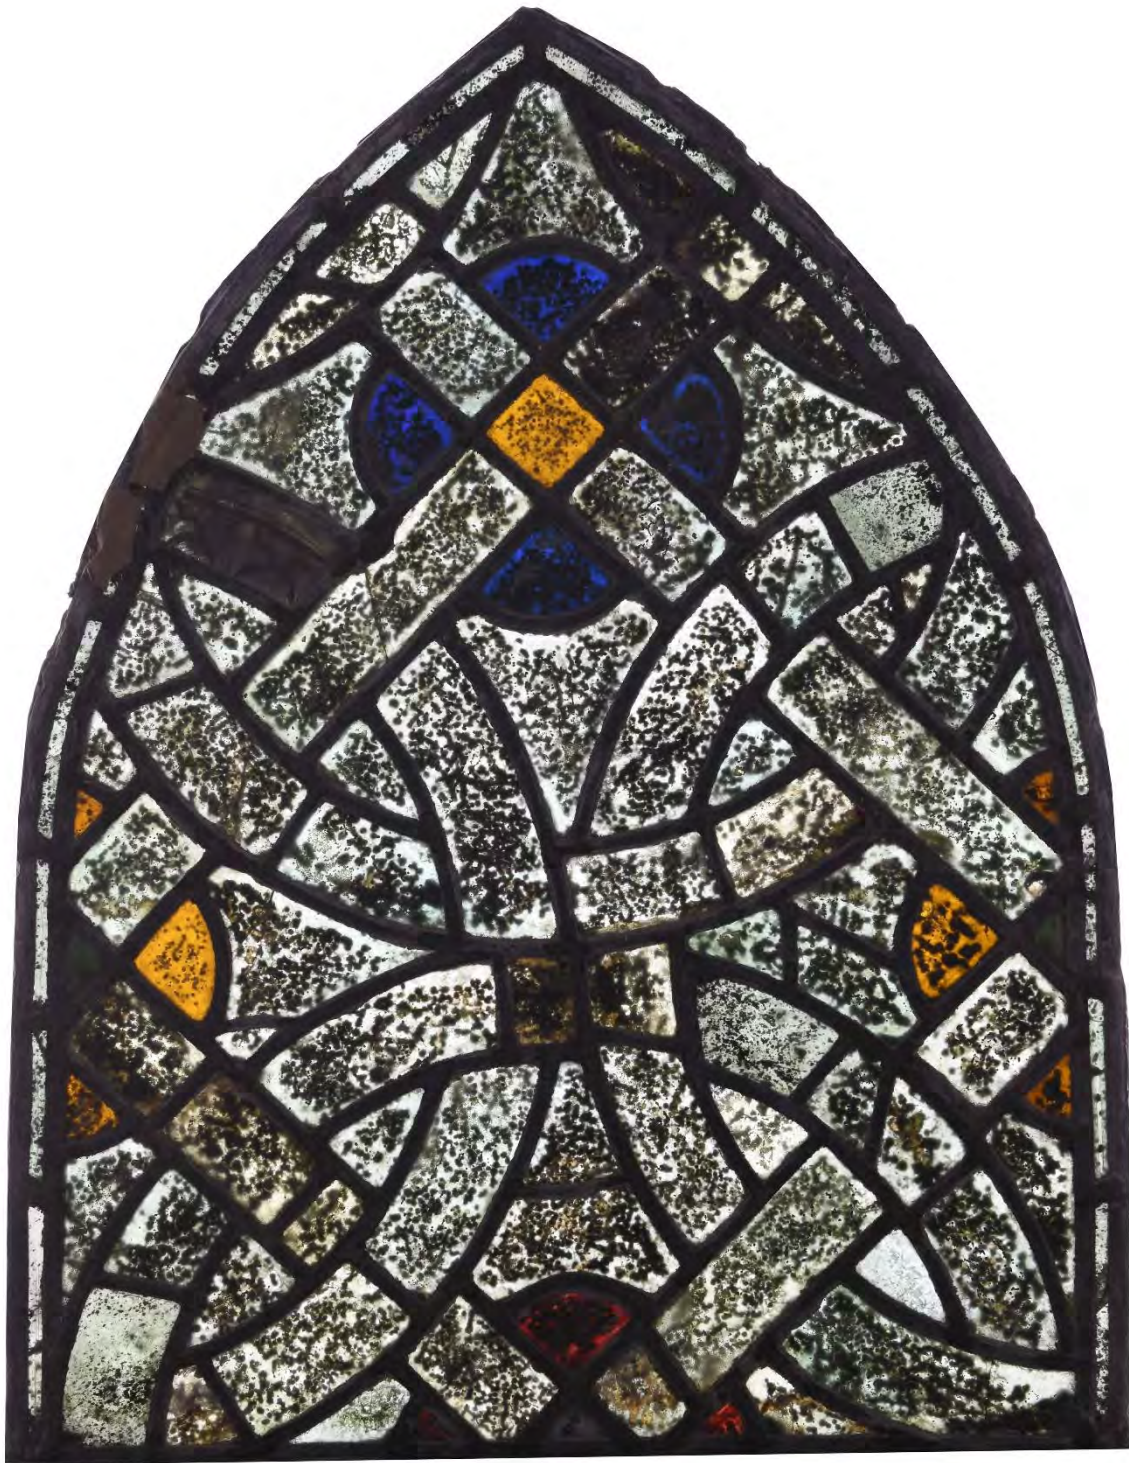
Location: St Mary the Virgin, Hastingleigh		Window: nVI
		Panel: 3a
Before Conservation Internal	Image Information: Digital, Studio darkroom, transmitted light

3a has fifteen border glass pieces and three glass pieces that are modern replacements painted to mimic age, dirt, and corrosion.

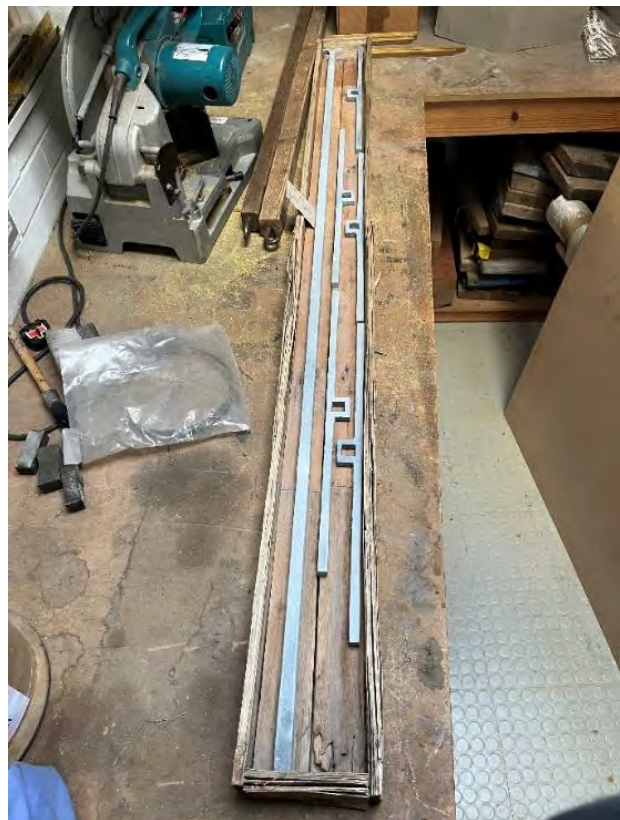
After zinc spraying

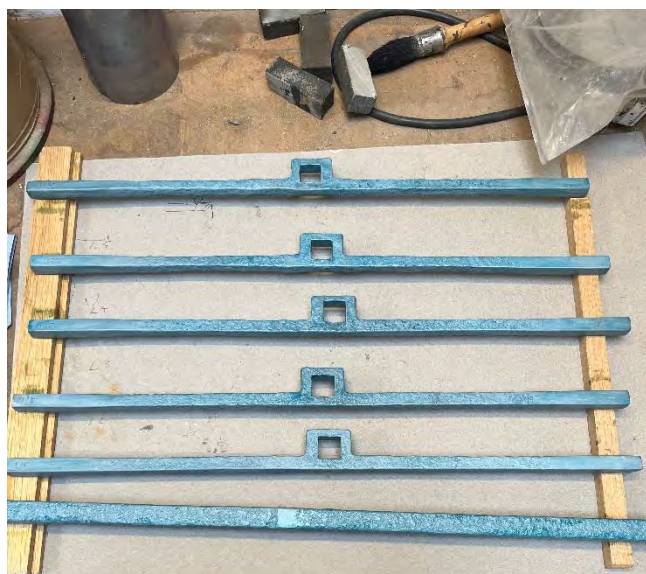
During painting of primer

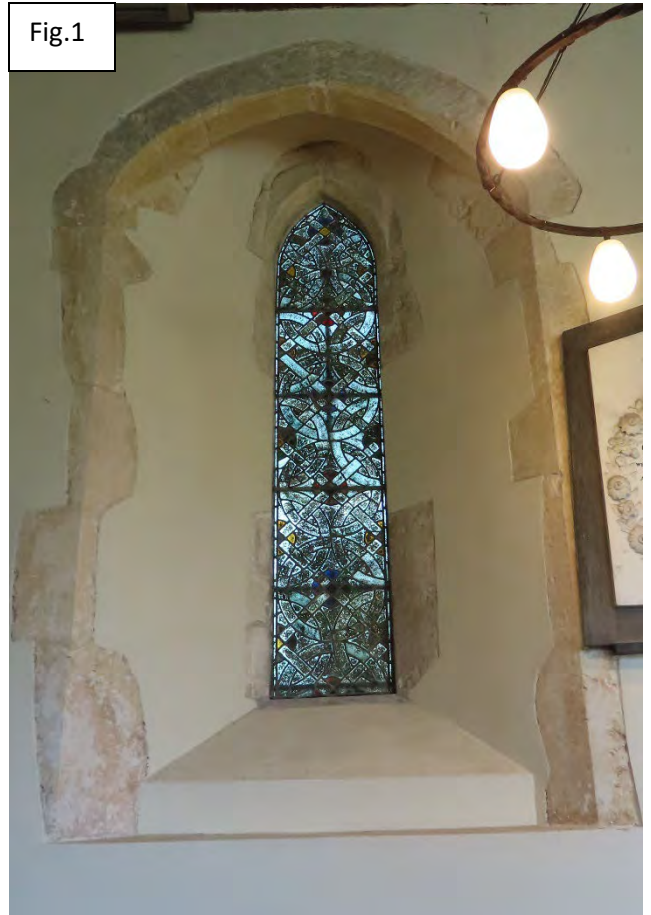
Fig.1

2. Window nVI (north side of the chancel, fig.1)

Summary: This is without doubt the most important window in the church. It is in very poor condition and requires urgent action to reduce the currently high environmental stresses on the medieval glass.

There are significant corrosion damages as well as many compound fractures in the glass.

The existing external polycarbonate sheets have discoloured and do not prevent the growth of micro-organisms on the corroded glass. This means that they have failed to provide the necessary protection.

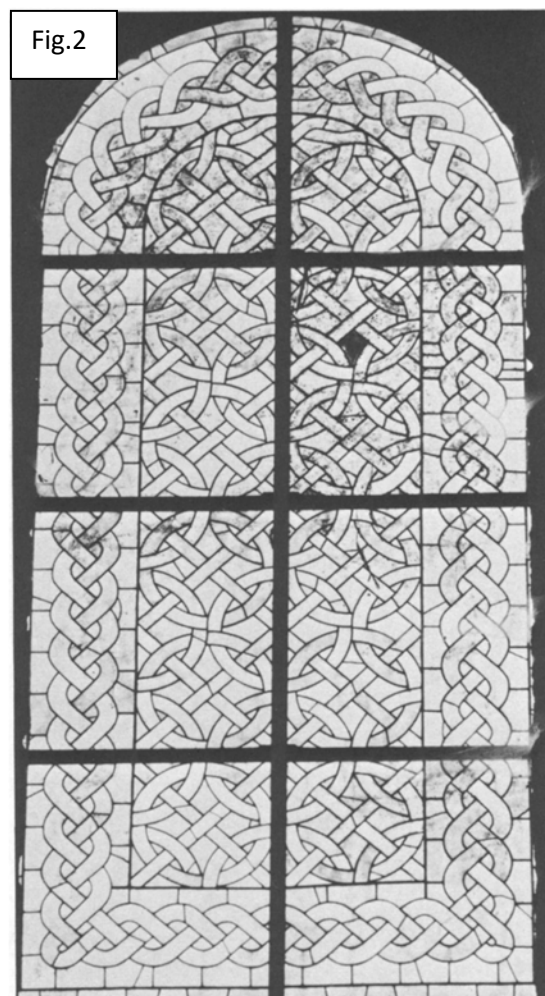
Fig.2

Geometric ornament, known as 'grisaille', glass. The ornament is based on interlocking circles and squares. Similar geometric patterns are present in York Minster and in French Cistercian glazing (fig2).

The similarity of the pattern with windows in York Minster and in the Cistercian Abbey of Obazine, France (fig.2), dating to the 2nd half 12th century, sets this window into an international context, illustrating the sophistication and connectedness of a rural location such as Hastingleigh in the Middle Ages.

Almost identical pattern in the Abbey of Obazine

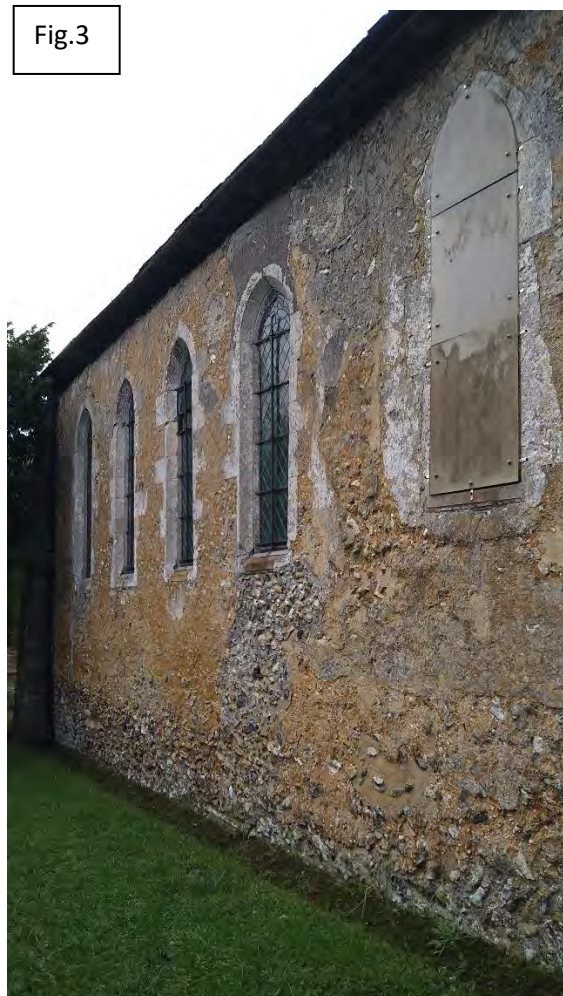
Fig.3

The window is protected on the outside by three stacked sheets of polycarbonate (fig.3). The sheets are affixed to the stonework surrounding the glazing with stainless steel shroud plates ¹ (fig.4).

The window seen from the outside (on the left)

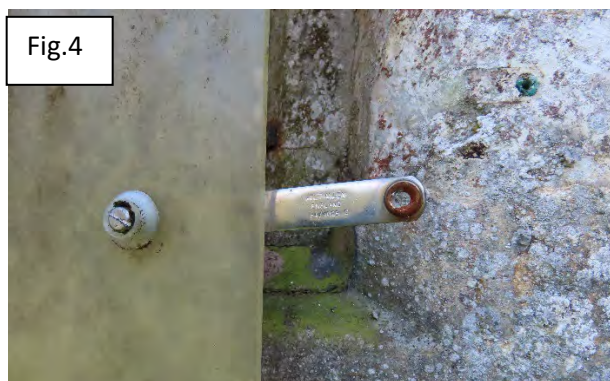
Fig.4

Shroud plate fixing

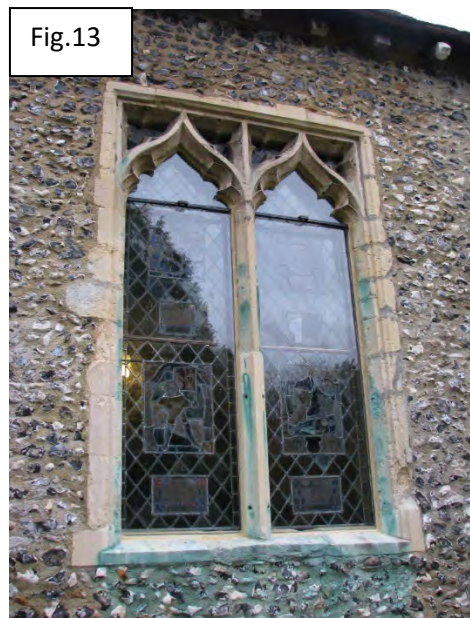
Fig.13

Examples of (from left to right) laminate glass; mouthblown glass in combination with wire grilles; mouthblown glass in simplified lead pattern

Glazing type	Advantages	Disadvantages
a. Laminate glass (fig.13)	Provides good protection from impact damage to the historic glazing. Is invisible from the inside. Cost effective.	Large reflective surface unlike the leaded windows. Can be perceived as unsightly.
b. Mouthblown glass with wire grilles (fig.14)	Provides good protection from impact damage, both to the historic glazing and to the mouthblown glass. Reflection of the mouthblown glass is less flat than that of laminate glass and is further	Wire grilles can be visible from the inside. Higher cost.

Of those, we recommend option 1 as the most suitable and cost-effective one in this location and for this glass.

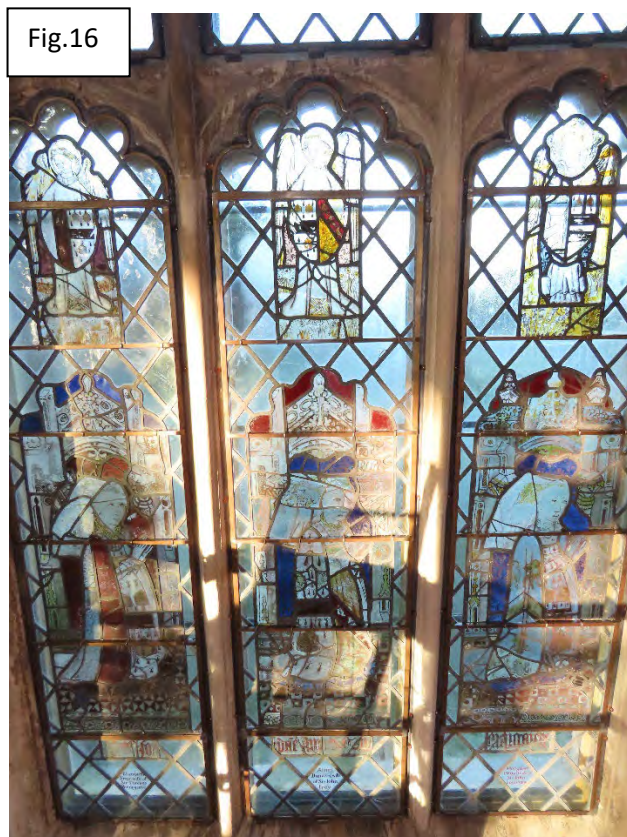
Fig.16

Examples of bronze-framed medieval stained glass in Holy Trinity Church, Long Melford, suspended on the inside of the stonework, with laminate protective glass on the outside

The medieval glazing will be brought inwards and suspended from the stonework in a bespoke bronze U-channel frame (fig.16). Narrow strips of lead flashing attached to the perimeter of the bronze frame will prevent light seepage between frame and stonework.
