ST DUBRICIUS CHURCH, PORLOCK

CONDITION SURVEY OF THE PAINTED AND GILDED TIMBER REREDOS

MARCH 2025

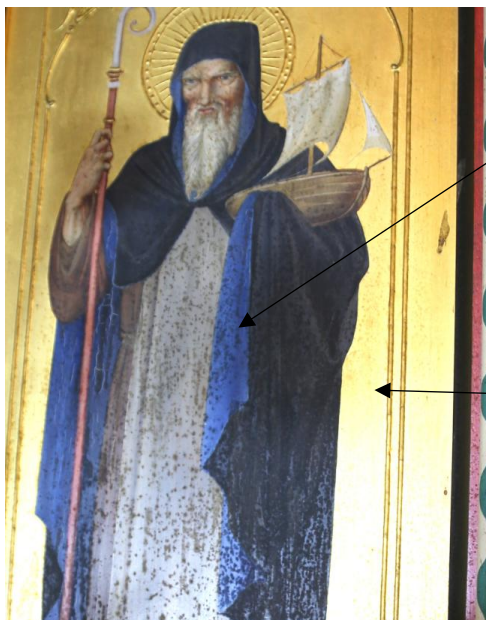
Sample 1. Blue on the lining of St. Brendan's robe.

In this area a microbiological growth has developed on the painted surface.

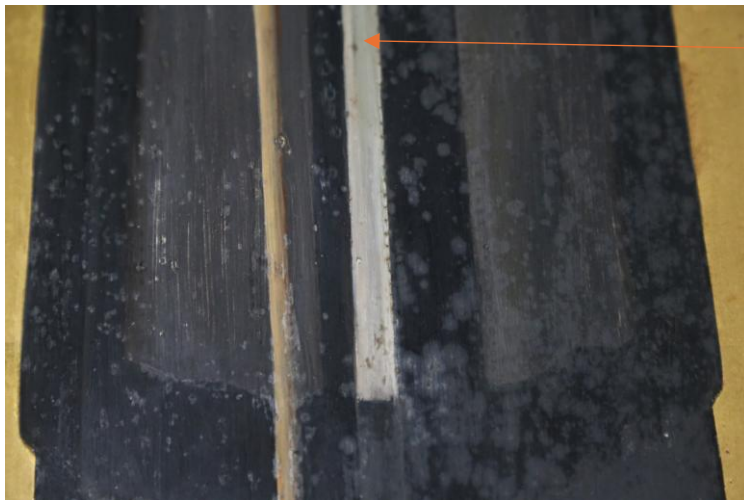
Sample 4

Black background of lower panel. This surface is in good condition.

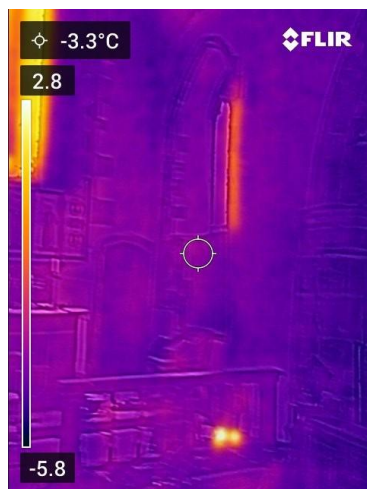
Southeast corner of the chancel

These photographs indicated that as expected the east chancel wall, particularly around the windows and in the corners were the coldest areas in the church.

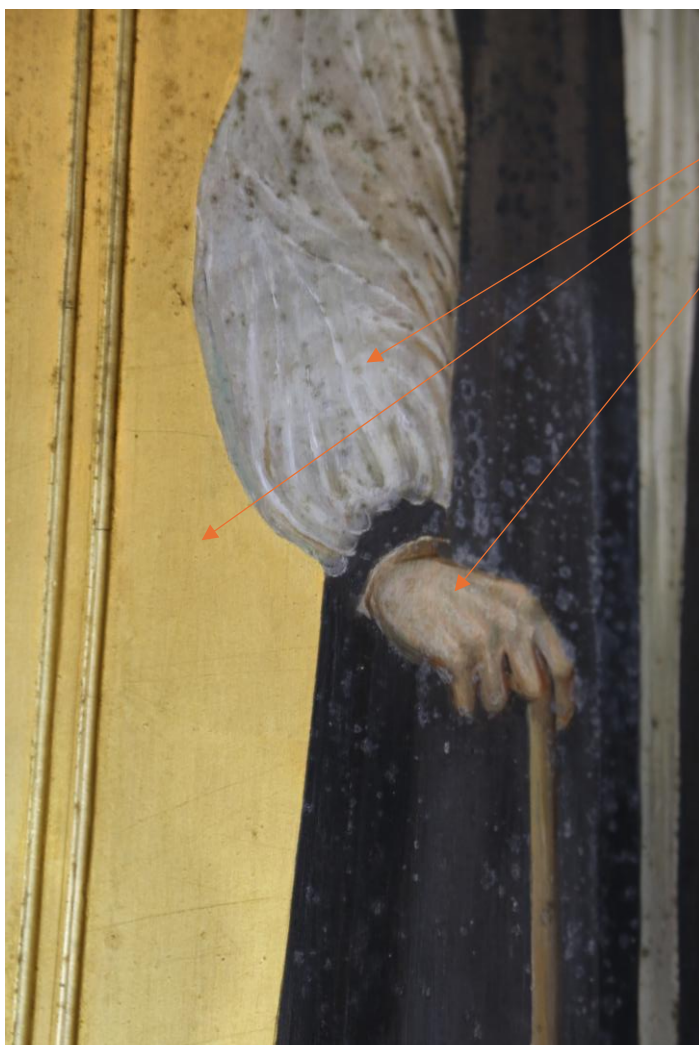
FIG. 16

Areas of white and gilding after cleaning.
