Porlock ST DUBRICIUS

BRIEF REPORT ON CONDITION OF SPIRE

as at November 2022

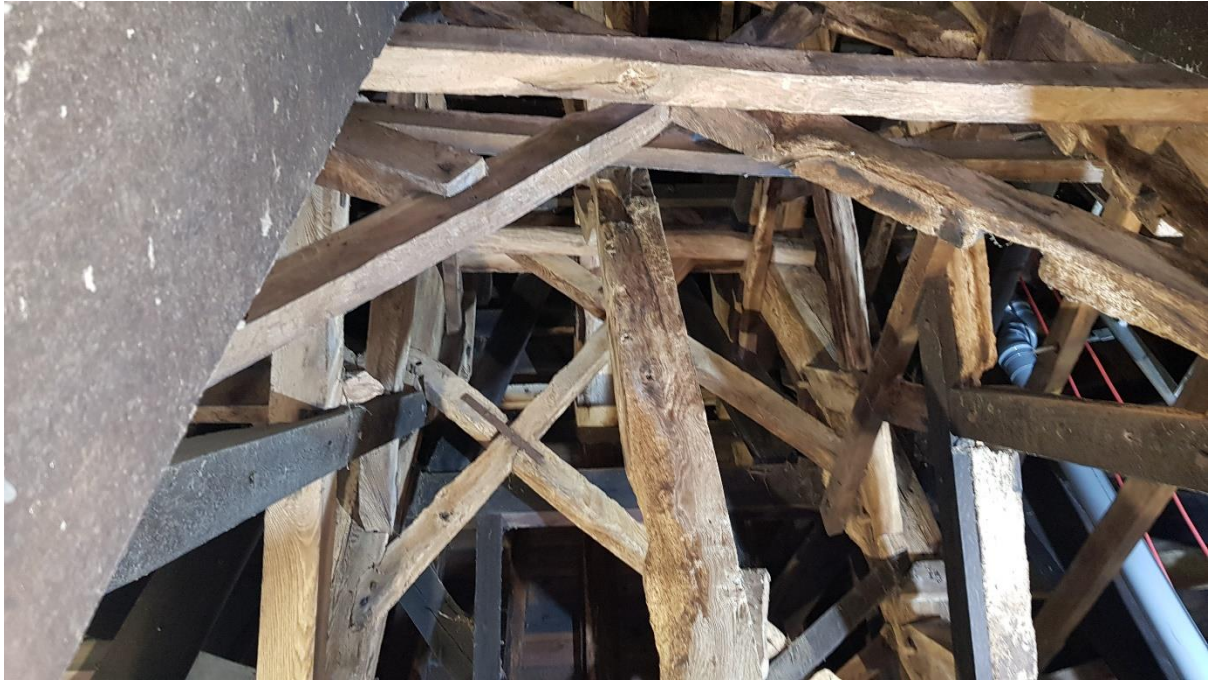
Interior framing (general)

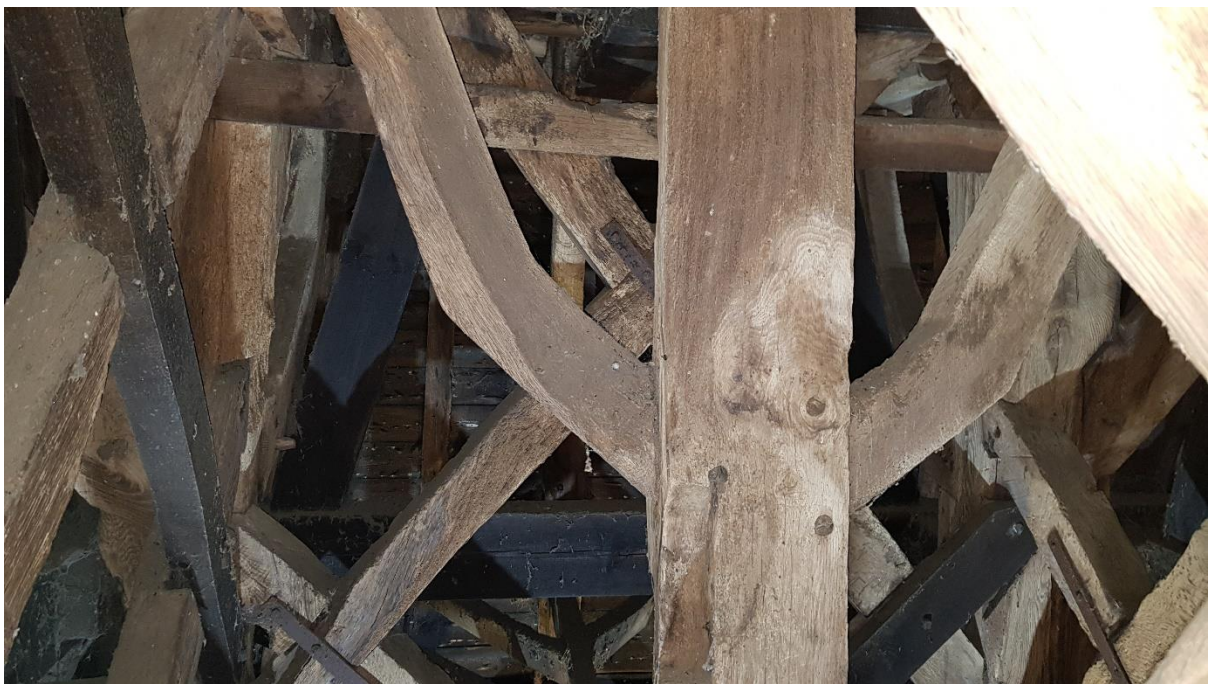
Interior framing (showing C13post structure with curved braces)

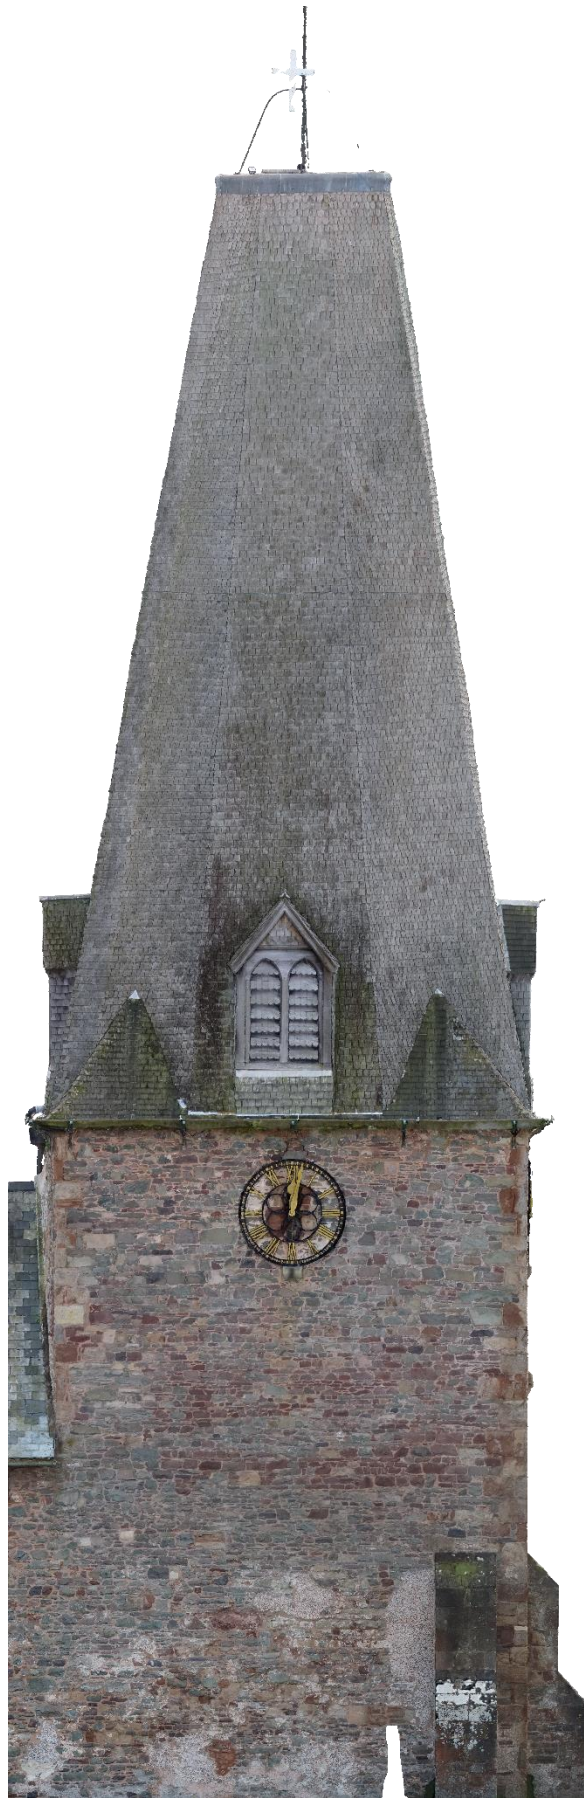
North Face

- 4.15. Both hips on the north side have areas of rot and the scarf repair to the central rafter has itself rotted.
- 4.16. On the south face the two support timbers to the lunette window are in poor condition.

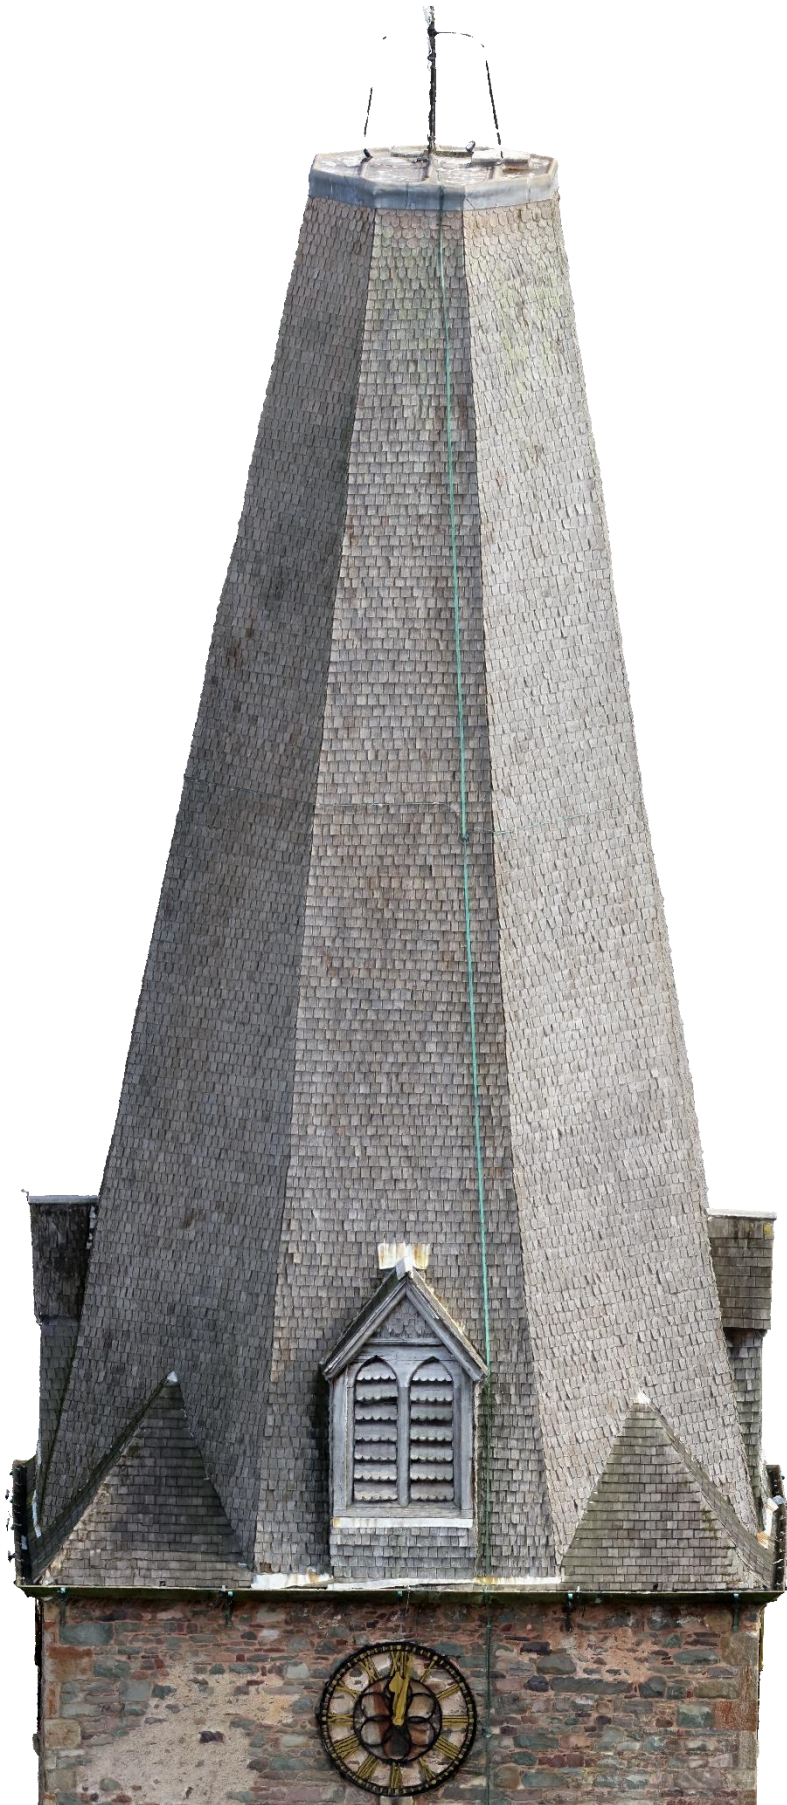
West face

- 4.13. On the west slope one rafter is rotten and has been paired up with several phases of repair.
- 4.14. Rafter feet have been repaired with simple scarfs in the 1933 phase of work. On the west face the upright to the lunette window and three rafters have extensive rot for the lower 12-16"
