The Church of St Matthew, Morley.

Report on the Conservation of the Glazing.  
Windows sII and nII.

**JIM BUDD**  
STAINED GLASS

July 2025

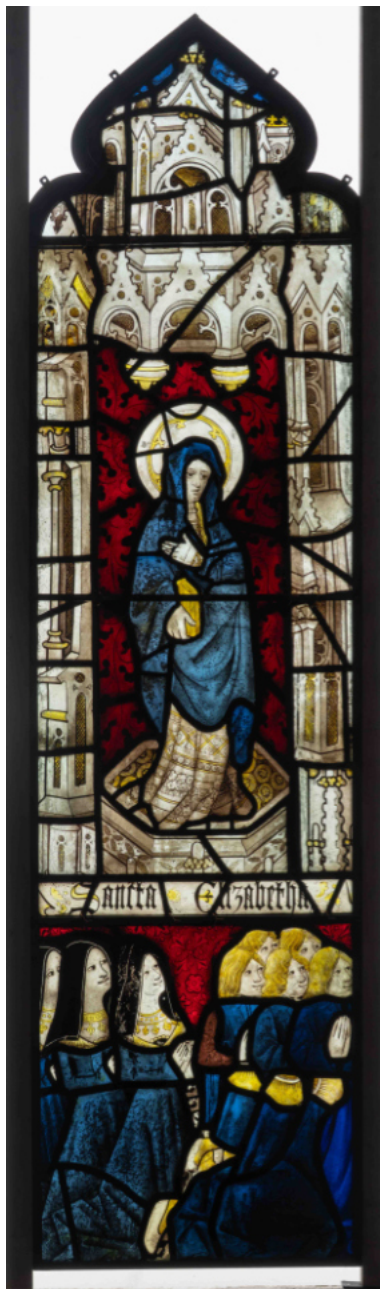
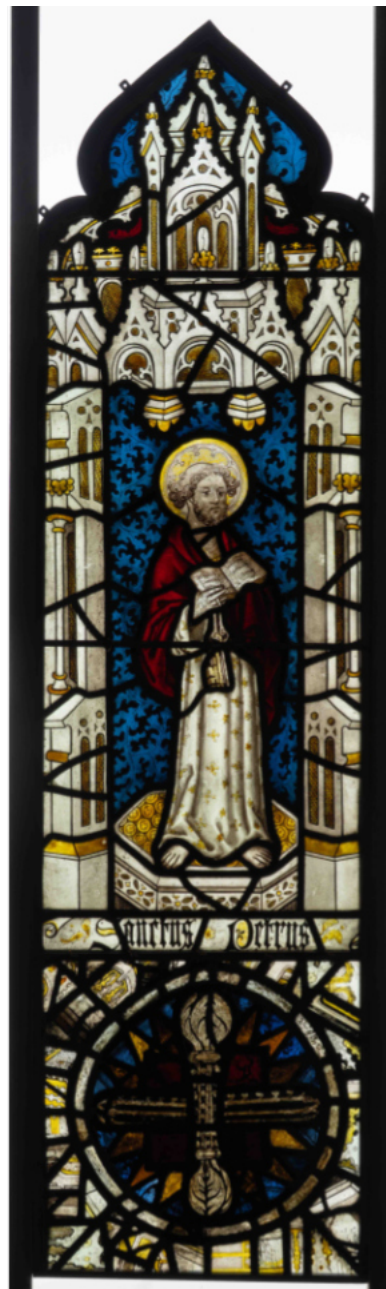
Window s11. Studio photographs. Post conservation.

In window sII, 20no. cracks were edge-bonded with Araldite 20:20 epoxy resin.

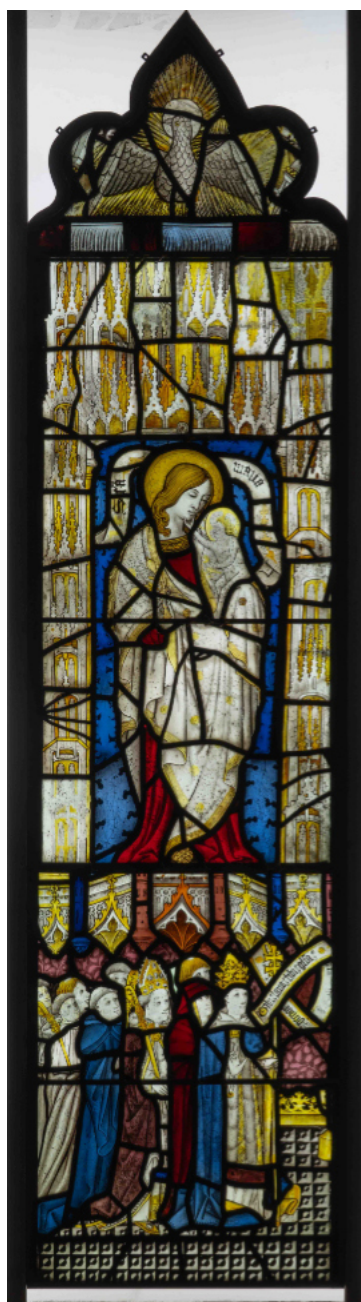
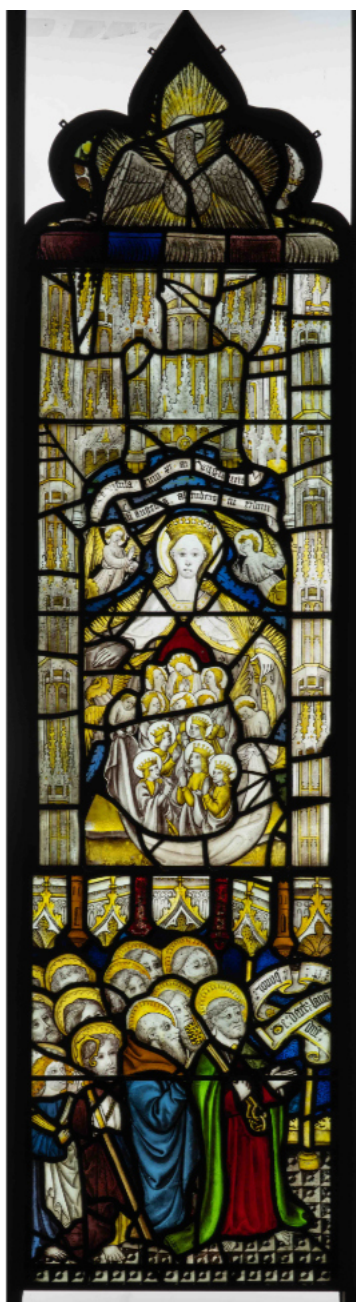
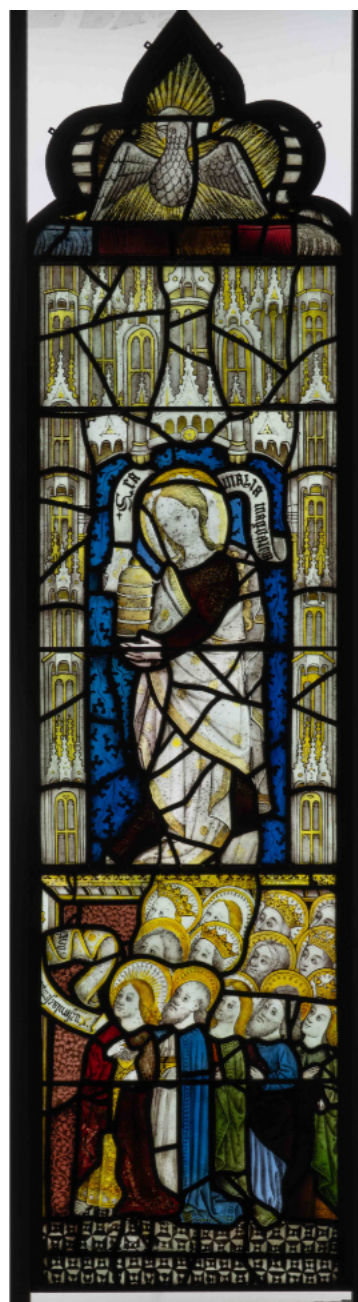
Window nll. Studio photographs. Post conservation.

In window nII, 35no. cracks were edge-bonded with Araldite 20:20 epoxy resin.
