CHADBURN CONSERVATION ARCHITECT

Architects instruction

Works: Repointing of the church tower.
 Contract dated: 28th March 2025

St Bridget Church, Bridgerule - Tower south east pinnacle.

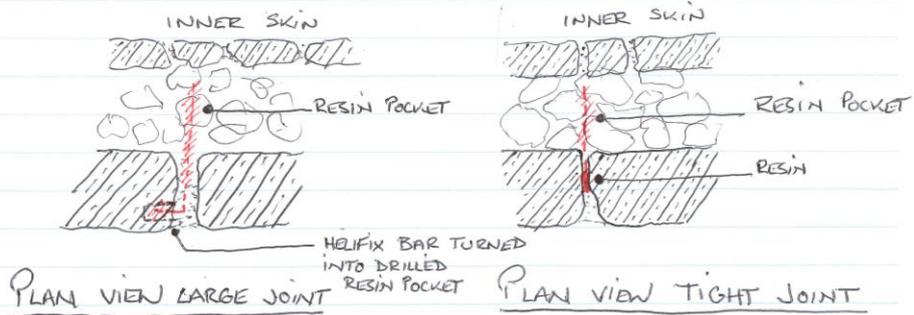
13/2020/SK03 - 10.07.25

- With respect to the pinnacle itself, the base stones of the upper tapered section of the pinnacle appear slightly displaced from the supporting stones, which may have occurred at the time of a lightning strike, but there is no evidence of further movement.

- During the repointing process, it should be possible to pin the base tapered stones to the stone course beneath, providing better connection at the base of the pinnacle.

--- 300mm LONG 4-6mm HELIFIX RODS
