**Conservation report for the reredos, communion rail,
candlesticks, vestry door, exterior chancel east wall, pinnacles and
coping stones**

**All Saints Church, Mackworth
Diocese of Derby**

July 2017

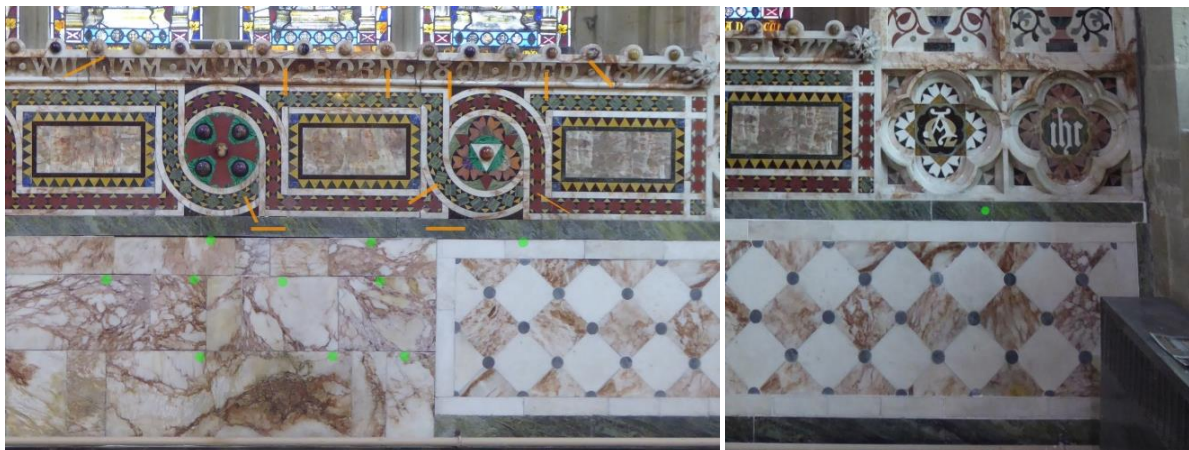
Figure 12 Location of pinning between stone blocks (orange) and pinning to wall (green)

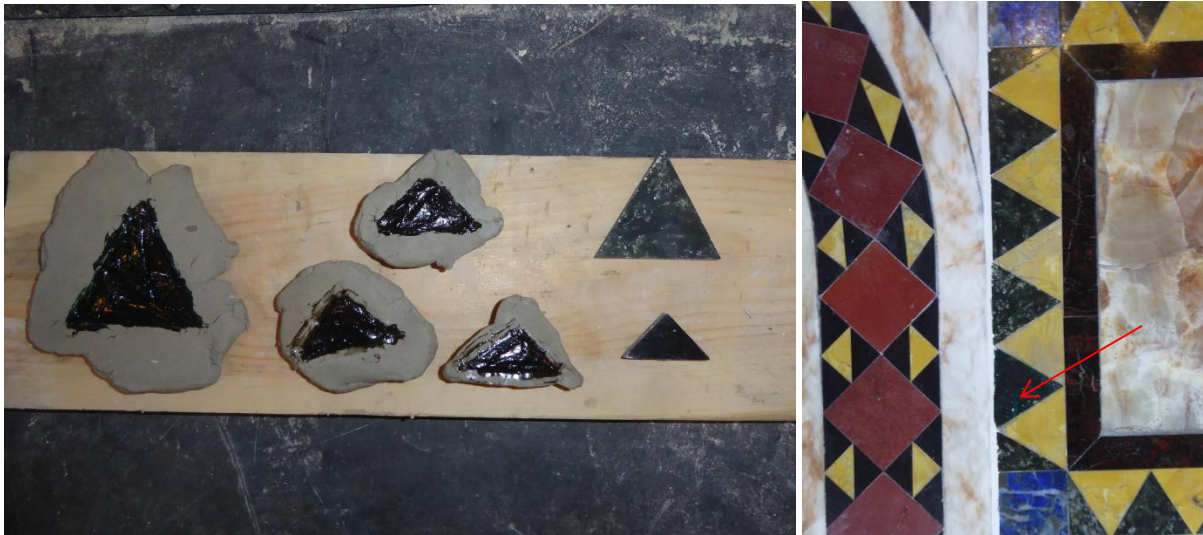
There were four geometric stone pieces missing to the lower section of the reredos. They were replicated in polyester resin with pigments and fixed with polyester resin to the reredos.

Figure 16 Replica of the missing sections

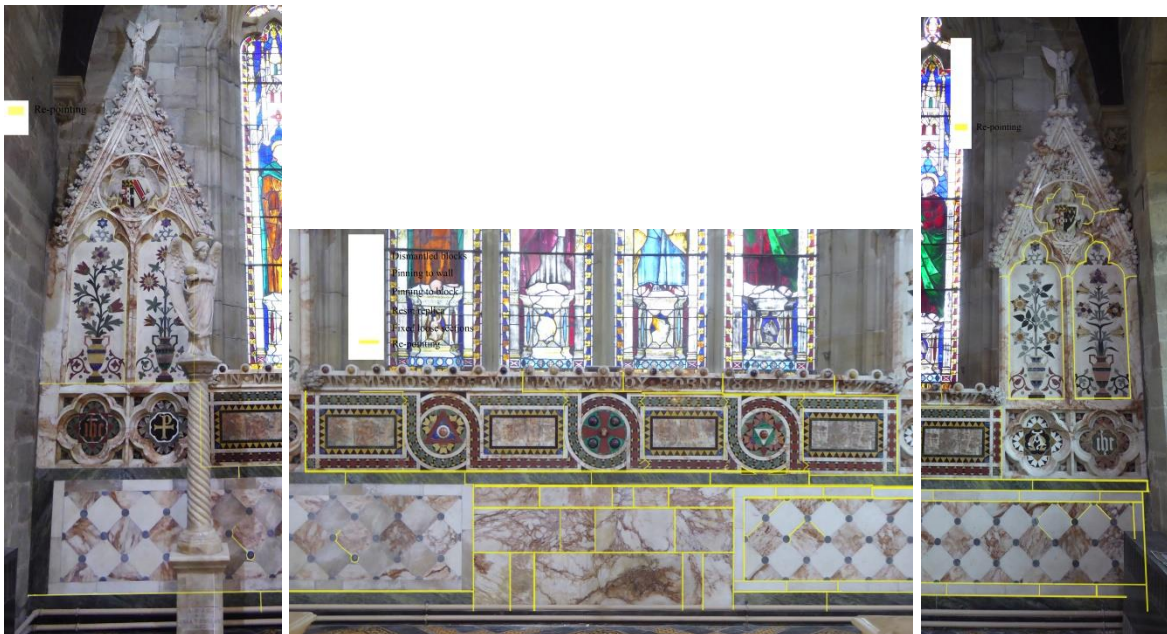
Much of the pointing mortar had failed due to the movement of the stone blocks, and some was totally missing. The failed pointing mortar was carefully raked out with very small chisels and scalpels. They were re-pointed with gypsum without any aggregate. For a larger image see Appendix A.

Figure 17 Location of the re-pointed joints

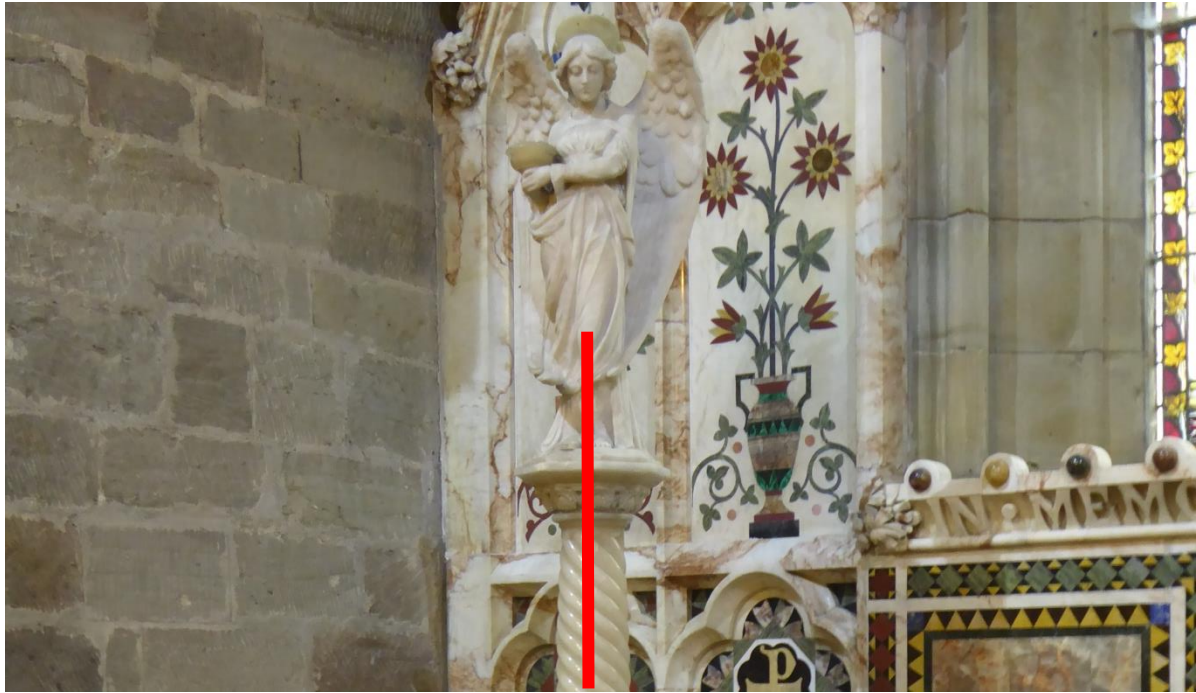
Figure 26 Location of the metal rod inside the angel and the column

The angels were carefully lifted and relocated without adding any resin or gypsum. The large metal rods that run through the columns serve as supports to the angels, not requiring any further fixing. They were not fixed before dismantling and this allows changing the position of the angels without difficulty. The chalices and auras were re-fixed using the same screws as before their dismantling.

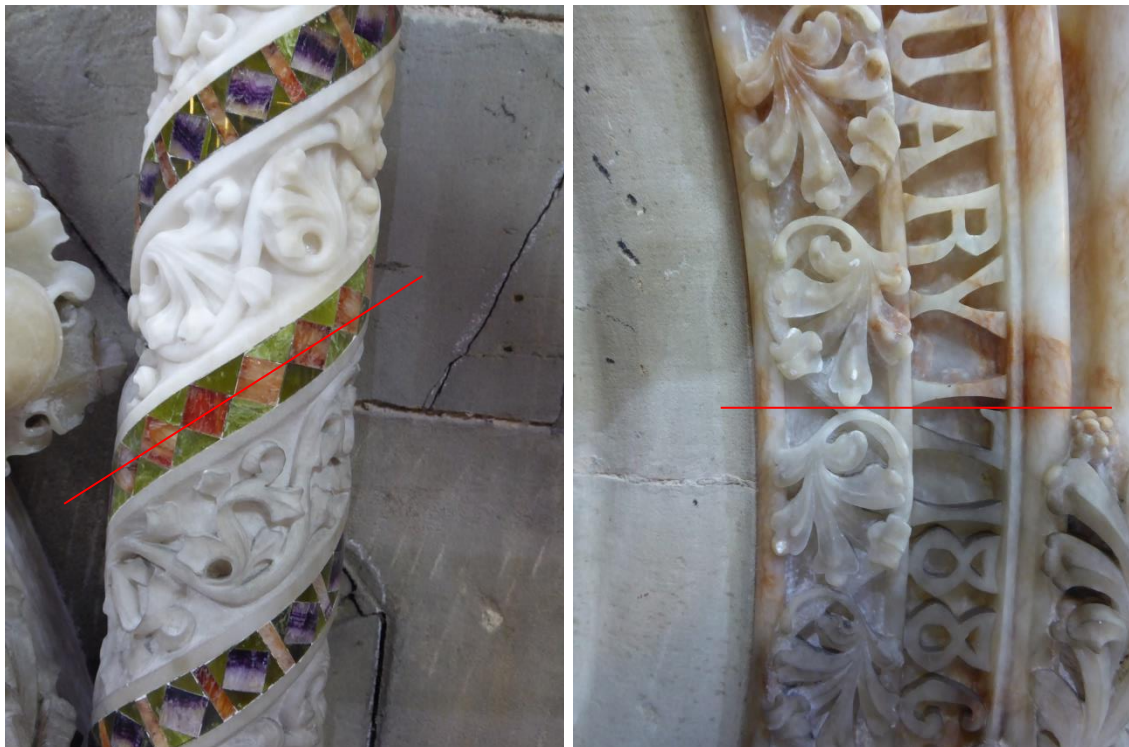
Figure 32 Examples of cleaned and uncleaned sections

The monument was dusted and vacuumed to remove dust, cobwebs and debris using a soft brush. The same materials used for the reredos cleaning were tested and used for the cleaning of this monument; a combination of chemical cleaning with ammonium hydroxide diluted in water (1:25) and mechanical cleaning with melamine foam was used.

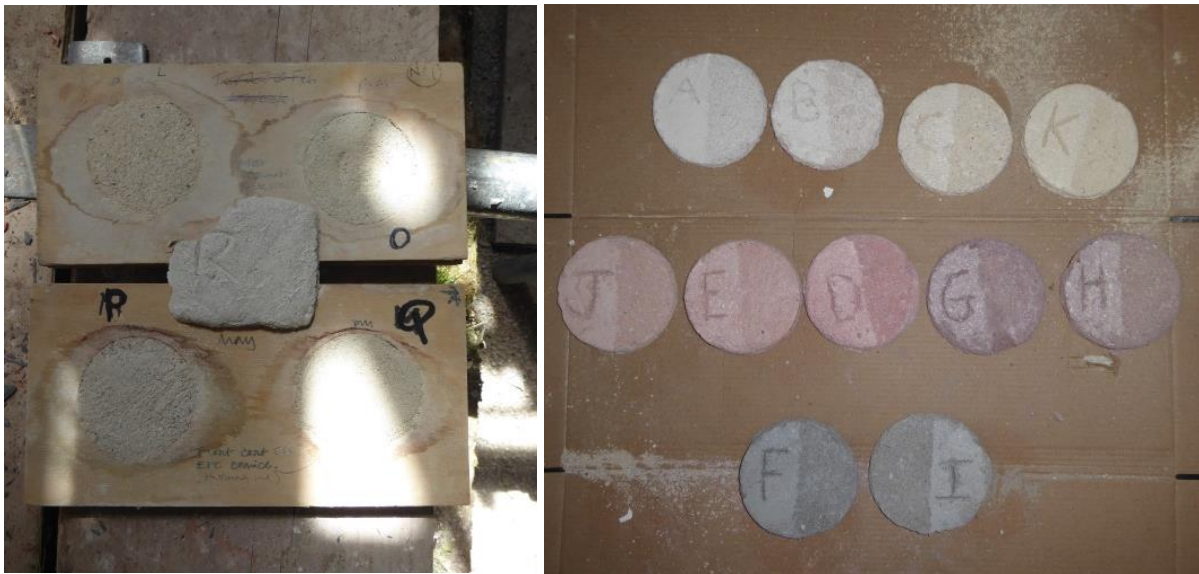
Mortar trials with different aggregates and lime-aggregate ratios were performed to match the colour and texture of one of the existing pointing mortars and the stone for the mortar repairs. The selected mortars were intended to be lighter in colour as they will eventually get darker/greener from weathering.

Figure 33 Mortar trials for repointing and mortar repairs

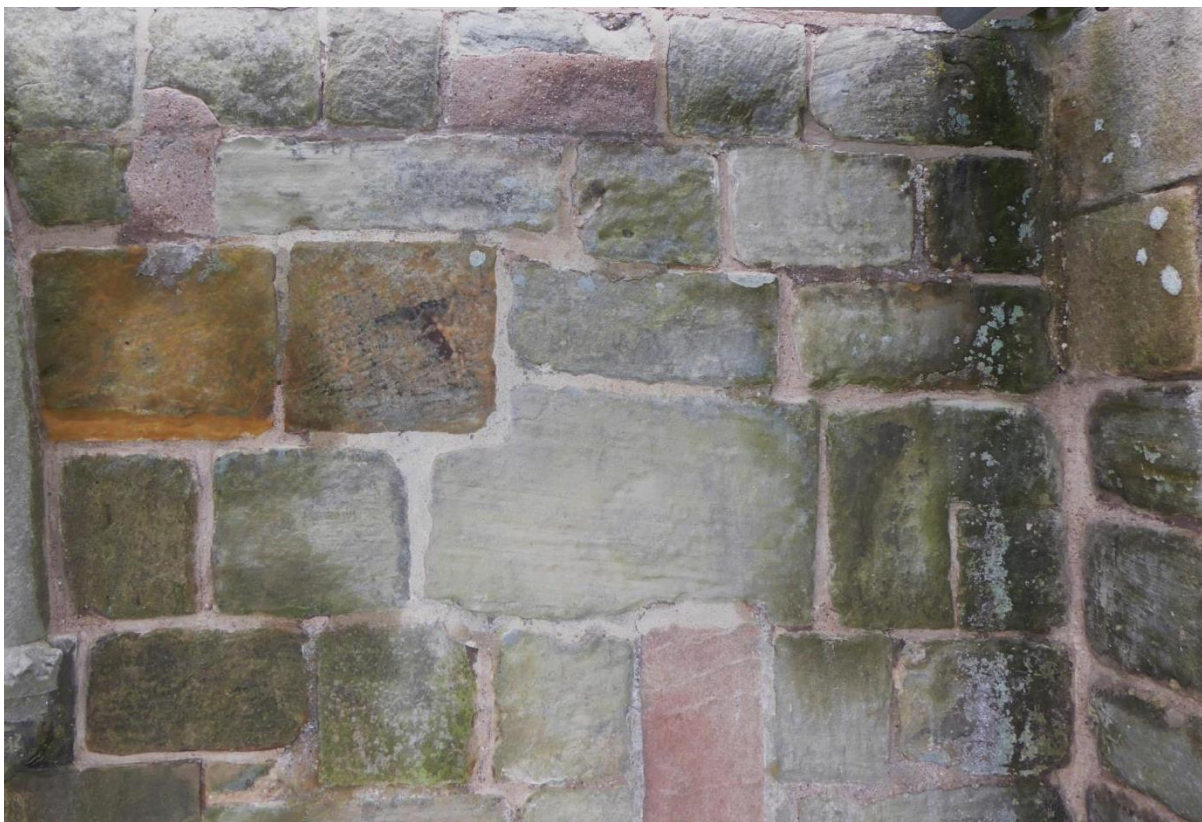
Figure 36 Wall section after the application of the base coat mortar to most of the joints

Since many joints were very deep, a base coat mortar was applied while filling with slate and bricks: natural hydraulic lime 3.5 and sharp sand (1:3).

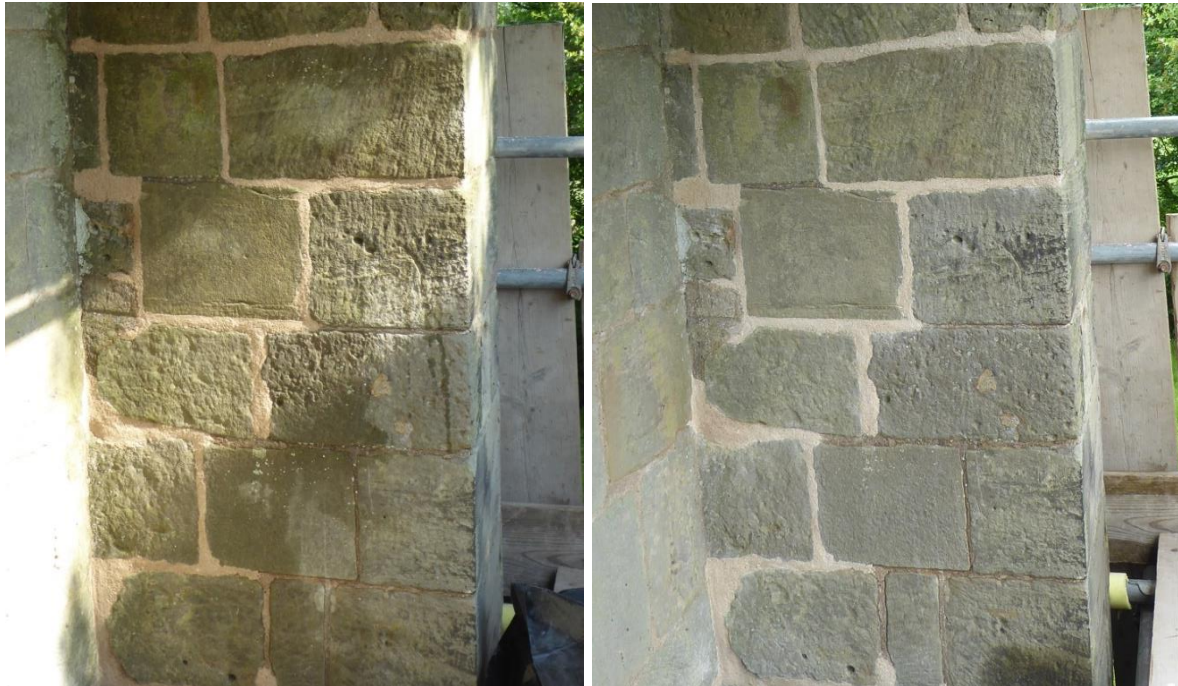
Figure 37 Re-pointing top coat mortar while still wet (left) and dry (right)

The selected top coat composition is natural hydraulic lime 3.5, sieved sharp sand (reddish) and coarse sharp sand (yellowish) with a 1:2:1 ratio.

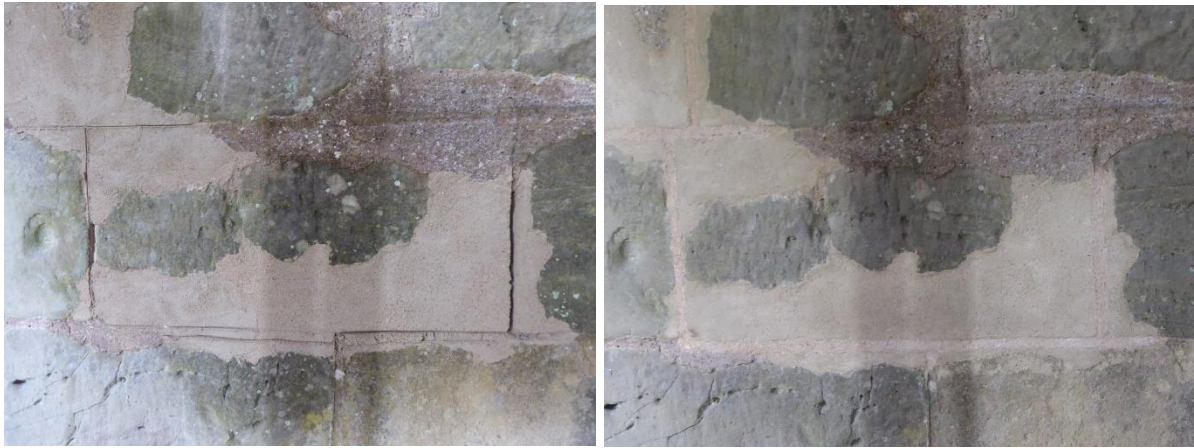
Some previous mortar repairs had also failed, and stone degradation to some ashlar blocks required capping repairs⁶ to prevent further degradation.

Figure 41 Application of top coat and final mortar repair with pointing lines

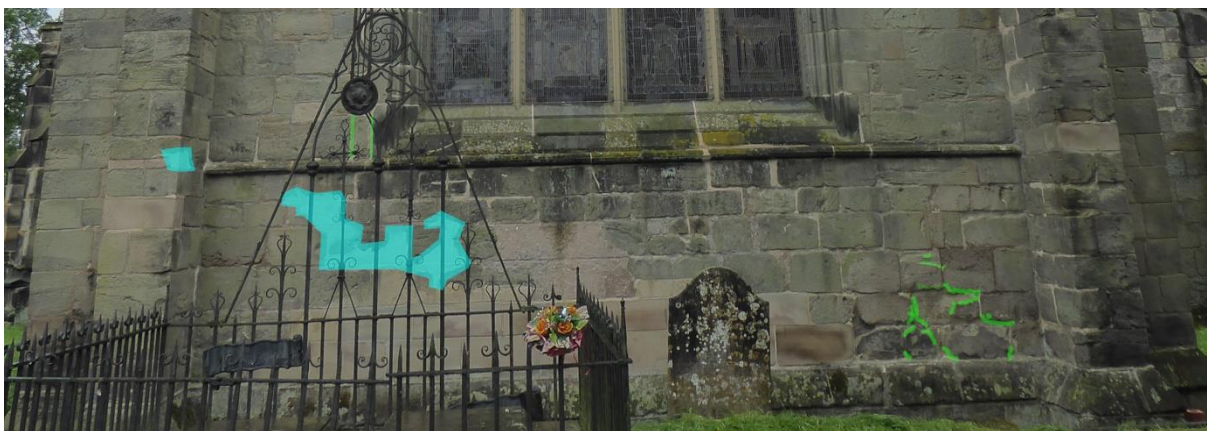
Figure 43 Location of the mortar (blue) and capping (green) repairs to the Chancel exterior east wall

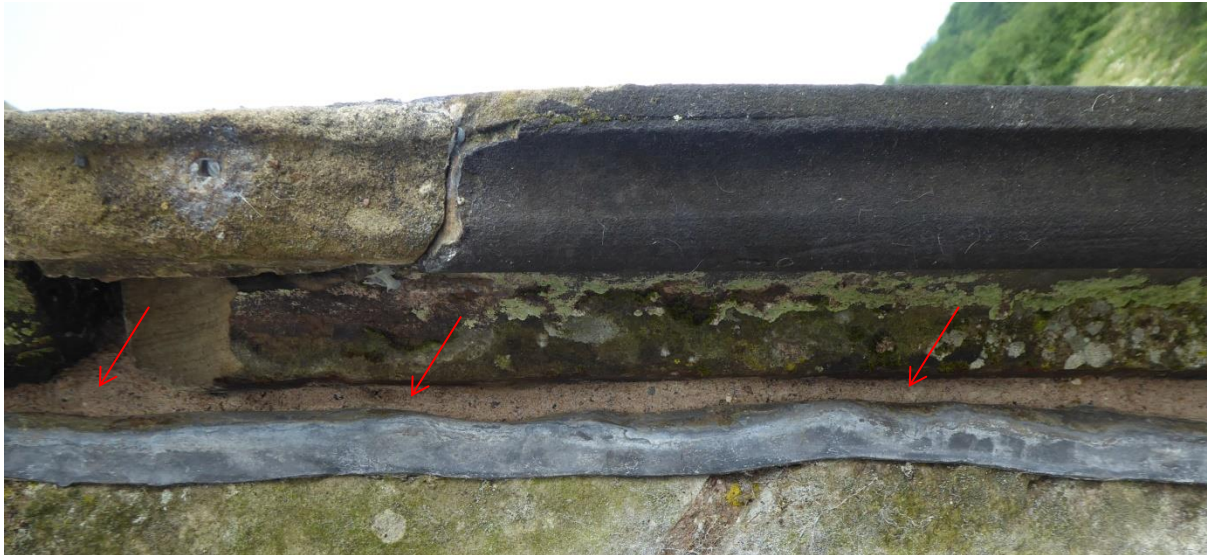
Figure 48 Base mortar coat for pointing works to the coping stones

The joints gaps were filled where possible with pieces of slate. A base coat of lime mortar [NHL 3.5 and sharp sand (1:3)], was applied, followed by a top coat of lime mortar, [NHL 3.5, sieved sharp sand and sharp sand (1:2:1)]. They were all protected with hessian to prevent cracks and quick drying.

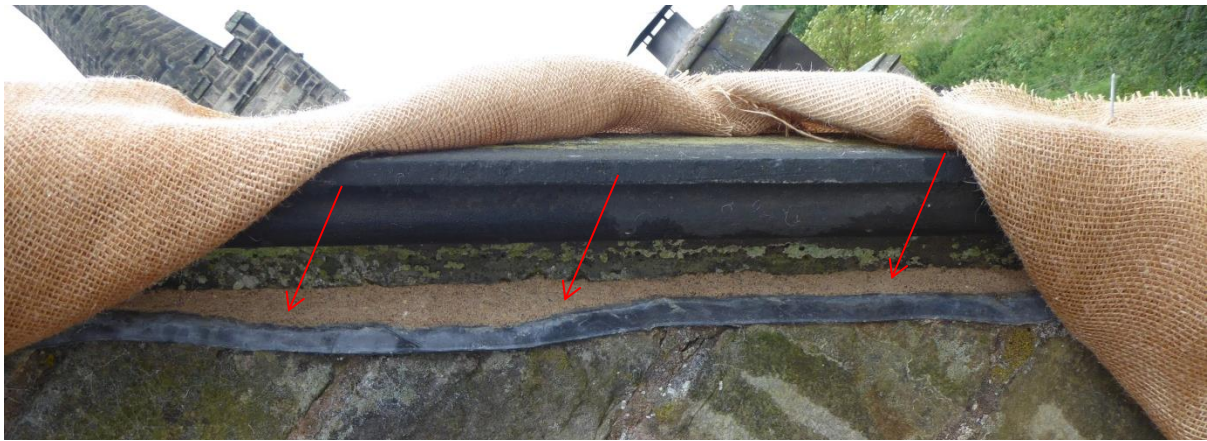
Figure 49 Top mortar coat for pointing works to the coping stones

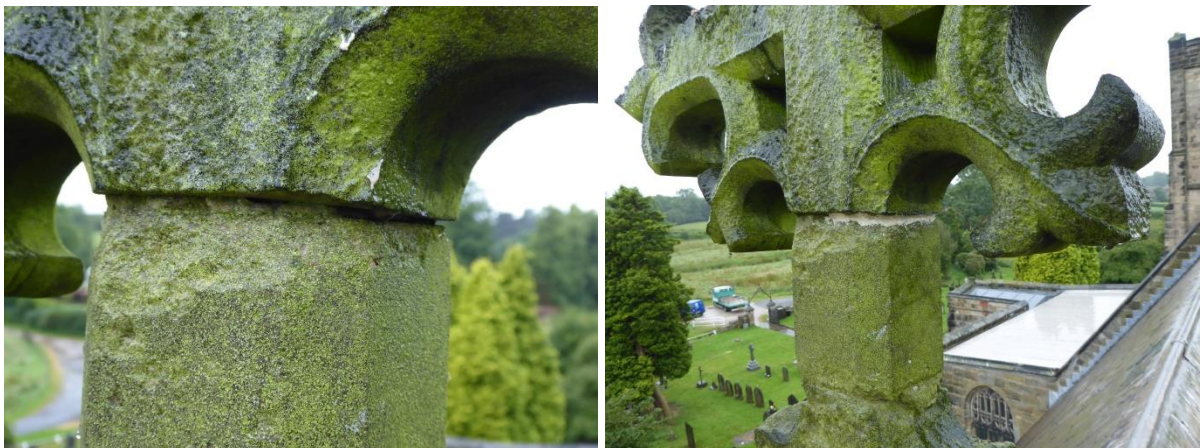
The cross to the east elevation exhibited slight movement although it appeared sound and was thought to pose no danger of falling. However, some polyester resin was injected to give it some further stabilization and prevent water ingress into the bedding mortar.

Figure 50 Injection of polyester resin to joint of the cross

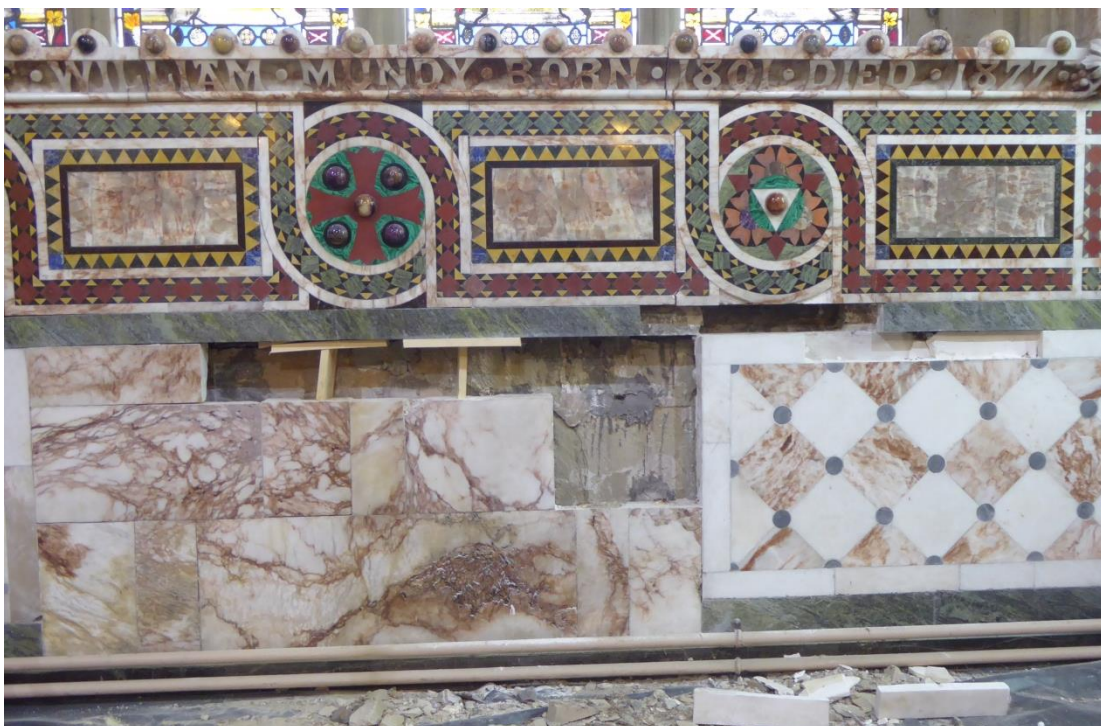
Figure 52 Dismantling of alabaster and marble blocks process

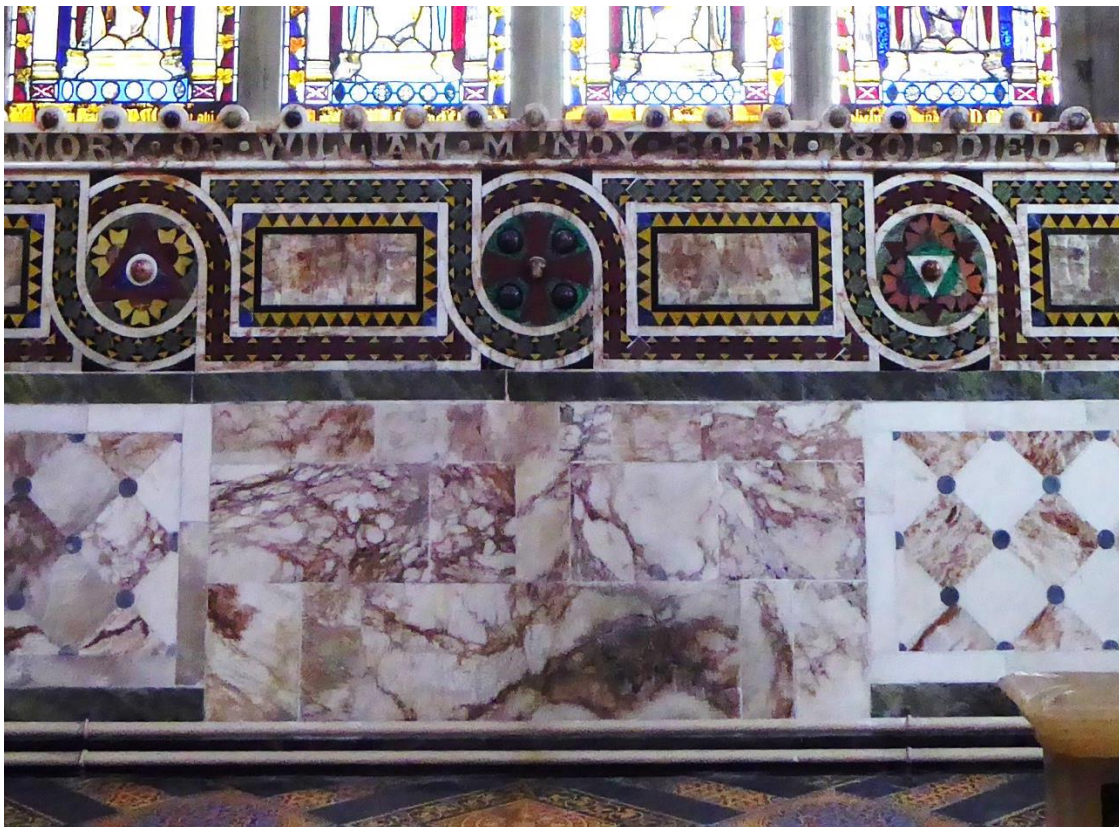
Figure 54 Final condition of central section

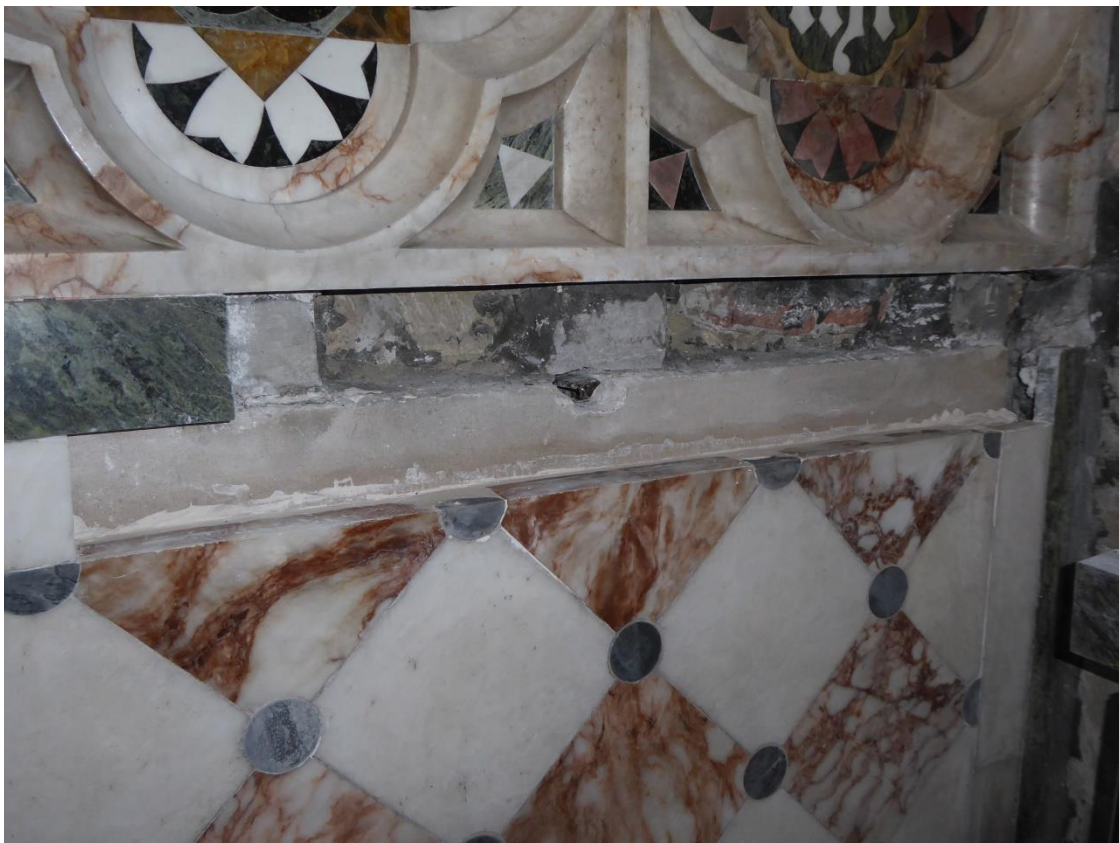
Figure 56 Dismantling alabaster and marble blocks to right area of reredos

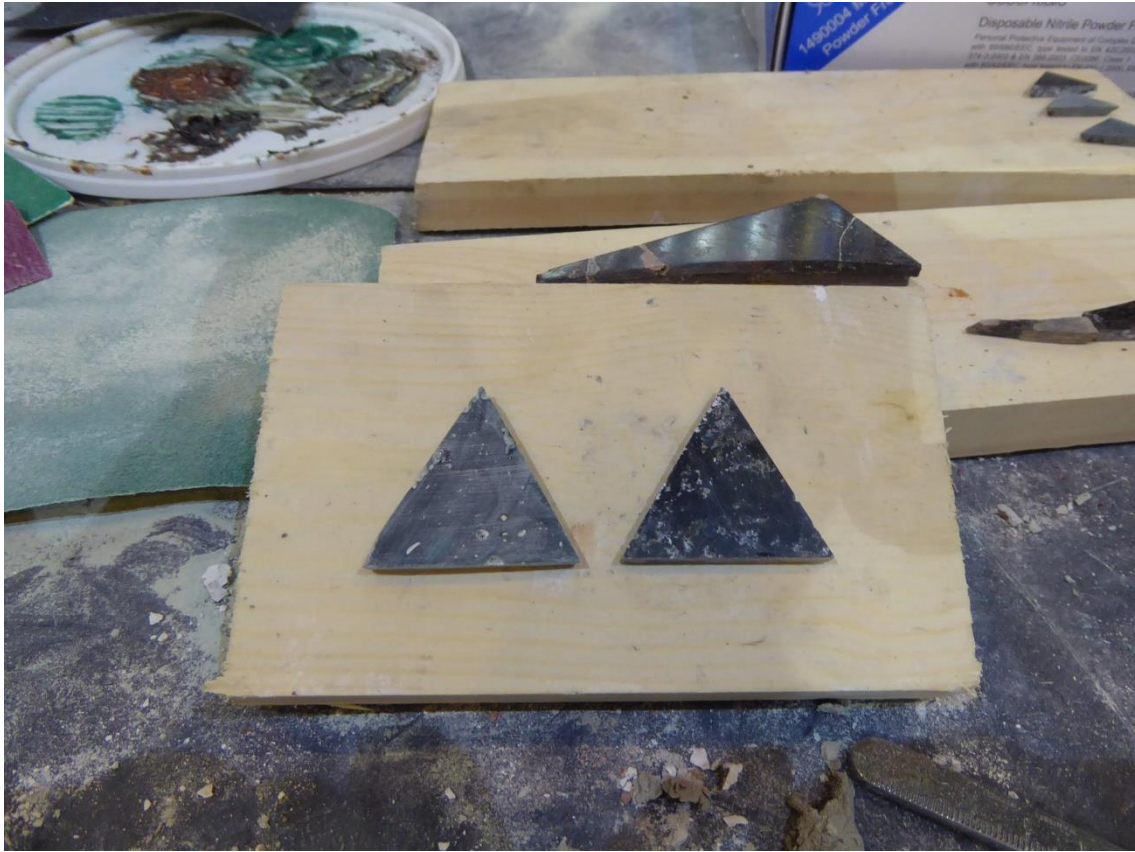
Figure 59 Replica of missing pieces to reredos

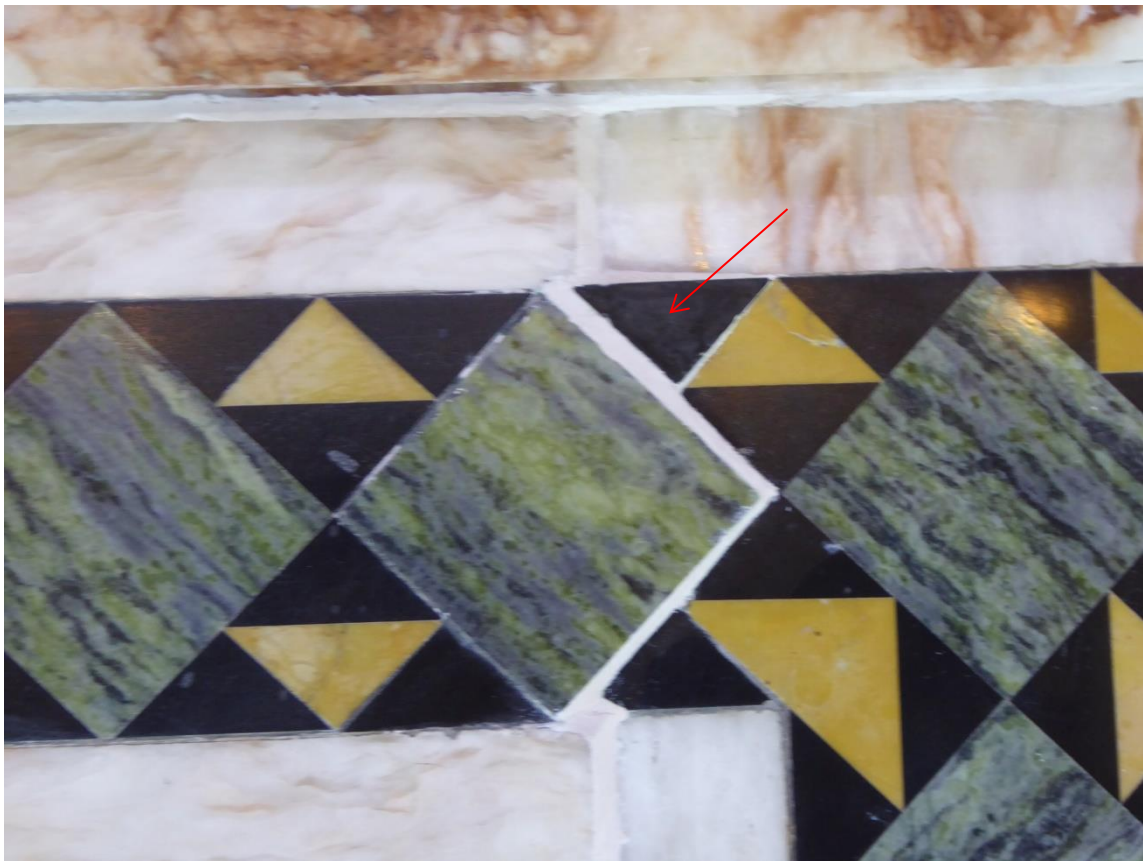
Figure 60 Fixing replica piece to reredos

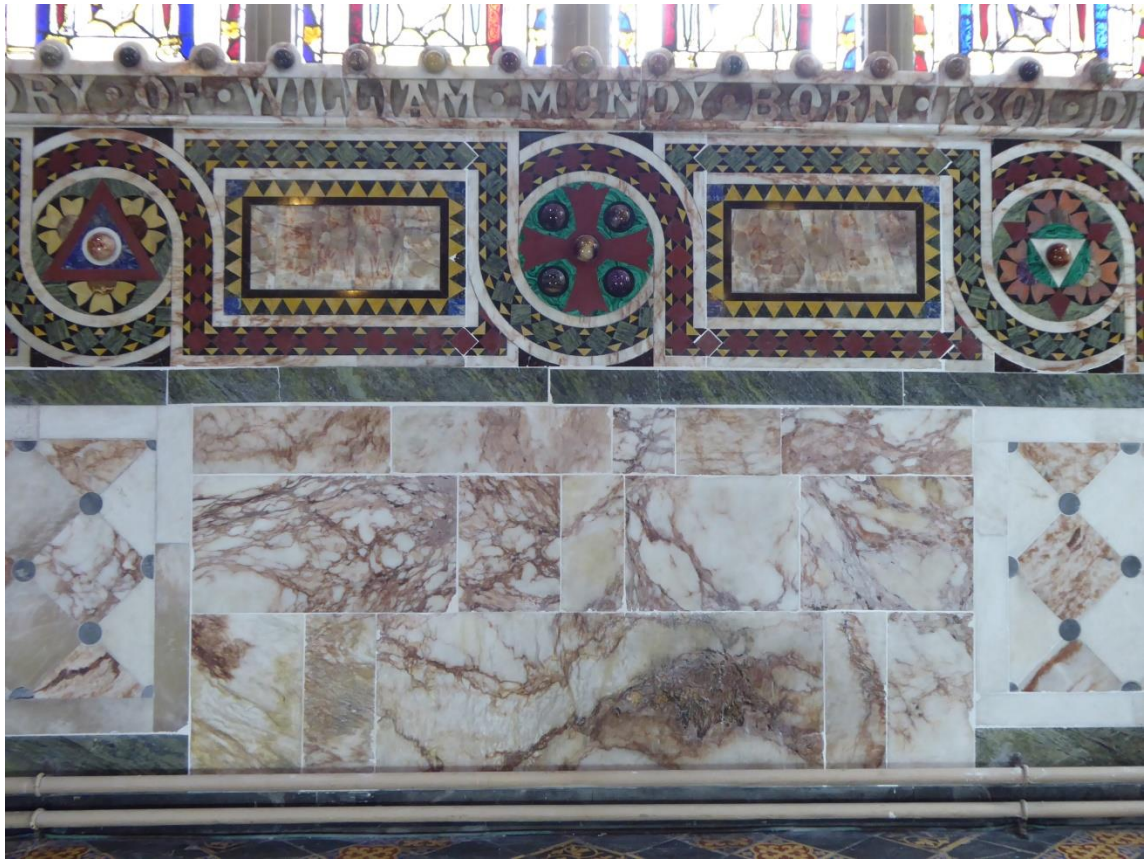
Figure 63 Pointing mortar before toning down

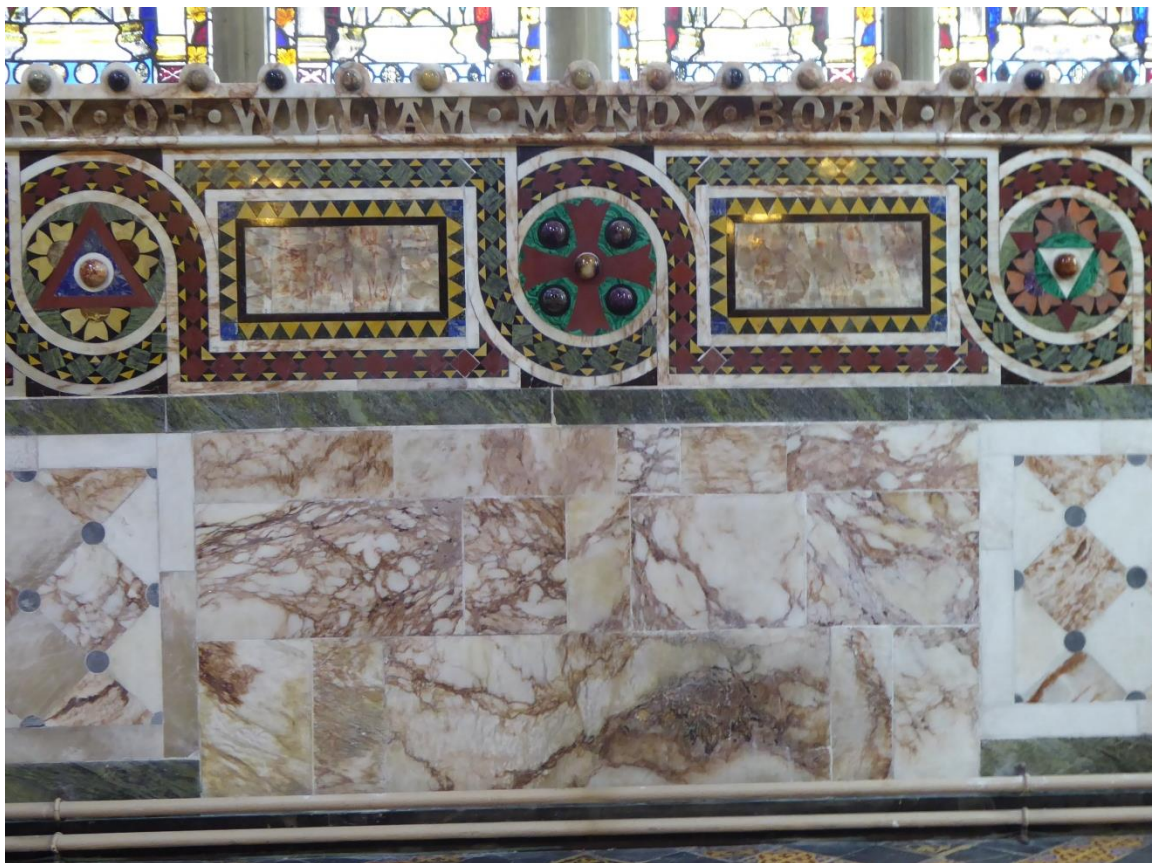
Figure 64 Pointing mortar after toning down

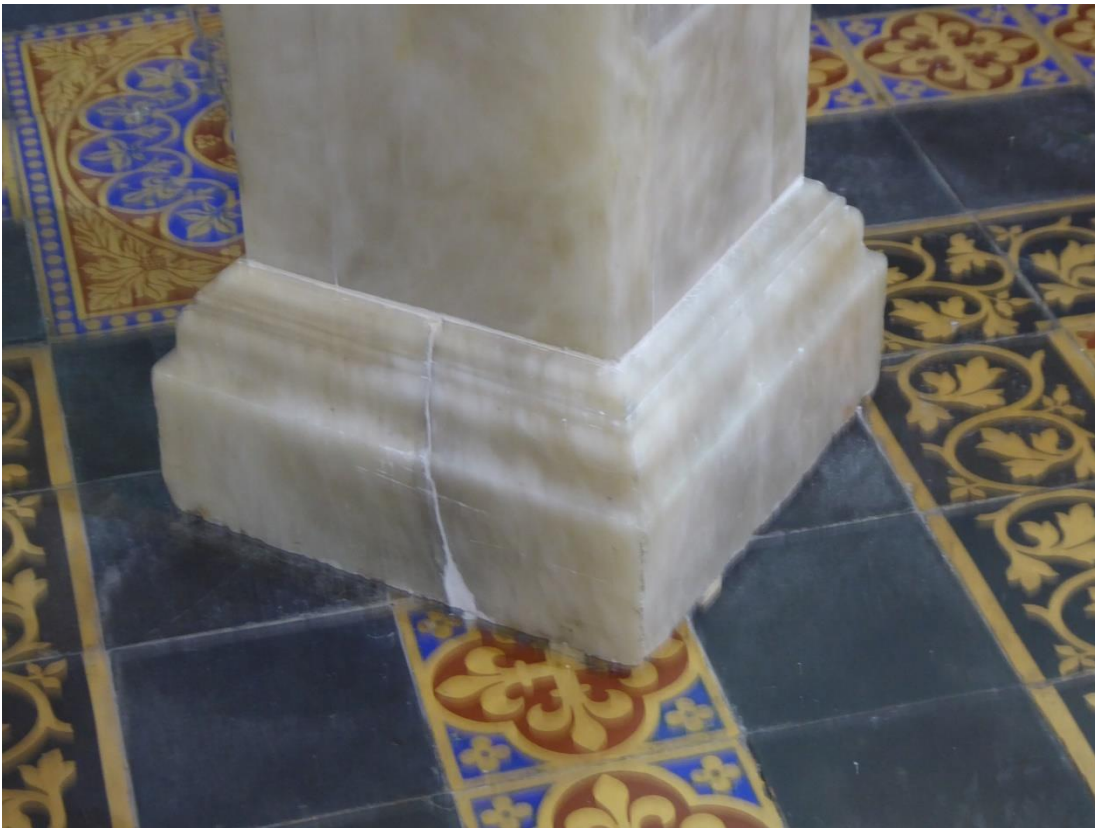
Figure 66 Crack condition after fixing and filling

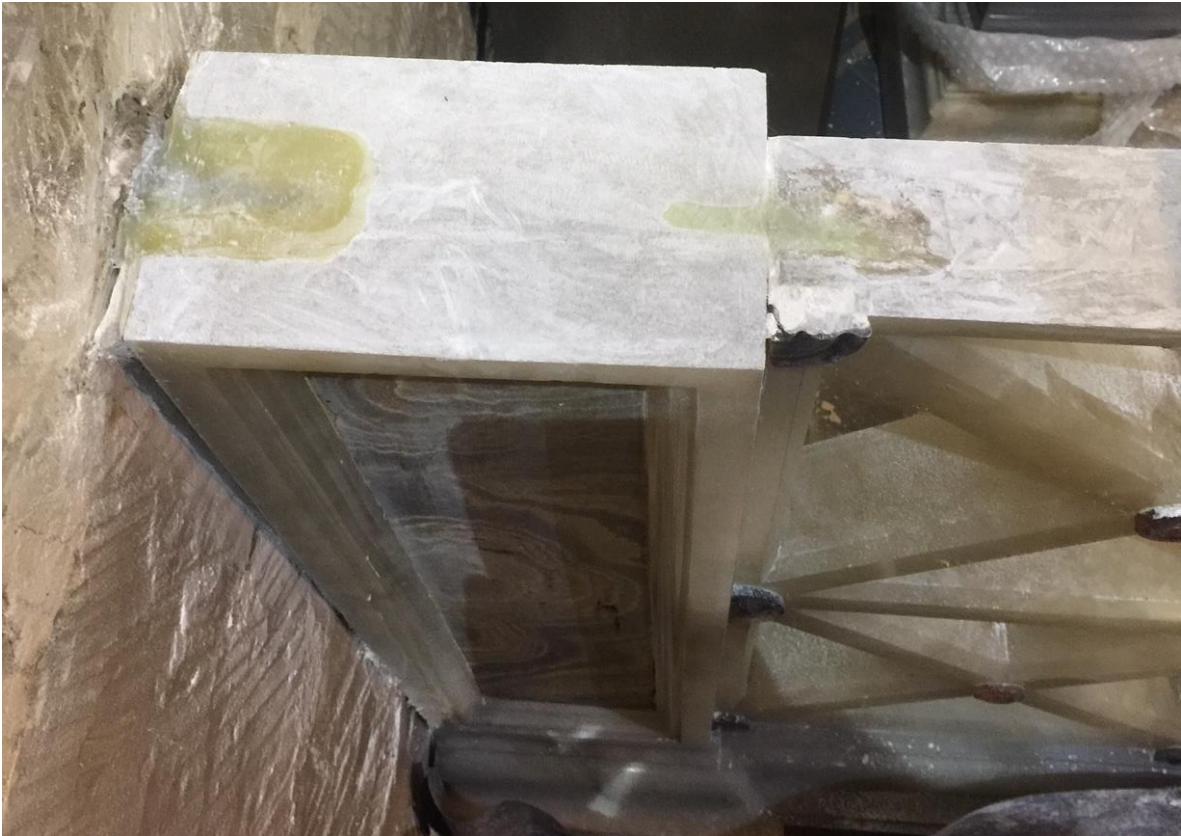
Figure 67 Replacement of two metal cramps and fixing with resin

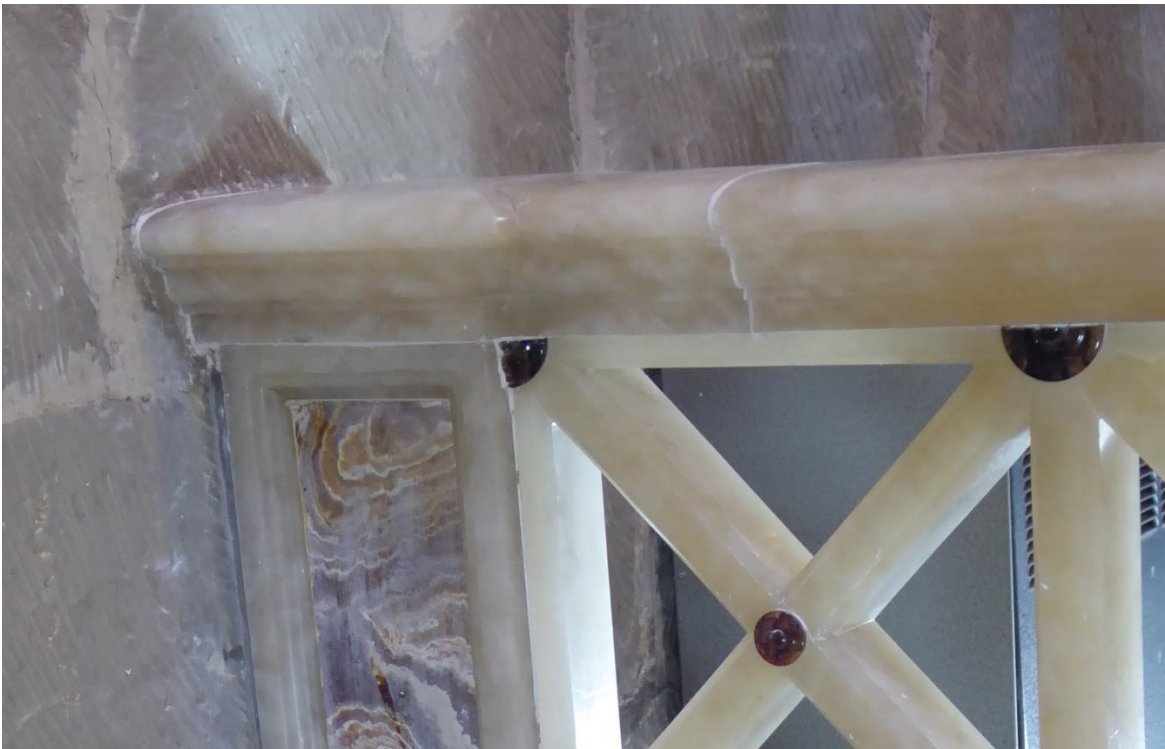
Figure 68 Relocation of block and new pointing

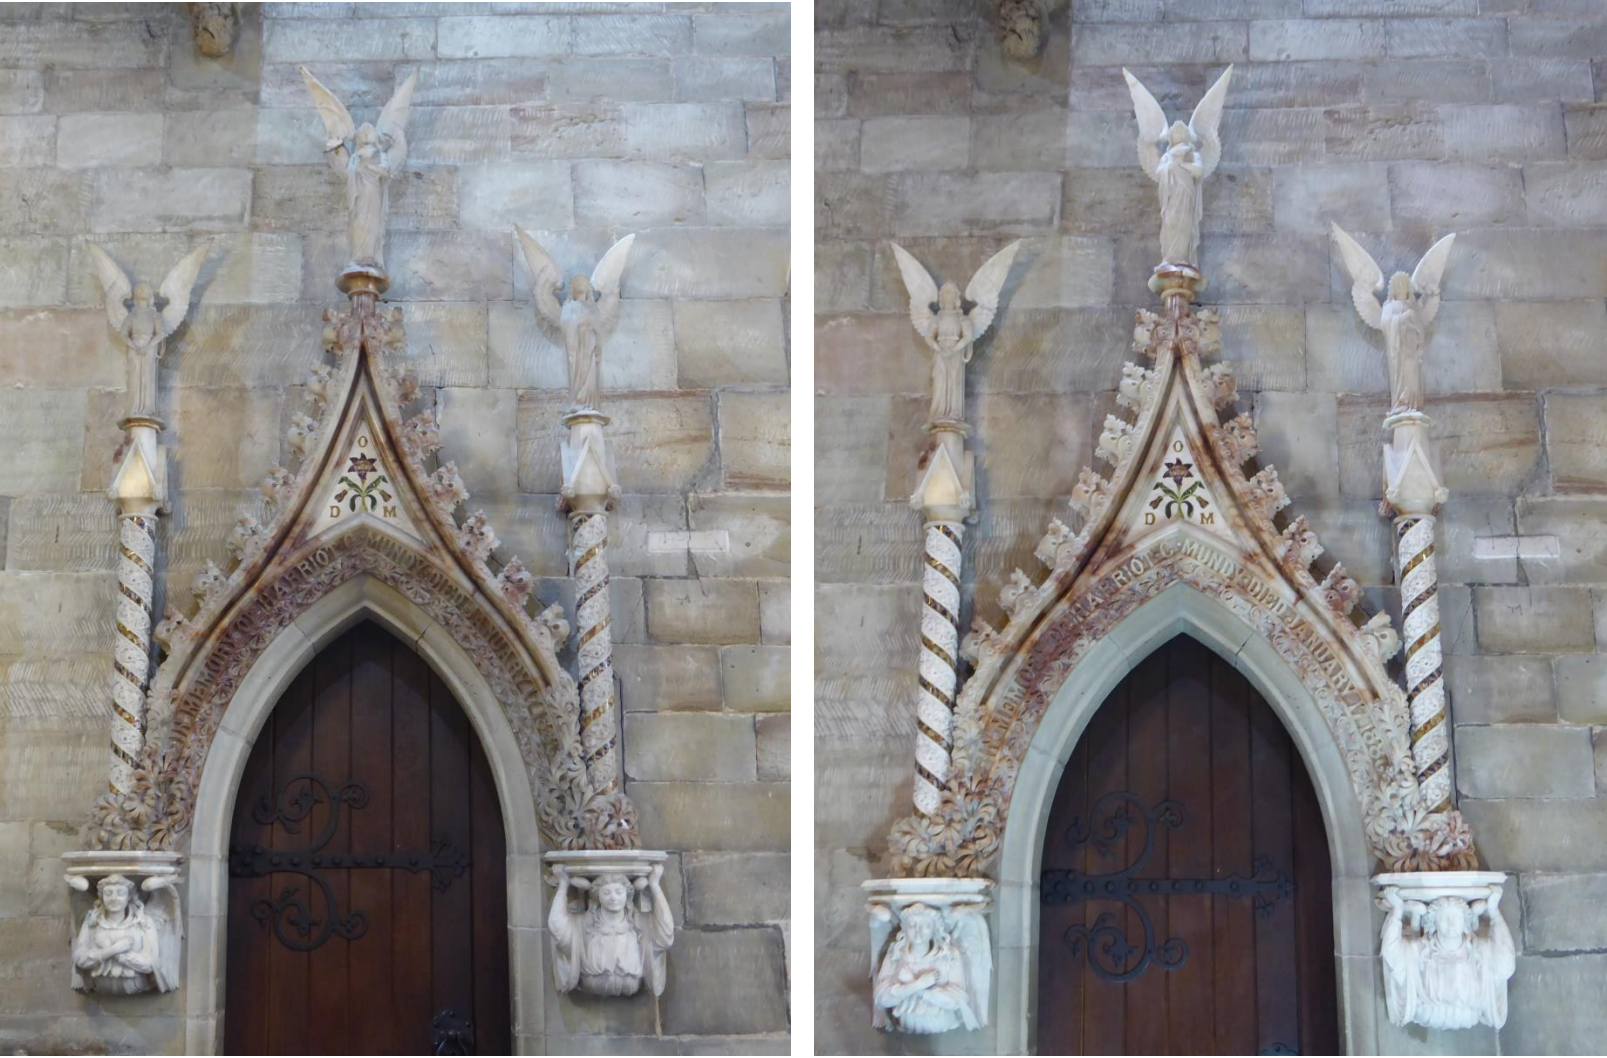
Figure 69 Initial and final condition of the vestry door

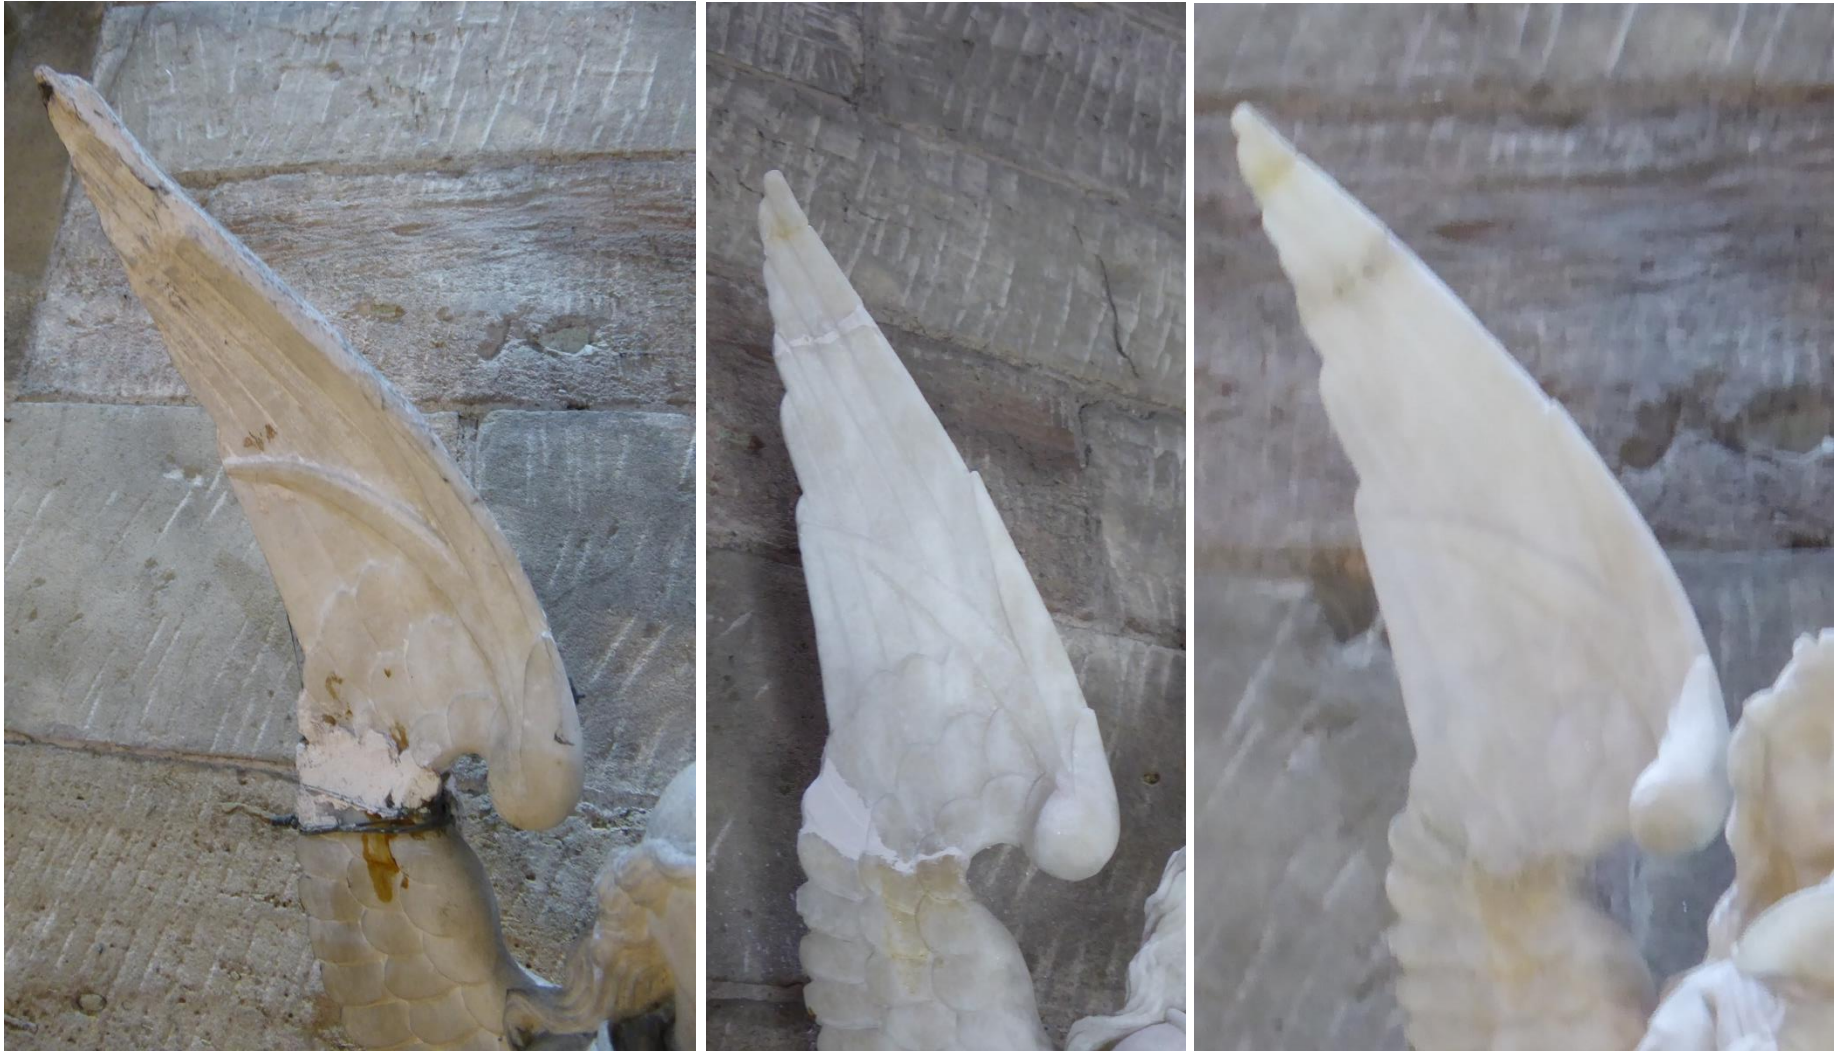
Figure 70 Initial, during process and final condition of the angel wing to the vestry door
