**Conservation report for the reredos, communion rail,
candlesticks, vestry door, exterior chancel east wall, pinnacles and
coping stones**

**All Saints Church, Mackworth
Diocese of Derby**

July 2017

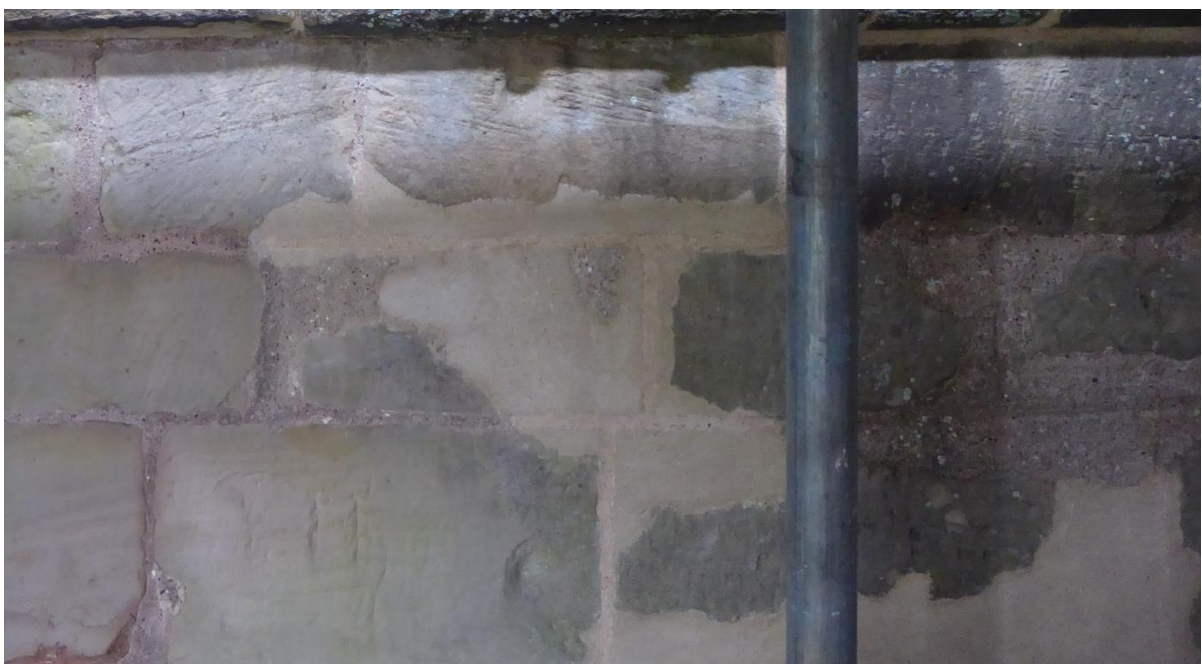
Figure 72 Condition of new mortar repairs to exterior wall

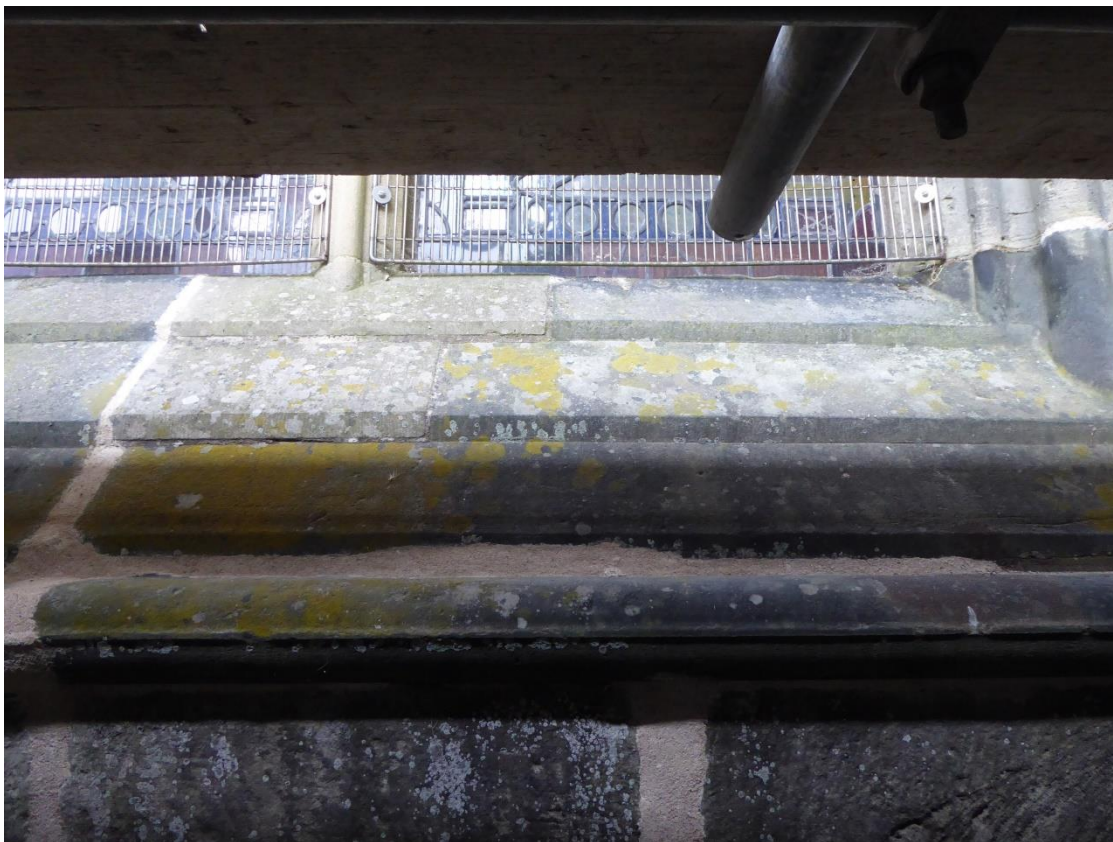
Figure 74 New pointing works to exterior wall

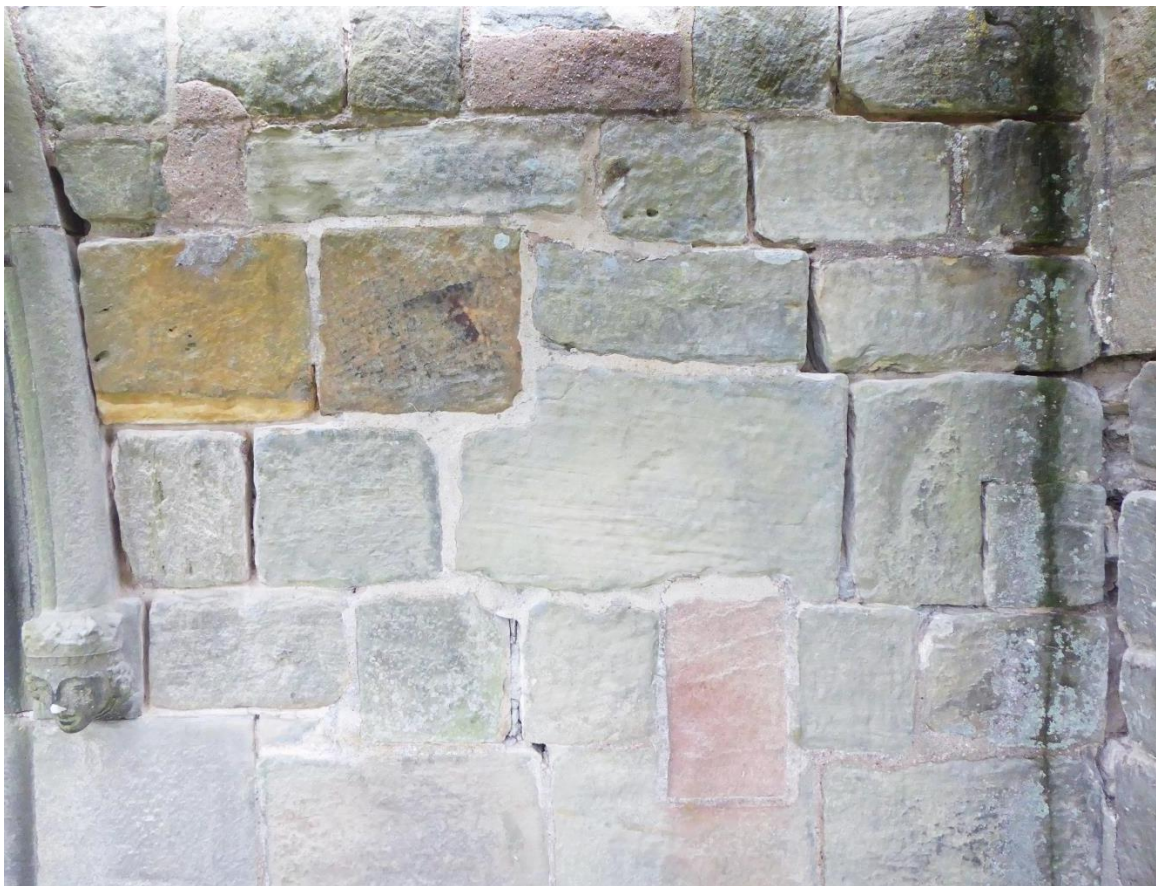
Figure 76 Raking out of failed pointing mortar

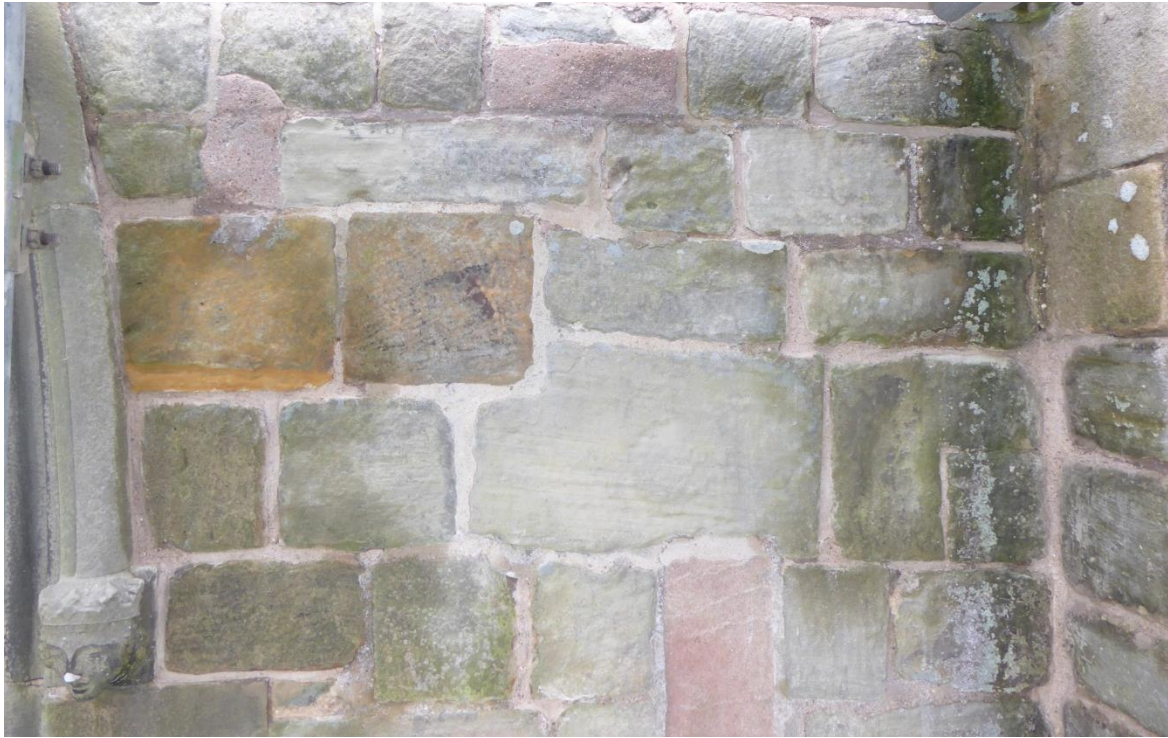
Figure 77 Application of first coat of pointing mortar to exterior wall

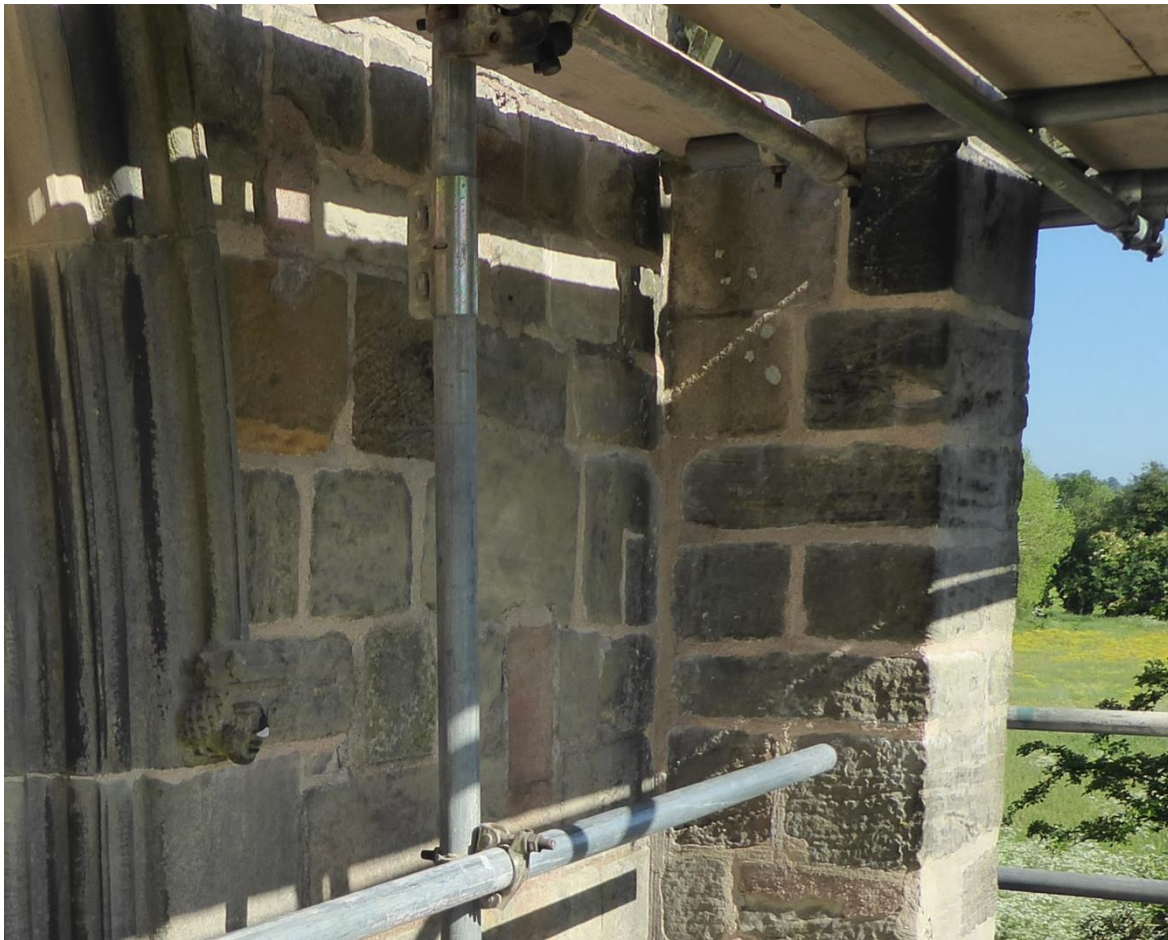
Figure 78 Application of pointing top coat to exterior wall

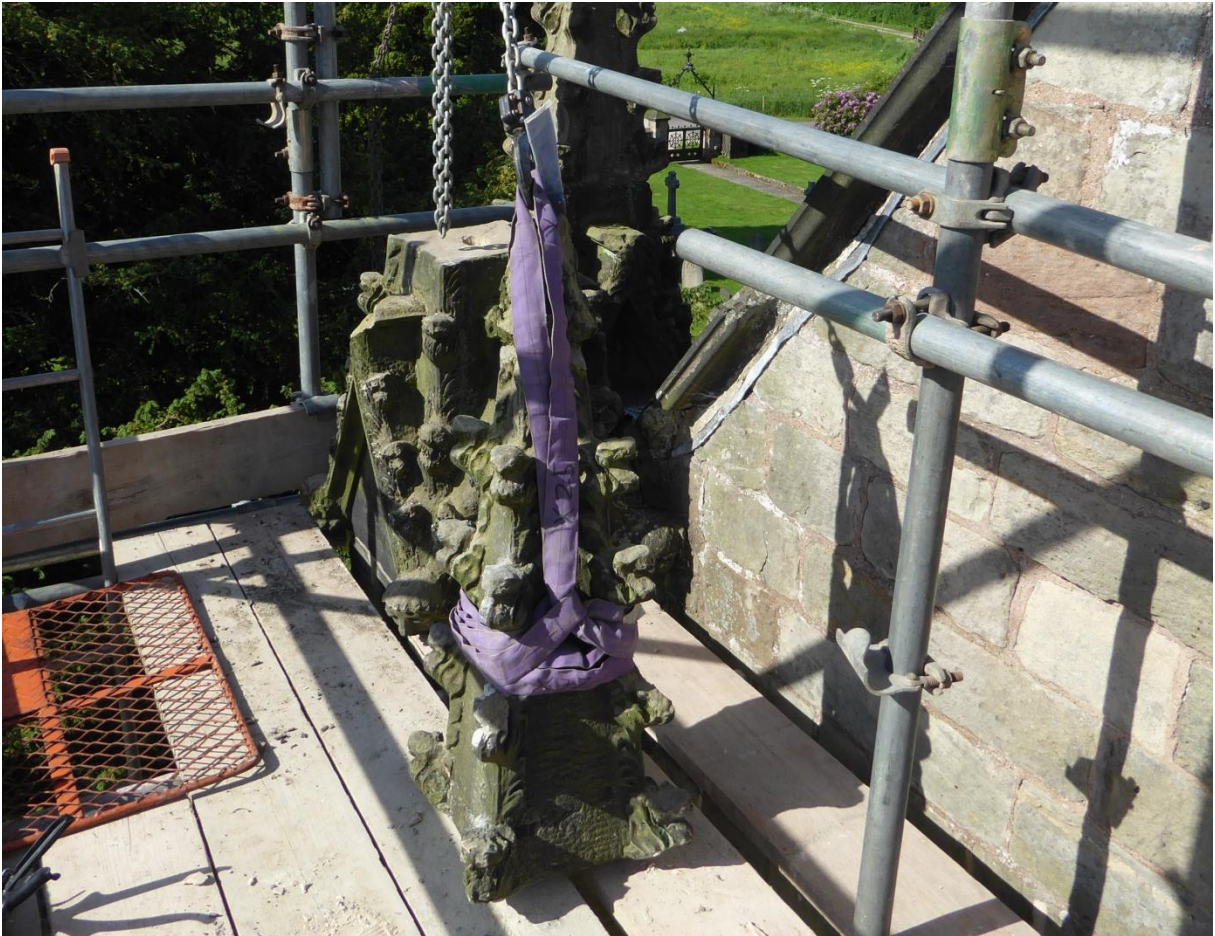
Figure 79 Dismantling top section of pinnacle

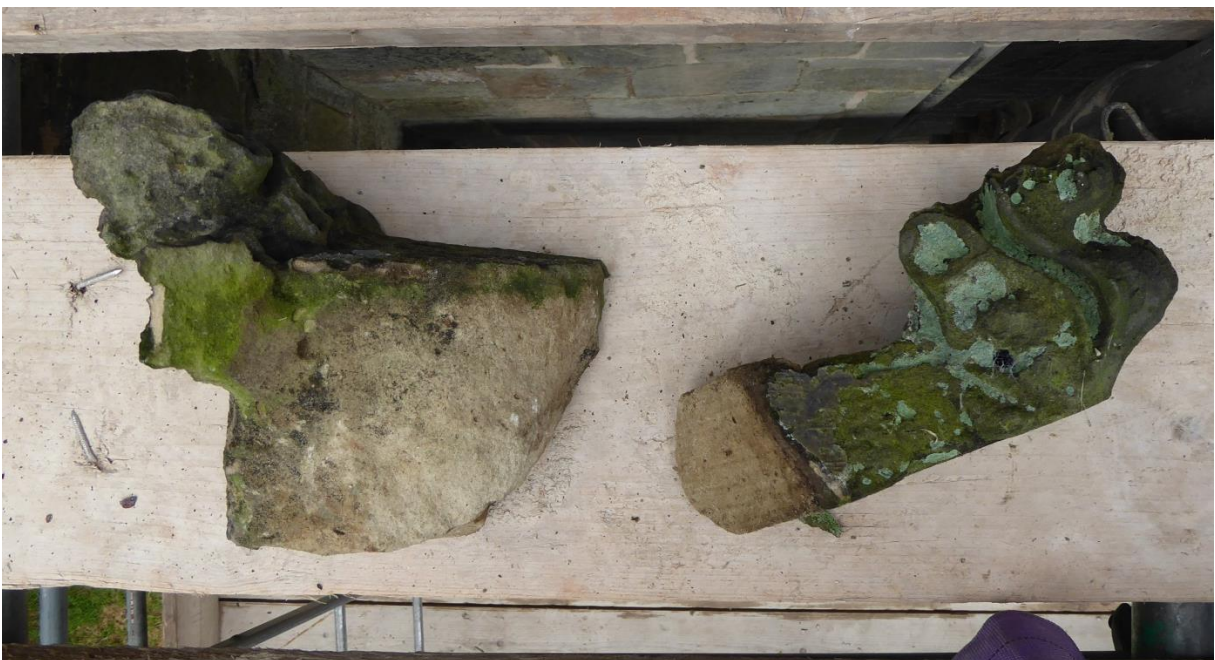
Figure 80 Fragmented pieces to south pinnacle

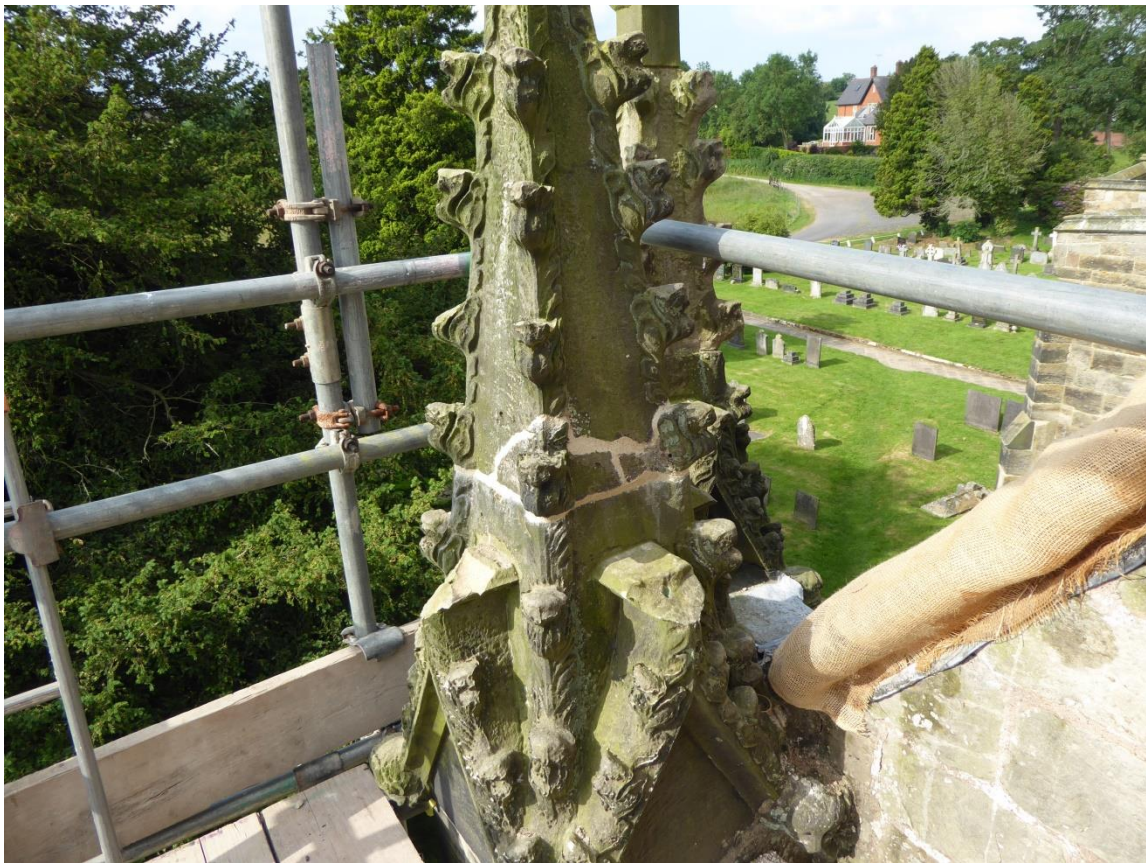
Figure 82 Final condition of pinnacle with pointing works

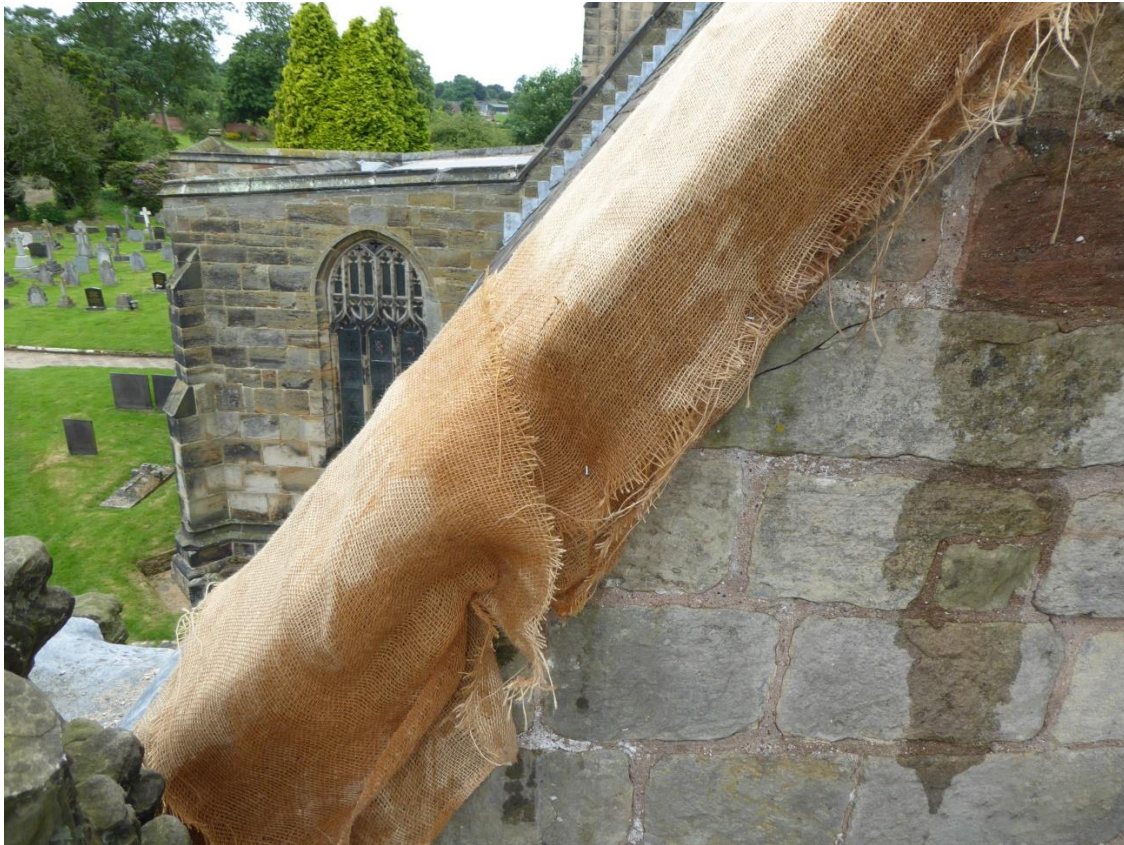
Figure 85 Wetting and protection with hessian of new pointing mortar

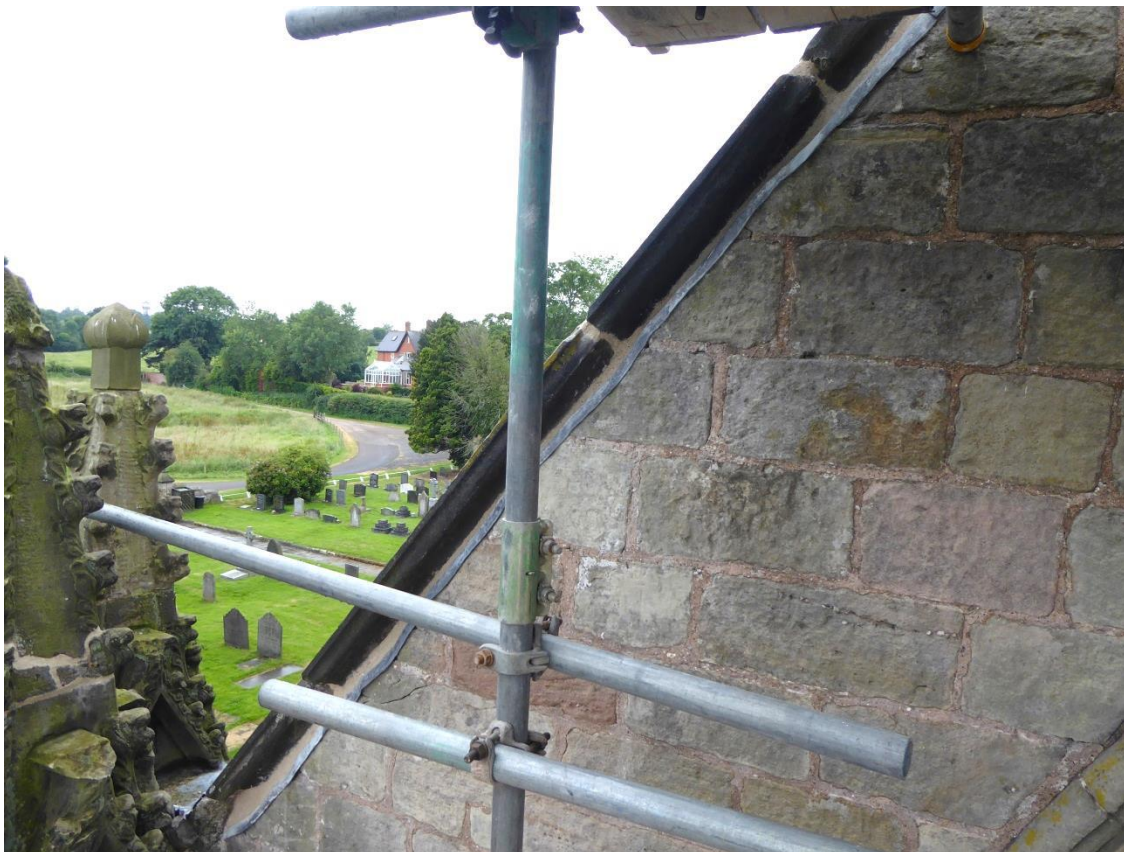
Figure 86 Pointing top coat to coping stones
