**St Giles' Church
Stanton St Quintin
Wiltshire
Diocese of Bristol**

Built Heritage Assessment

CA Project: 5177
CA Report: 15002

August 2017

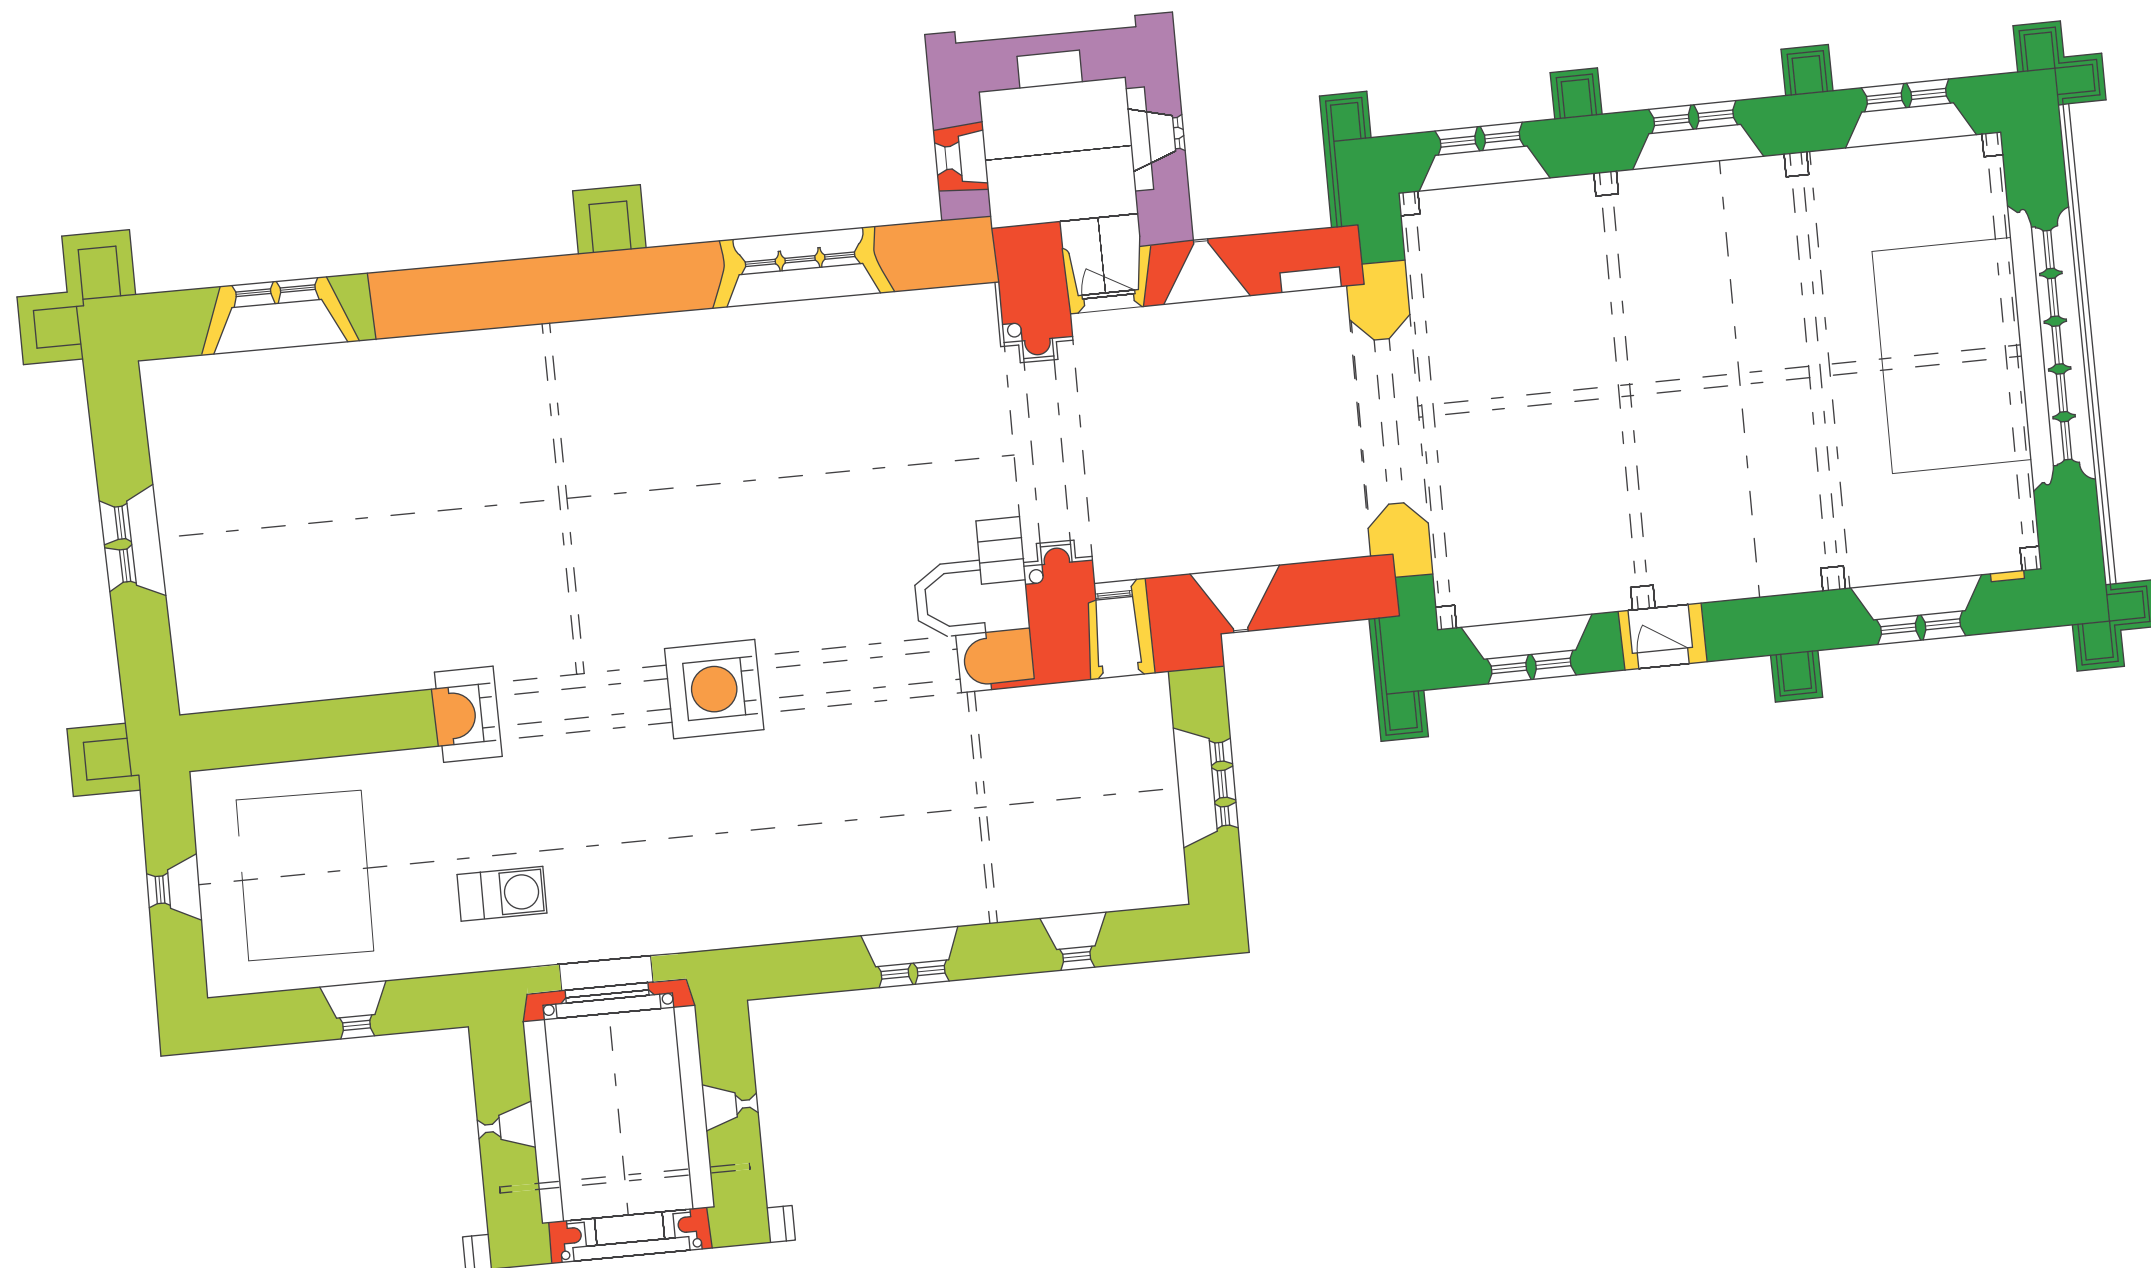
DRAWN BY	AO	PROJECT NO.	5177	FIGURE NO.
CHECKED BY	JB	DATE	26/01/2015	3
APPROVED BY	GS	SCALE@A3	1:100

- c. 1125
- later 12th century
- 14th/15th century
- 1827 (1851?)
- 1888/9
- medieval (uncertain date)

FIGURE TITLE
Phased building plan

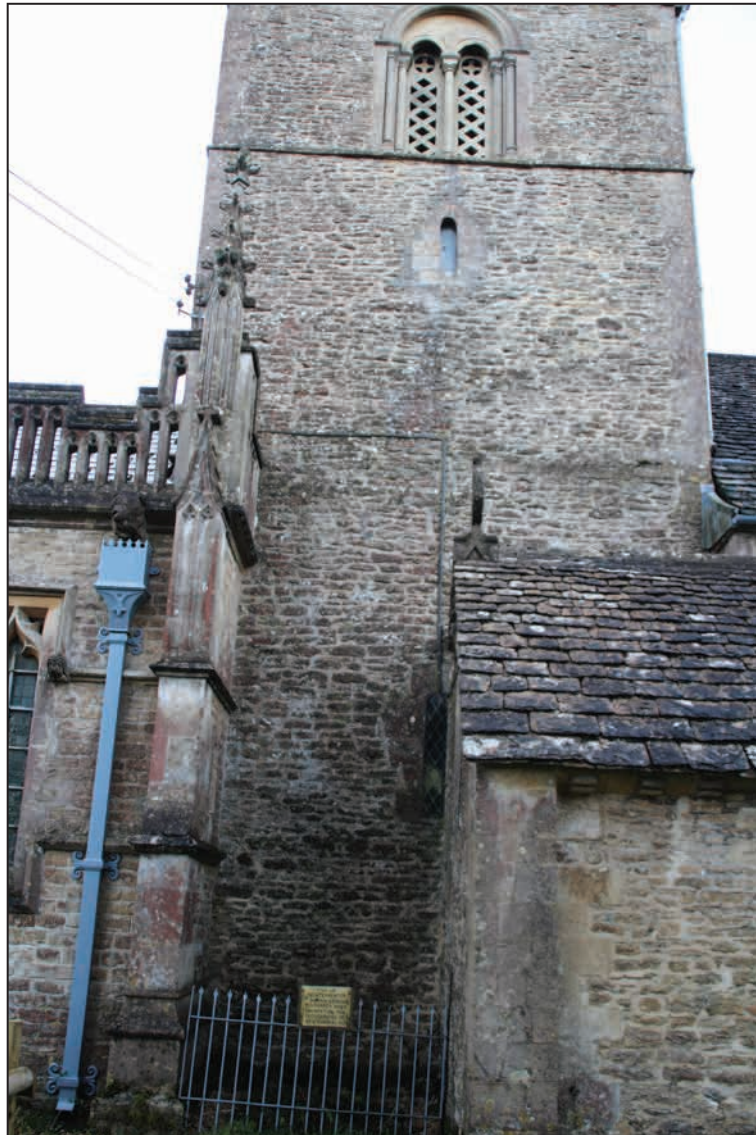
7 The north side of the tower showing the masonry (chancel to left, north chapel to right)

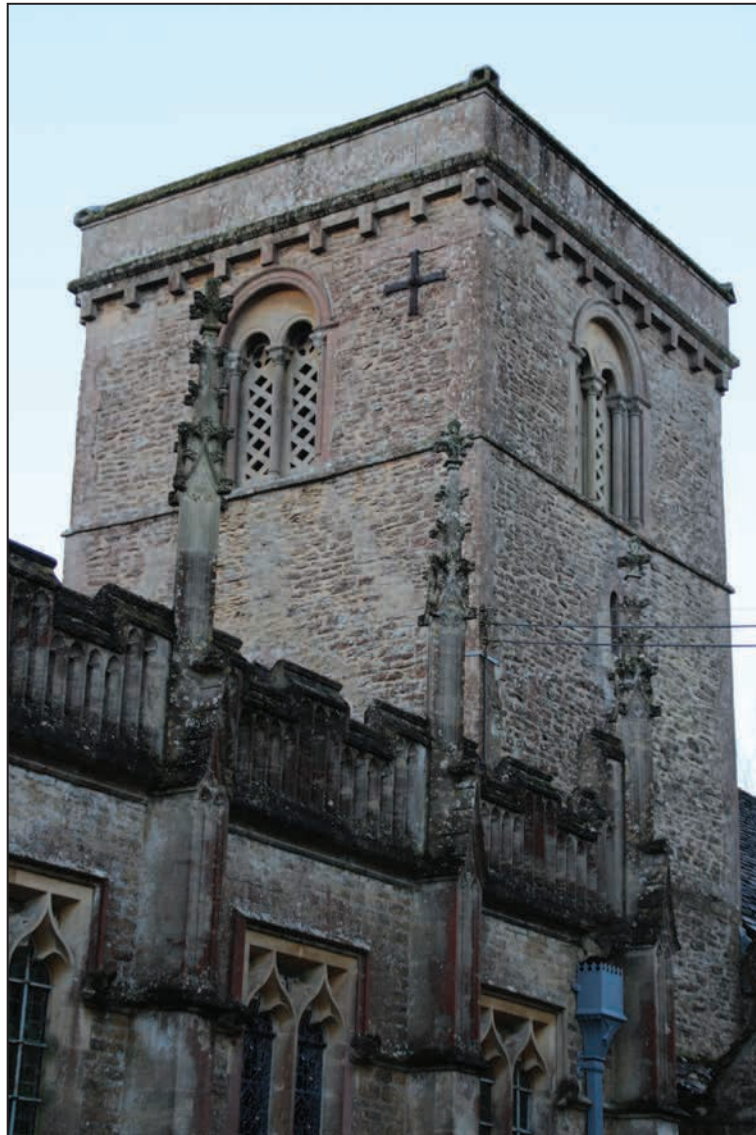
8 The upper stages of the tower looking south-west, showing inserted windows and the added parapet etc

5.3 The tower is dated by the style of the tower arch inside (Fig. 9) and a date of c. 1125 seems to be acceptable. The upper storey is supposed to have been added or rebuilt in 1827 but the fabric suggests that this work must have been relatively minor repair works which were replaced in 1851. An iron cross-pattress on the east face of the tower (Fig. 8) suggests structural work of around this time, certainly unnecessary if this storey was new then.

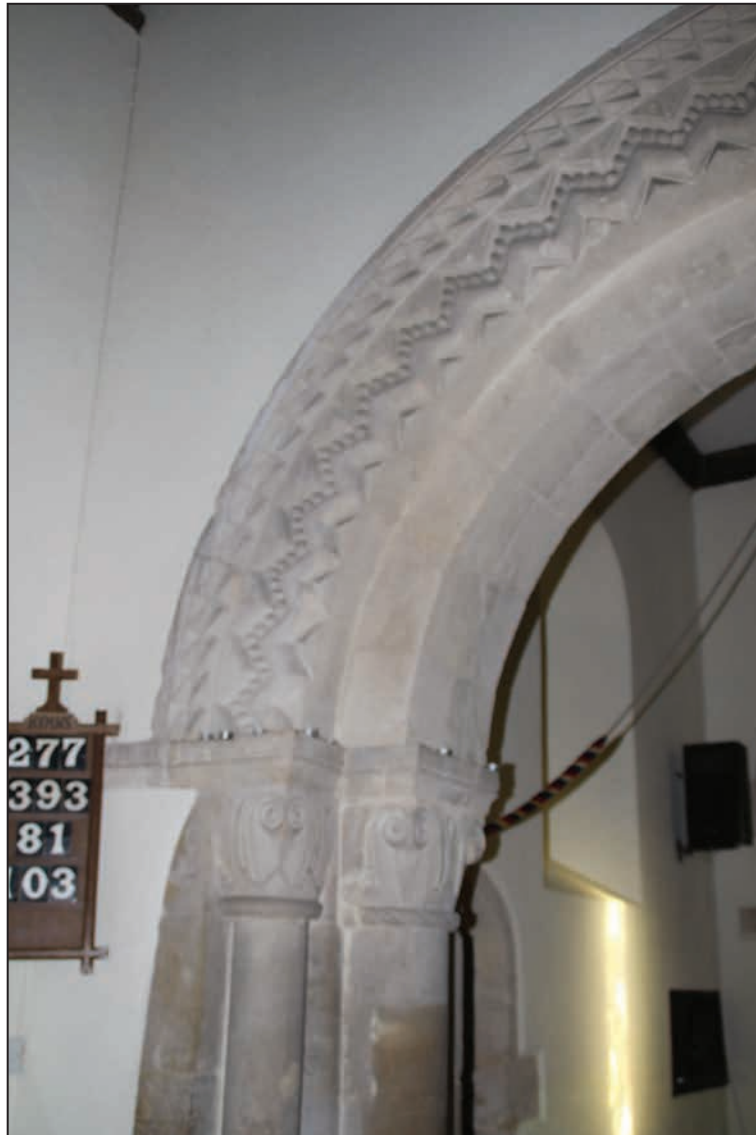
9 The tower arch north respond and arch looking north-east

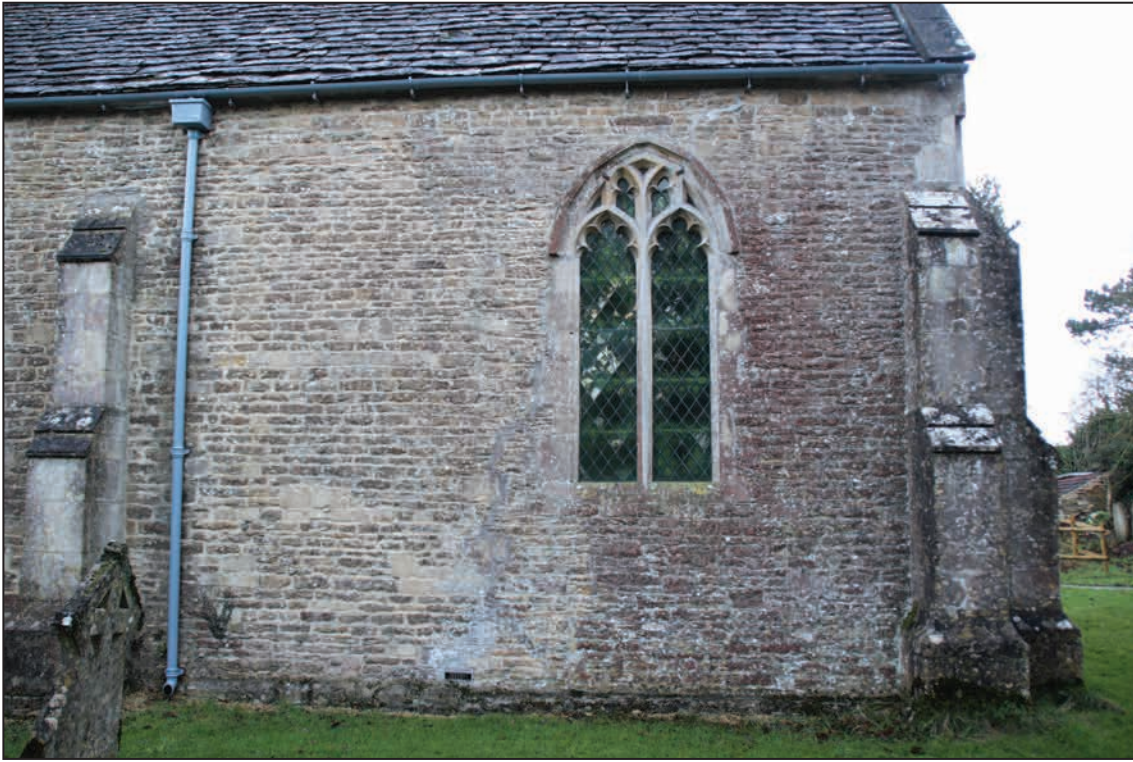
10 The north wall of the nave, showing the regular roughly squared stone work. The 1827 work is evident as the redder, rougher work on the right

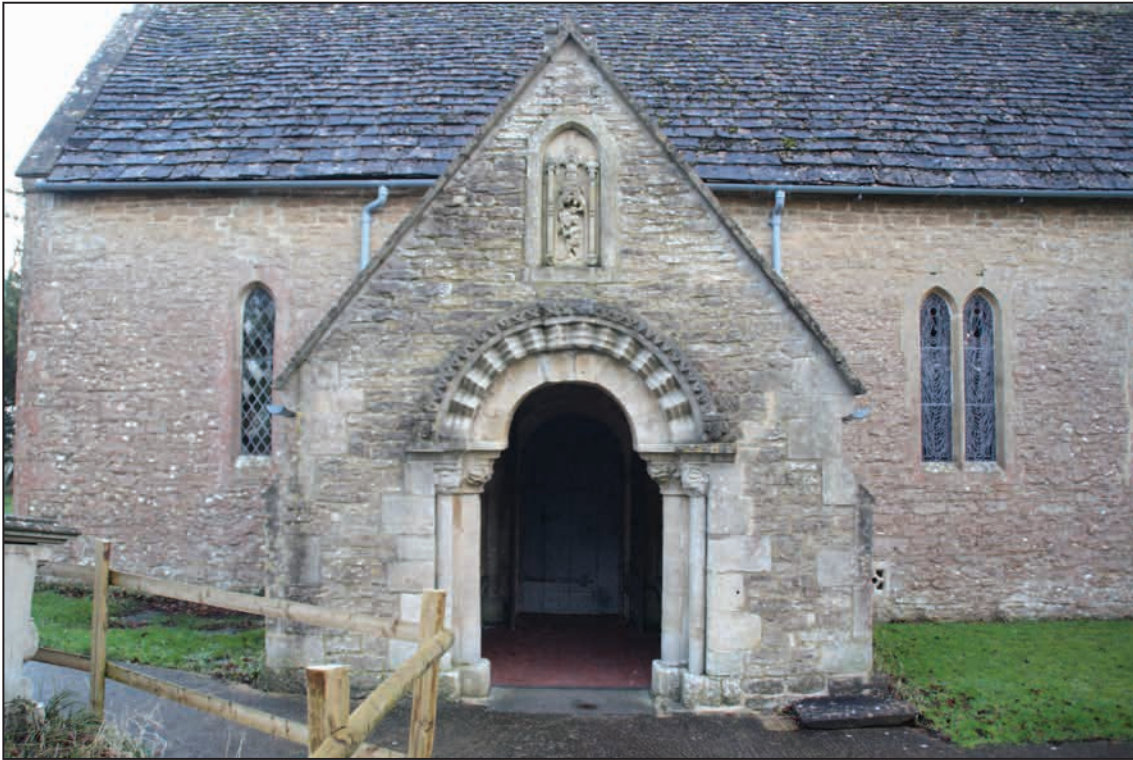
12 The south porch, also showing the different stonework in the upper part of the aisle wall

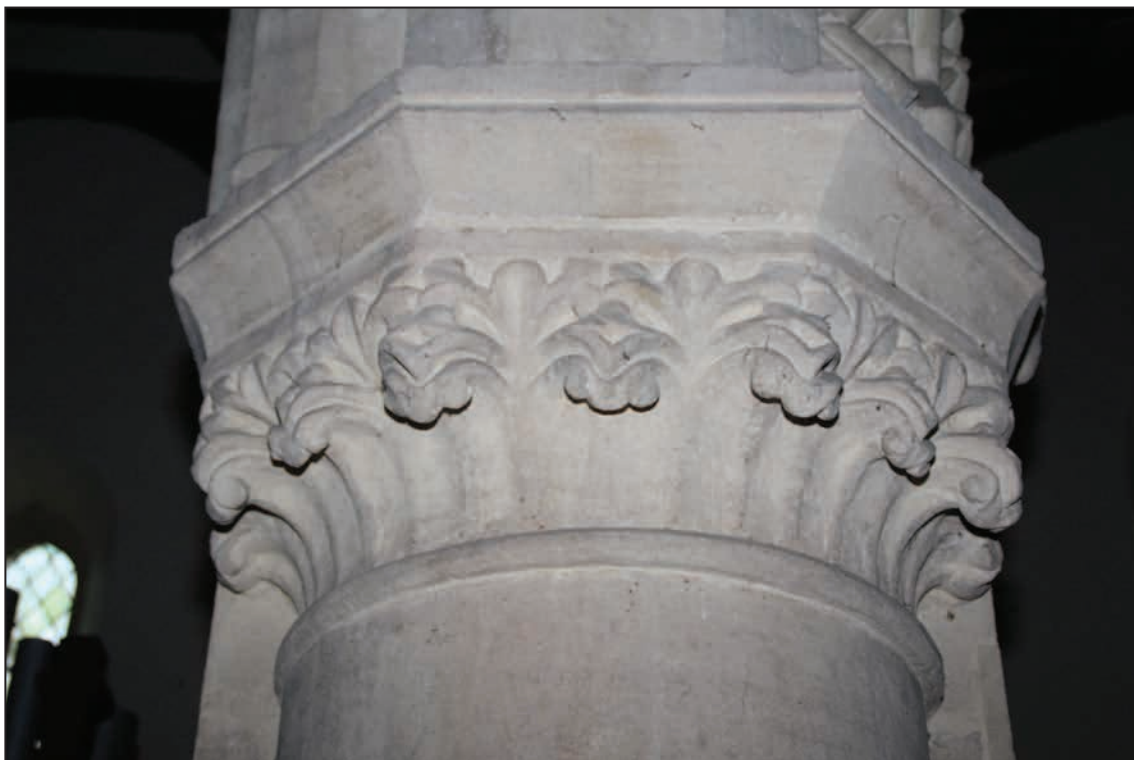
14 The capital of the western aisle respond

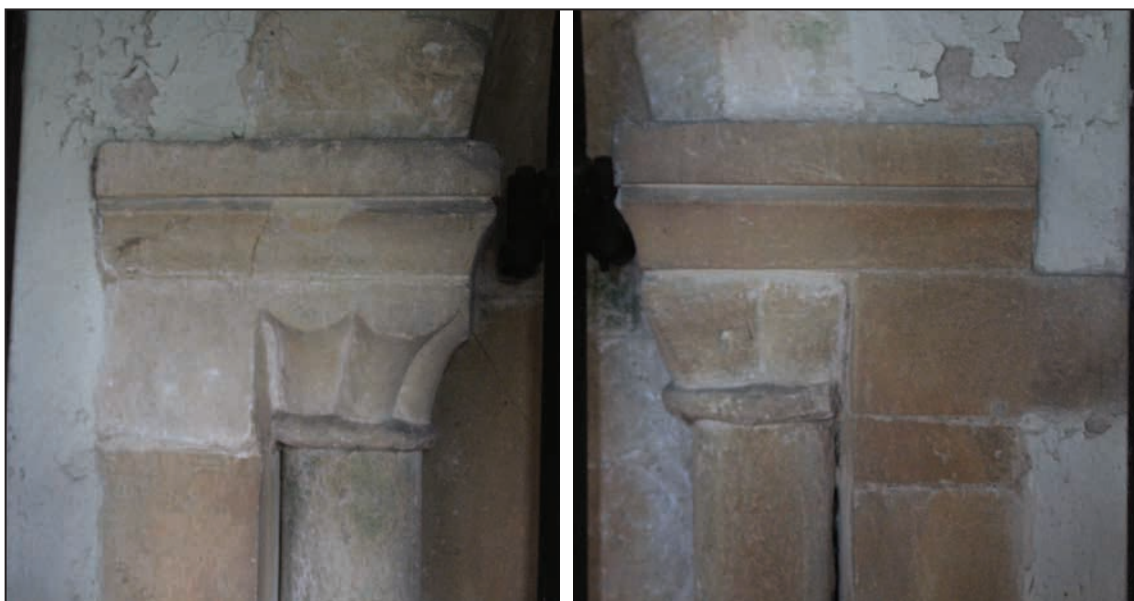
16 The two capitals to the inner doorway in the porch

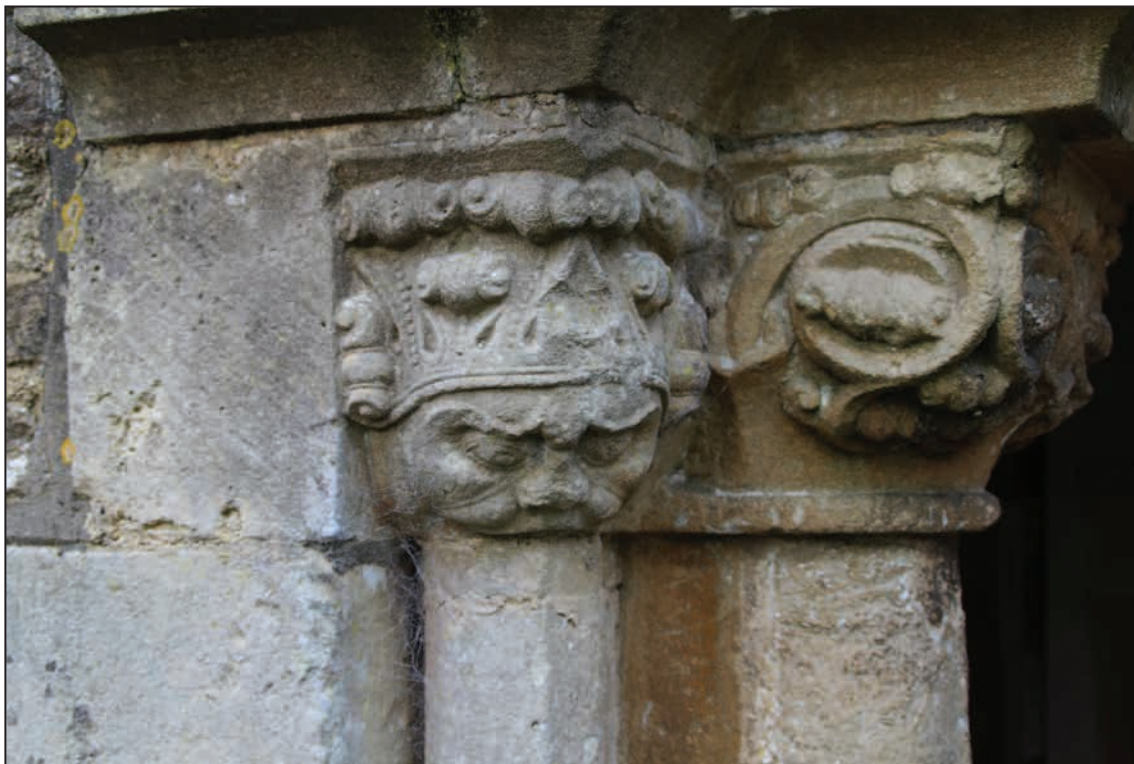
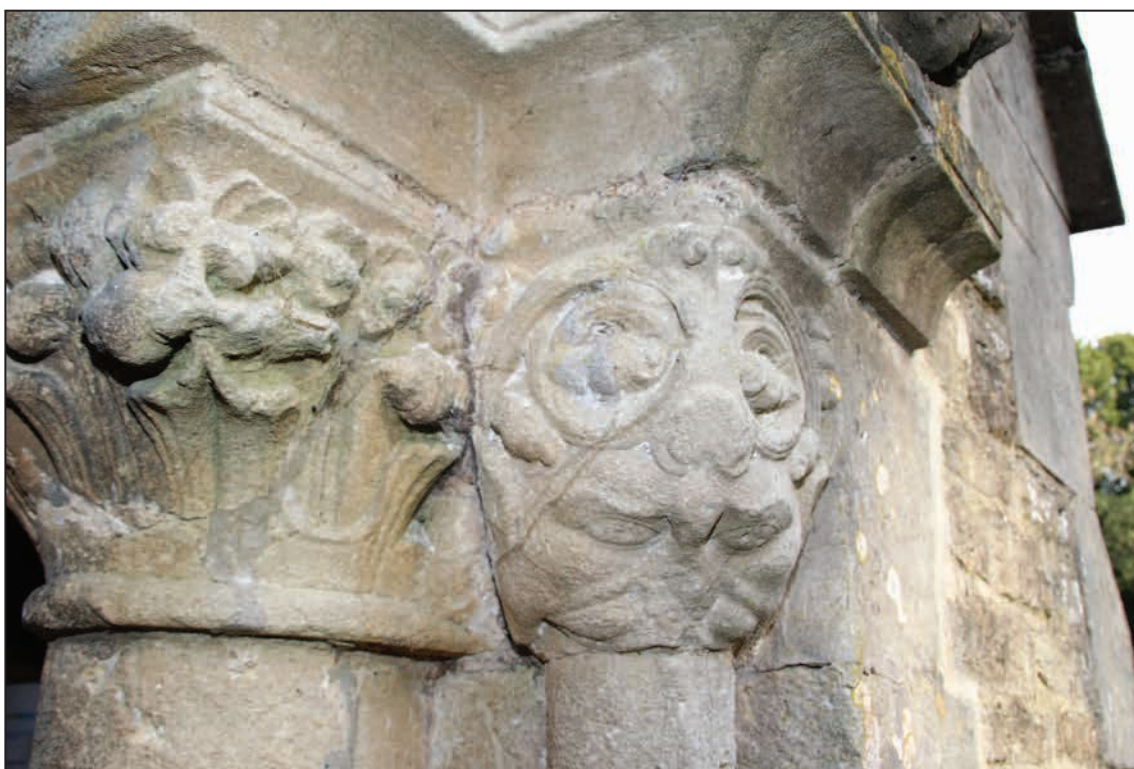
17 The four capitals in the outer portal of the porch

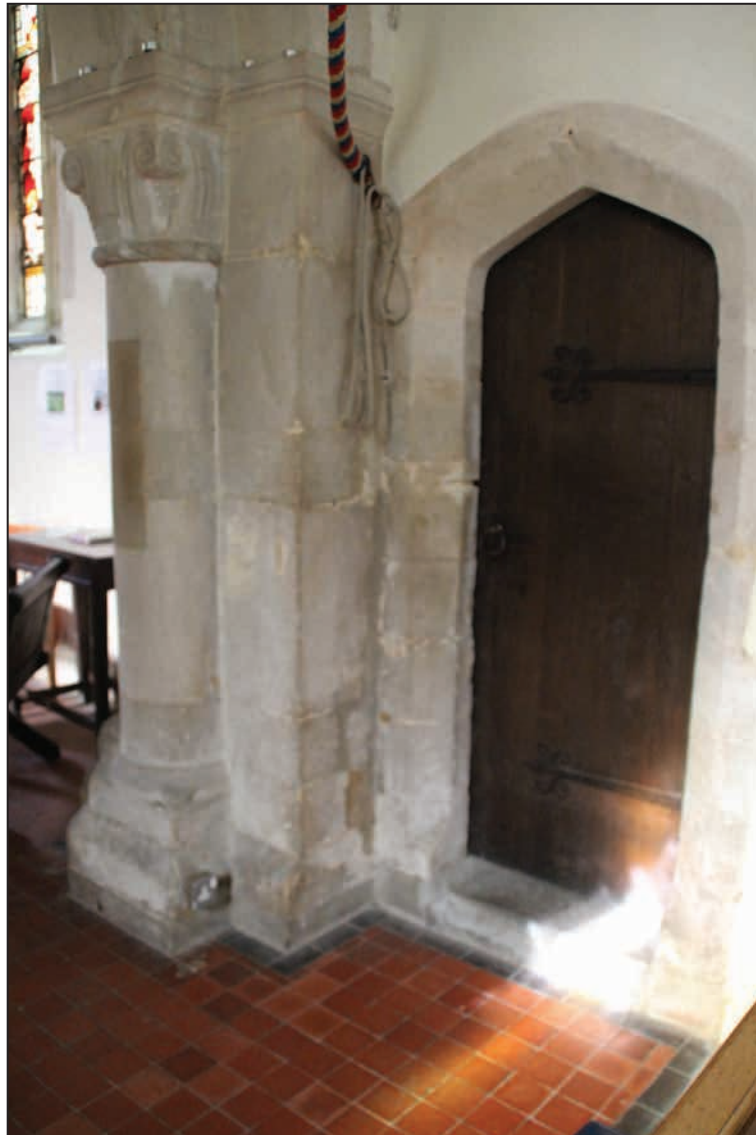
18 The door to the north chapel, in the tower space, and the north respond to the tower arch, looking north-west

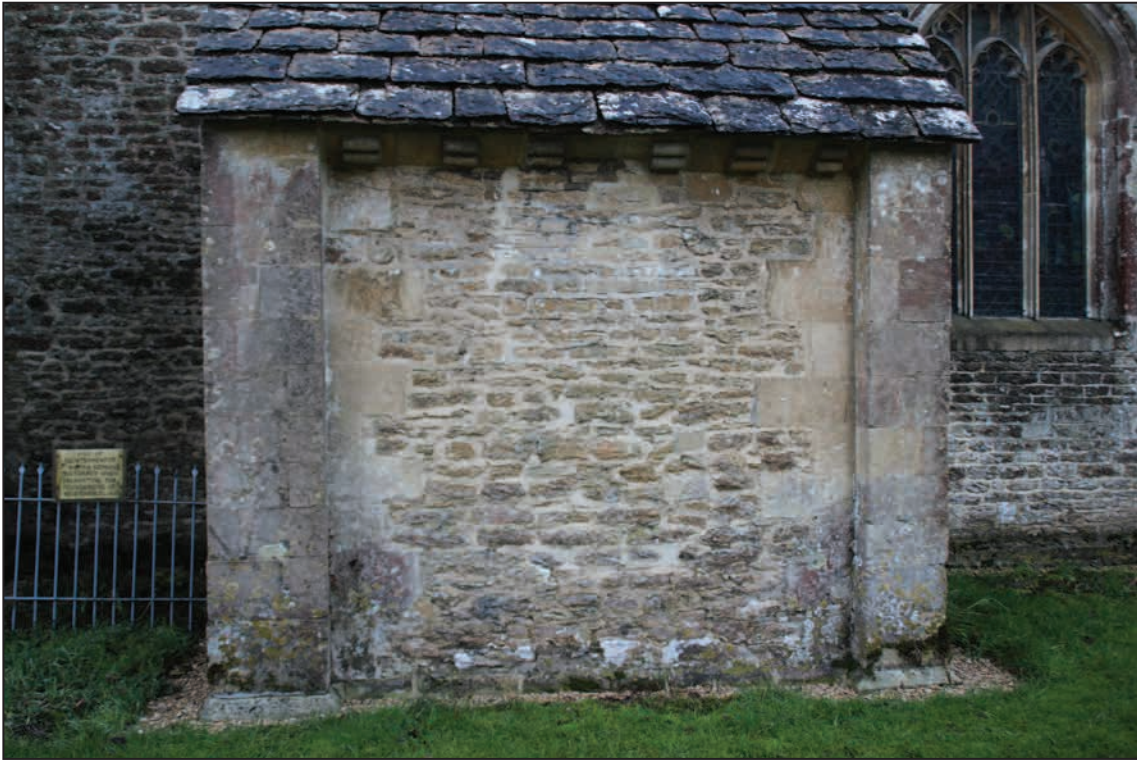
19 The north side of the northern chapel, with billet mouldings

- 5.21 The double billet moldings under the eaves of this building are of 12th-century type (Fig. 19), as is the round window noted by Pevsner (1985, 479), but neither of these elements are necessarily *in situ*, and the billets could date from the 19th century.

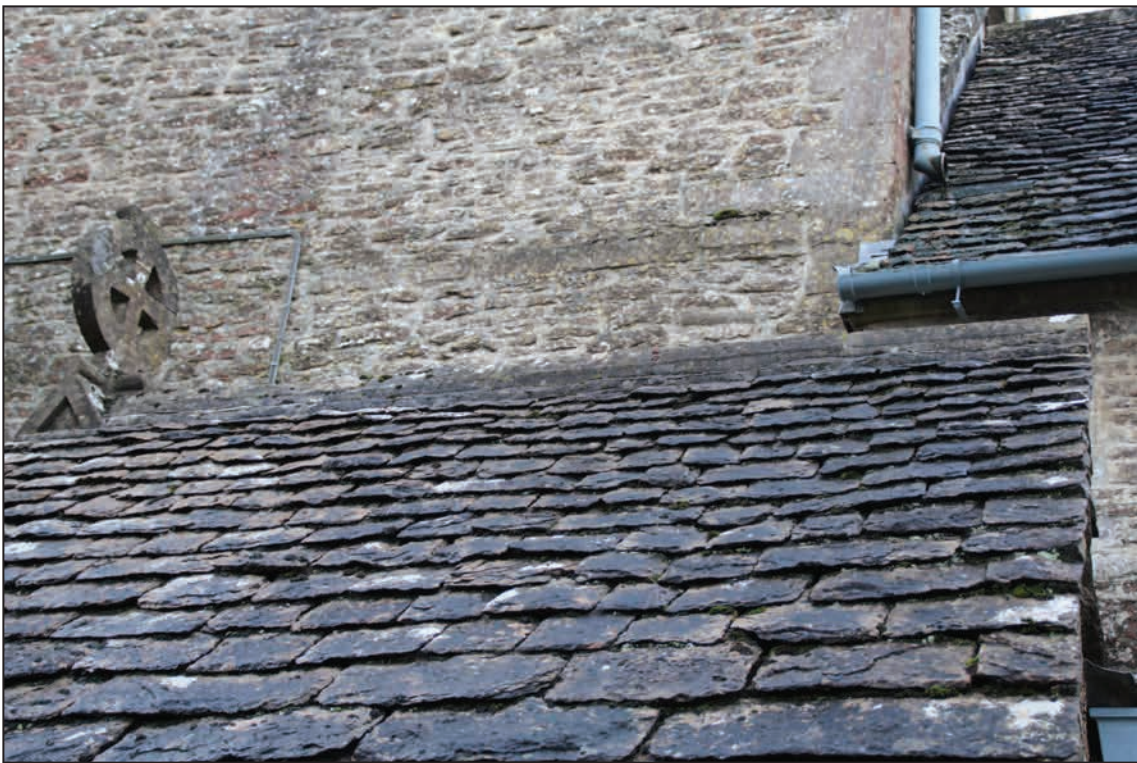
20 The repaired weathering for the former junction of the lean-to roof of the north chapel in the north wall of the tower (centre). The present nave roof, top right has been lowered slightly at some point

- 5.22 What is clear is that the roof has been re-organised. The present double-pitched roof and its gable ends have replaced a mono-pitched, lean-to roof that continued the slope of the nave roof (Fig. 20). The weathering where this roof met the tower is visible as a stone insert in line with the nave eaves, in fact slightly higher, as the nave roof has been lowered slightly (Fig. 20). It seems probable that this work was done either in the 1820s or in 1851, along with the insertion of the east window and the gable finial. The interior of the chapel was not accessible.

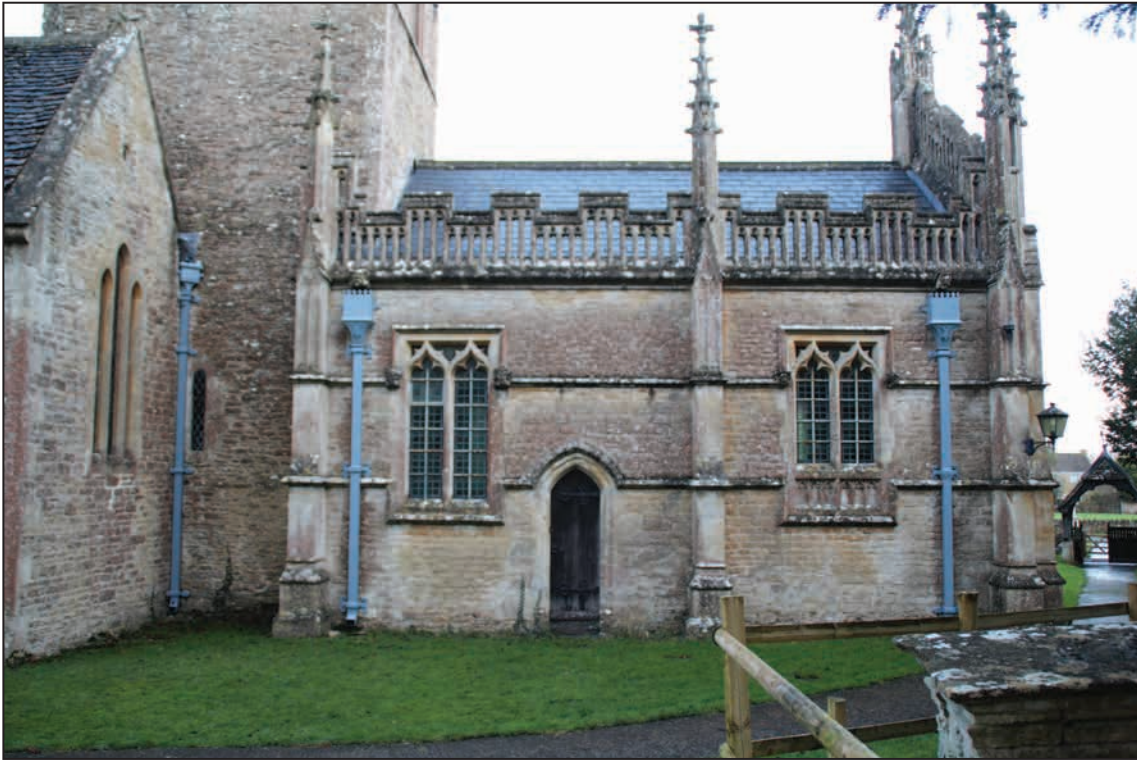
21 The south elevation of the chancel and the reset south door

- 5.25 It also retains, but here reset, the south door of the earlier chancel (Fig. 21). This is recognizable as an older piece of fabric from the shaping and condition of the stonework and the style. It is presumably the door seen in a pencil drawing of the church from the south-east, currently in the church, and dated on the back to c. 1870 (Fig. 22). This drawing certainly post-dates Hakewill's work on the tower and pre-dates Ponting's rebuild of the chancel. This shows the old chancel, thought to date from the 13th century (WCH 2011). The visible east window does not contradict this dating, though might better fit a 14th-century date with its lack of imposts to the window head.

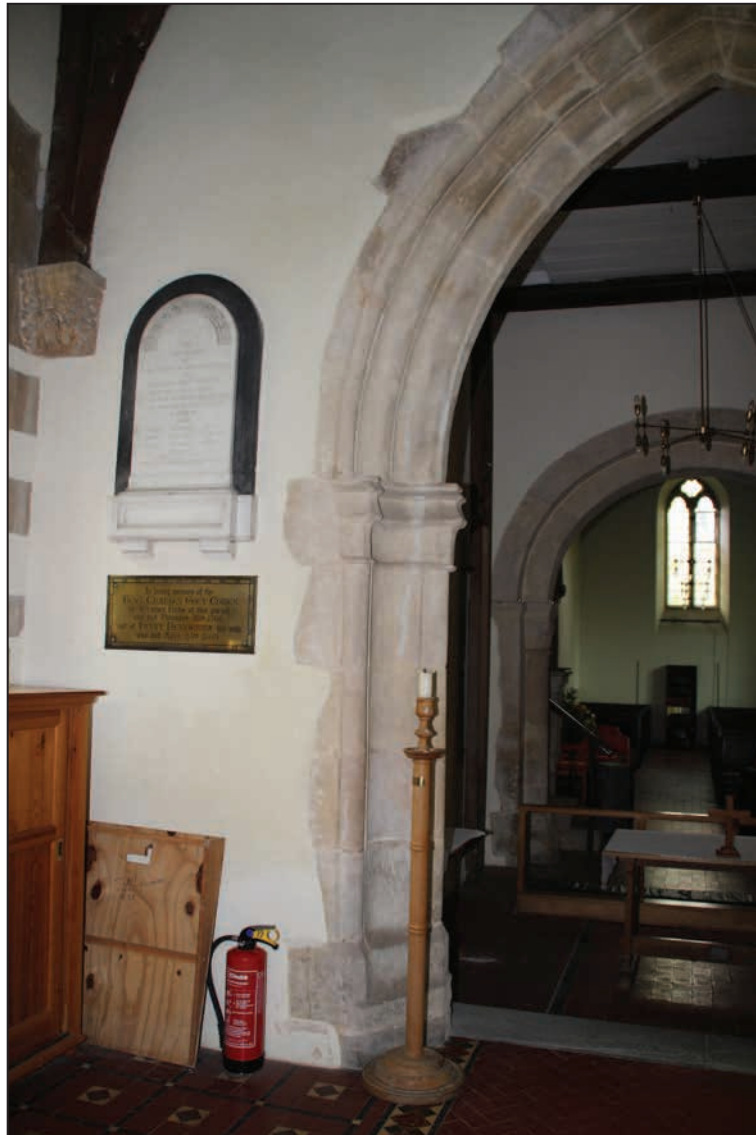
23 The chancel arch south respond, looking west

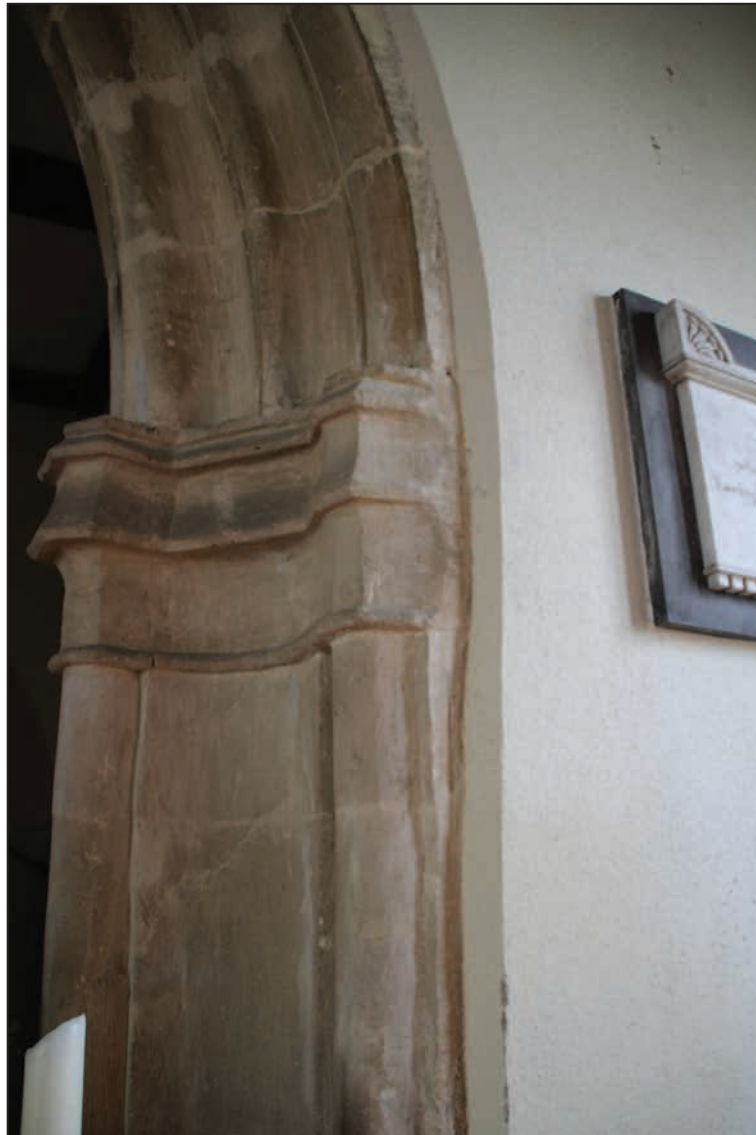
24 The north respond of the chancel arch, showing the poor fit of the arch and the cutting back of the sides

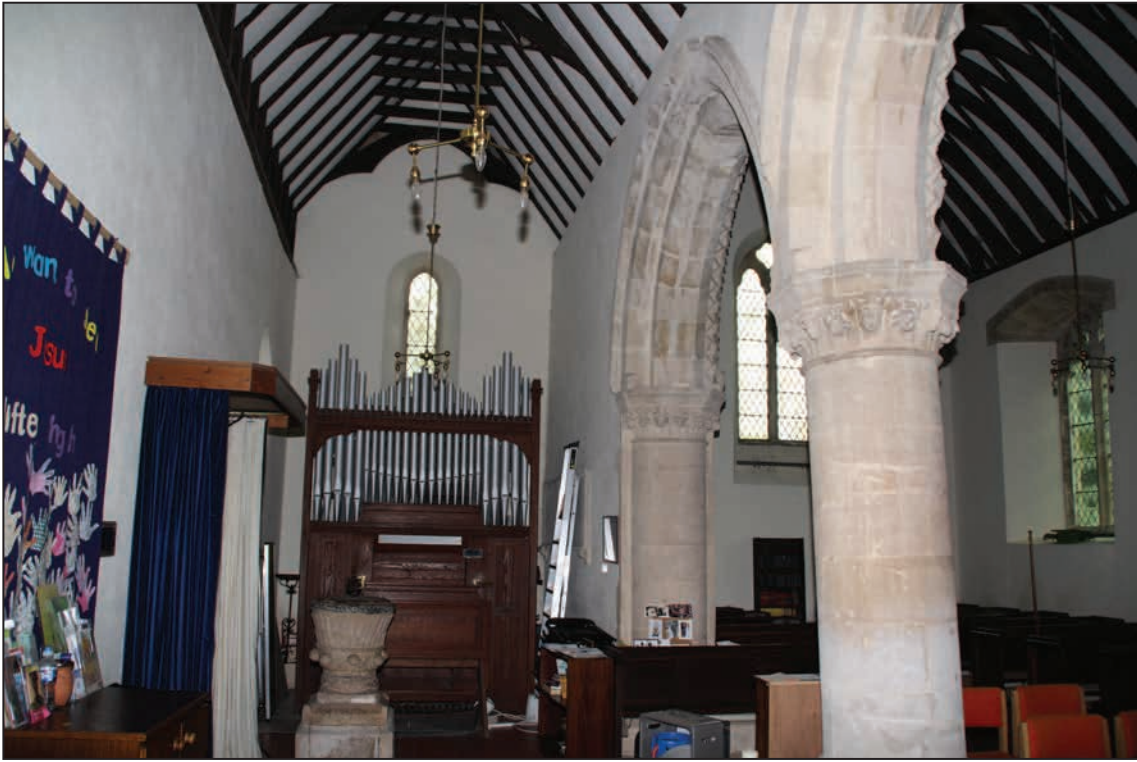
25 The west end of the nave and aisle, looking from the east end of the aisle

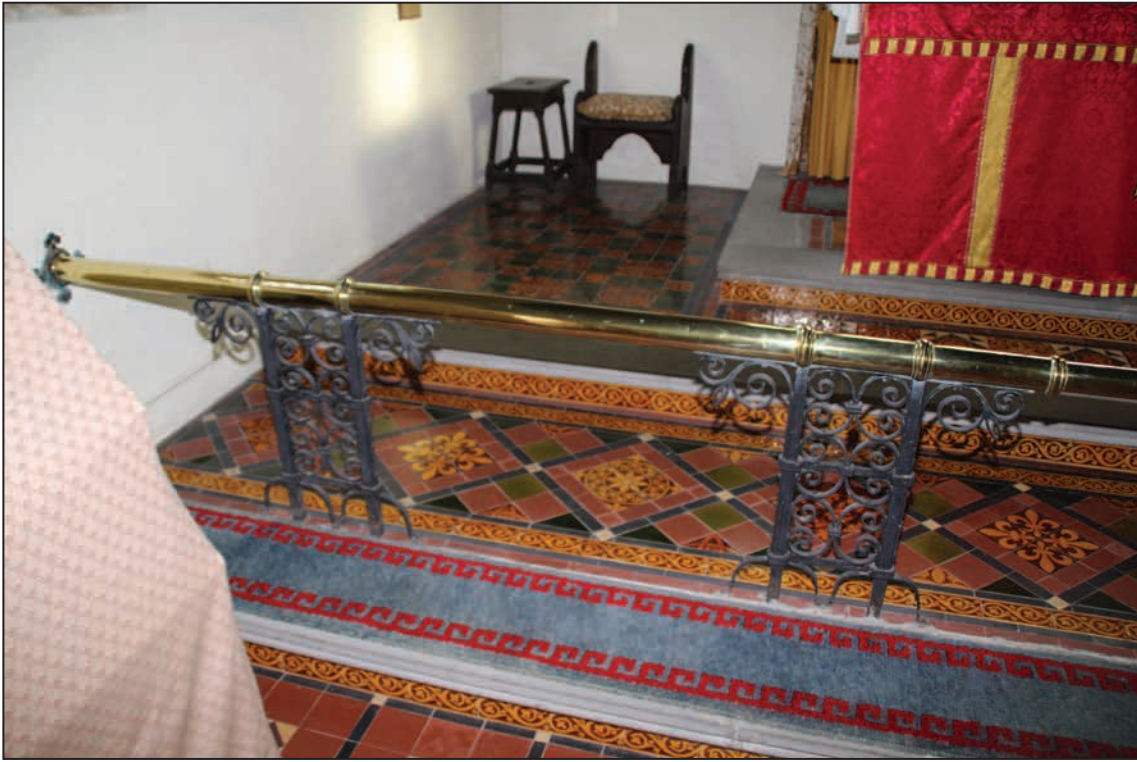
27 The communion rail and the tiles in the east end of the chancel

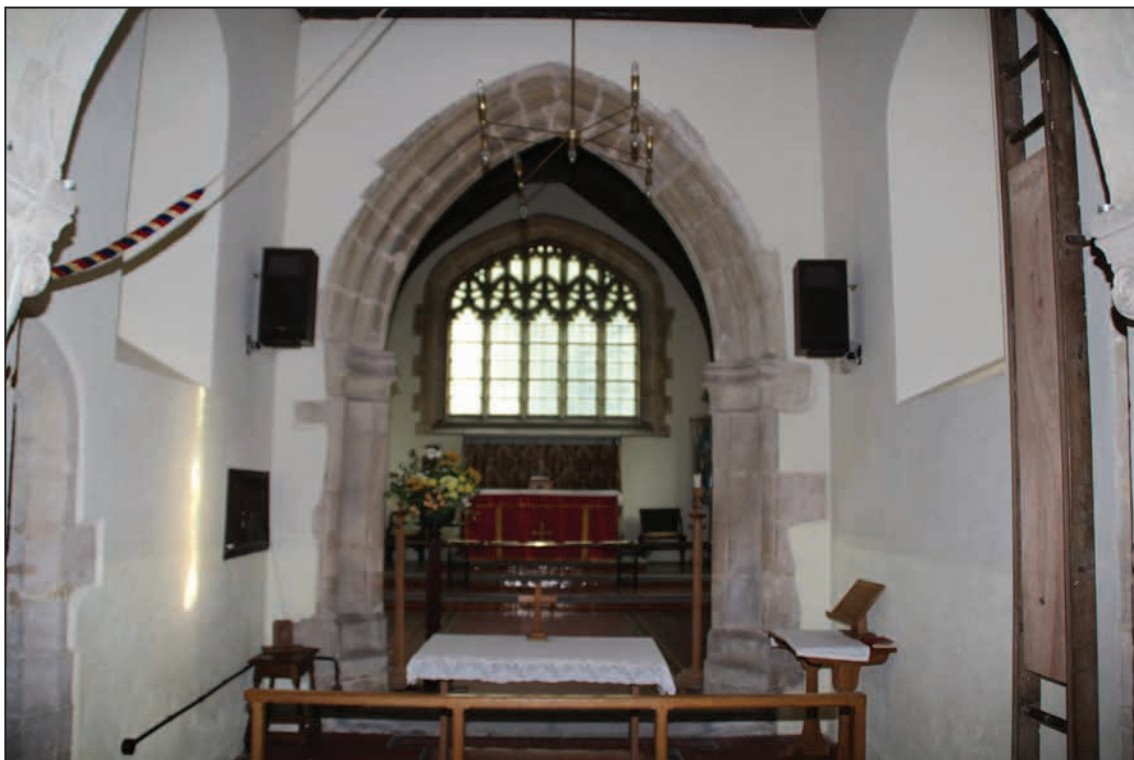
29 The chancel arch, looking east

- 5.28 Assuming that the tower always had a cell of the building to its east, then the present chancel arch must be replacement for an earlier one. Its jambs are very boldly and deeply moulded, with a profile that is certainly of late 14th or 15th-century date (Fig. 23). The execution is rather crude and it is just about possible that these jambs have been recut from older ones, of Norman date. They are comparable in height to those in the western tower arch.
