# Energy Audit and Survey Report St Eustachius Church PCC of St Eustachius, Tavistock

Author	Reviewer	Date	Version	
David Legge	Matt Fulford	30th January 2020	1.0

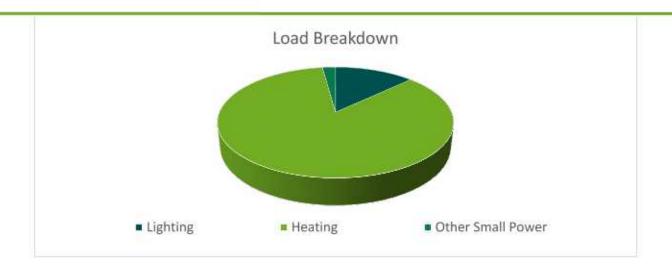
Service	Description	Estimated Proportion of Usage
Lighting	Predominantly SON uplighters, halogen spotlights and T8 fluorescent tube fittings.	13%
Heating	Provided by gas boiler with weather compensated control via perimeter radiators and underfloor pipes with grilles.	85%
Other Small Power Organ power, sound system and other small plug loads.		2%

As can be seen from this data, the heating makes up by far the largest proportion of the energy usage on site. The other significant load is lighting.
