**WATCHING BRIEF ON DRAINAGE TRENCHING AT ST PETER'S
CHURCH, PEBWORTH**

September 2020

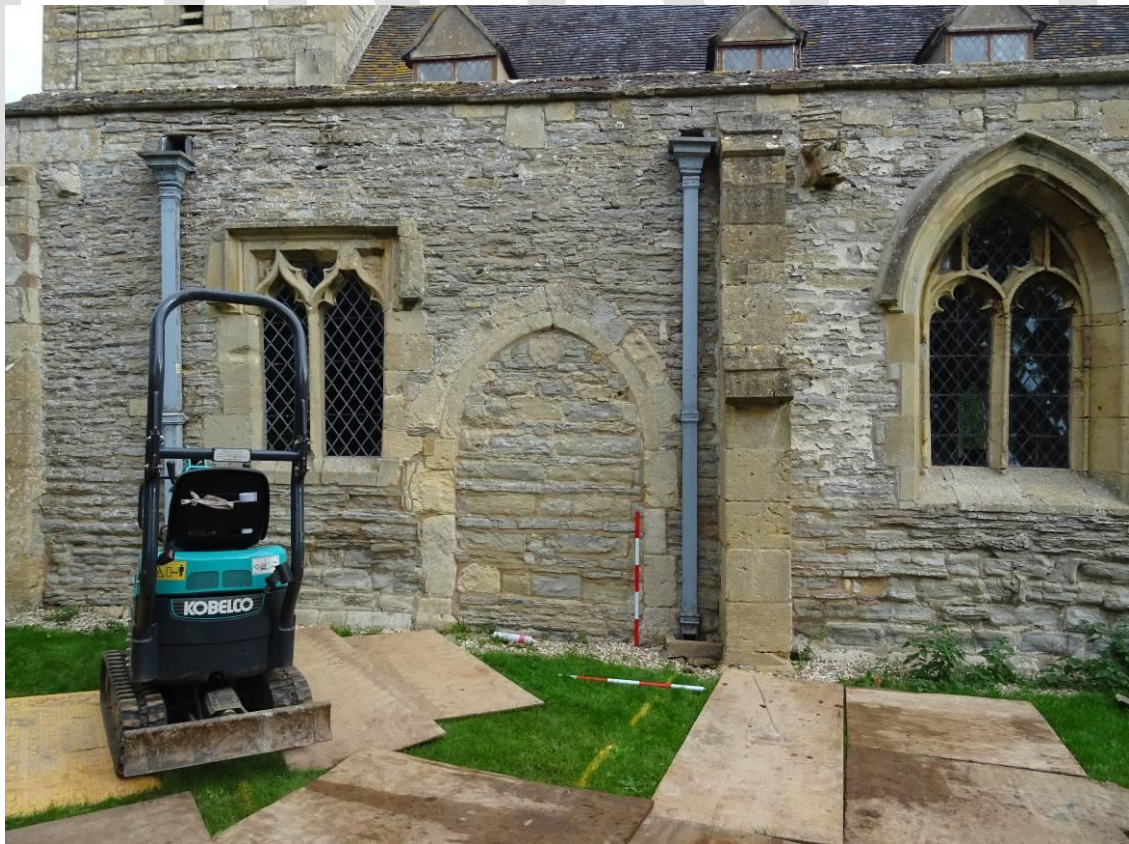
Plate 2. General view of the south aisle, looking north

The linear trenching and the connecting spur were positioned over two existing [cast iron] downpipes (**Plates 2 & 3**). Between the trench sections was a blocked-in door which was probably contemporary with the construction of the South Aisle (c. 15th century). The trench excavation revealed no evidence of an external threshold or any features associated with this door. Initial trenching did expose a 20th century failed ceramic drainage cowl and connecting ceramic piping; both were silted-up (**Plate 4**). The same failure was also encountered with the trench terminus of the NW spur (**Plate 5**). It was noticed that the trenching followed an existing drainage run which extended to a depth of c. 0.55m below the existing ground level. It is therefore assumed that this area of the churchyard, between the South Aisle southern elevation of the churchyard pathway had been previously disturbed by a 20th century drainage system; however both trench section north of the pathway abruptly stopped, allowing the rainwater to disperse into the surrounding soils north of the pathway (**Plate 6**). However, recovered from the NW spur was a large dressed limestone block (see **Plate 13**). The roughly cubed stone block contained a series of chamfered grooved lines that indicate a possible external masonry block.

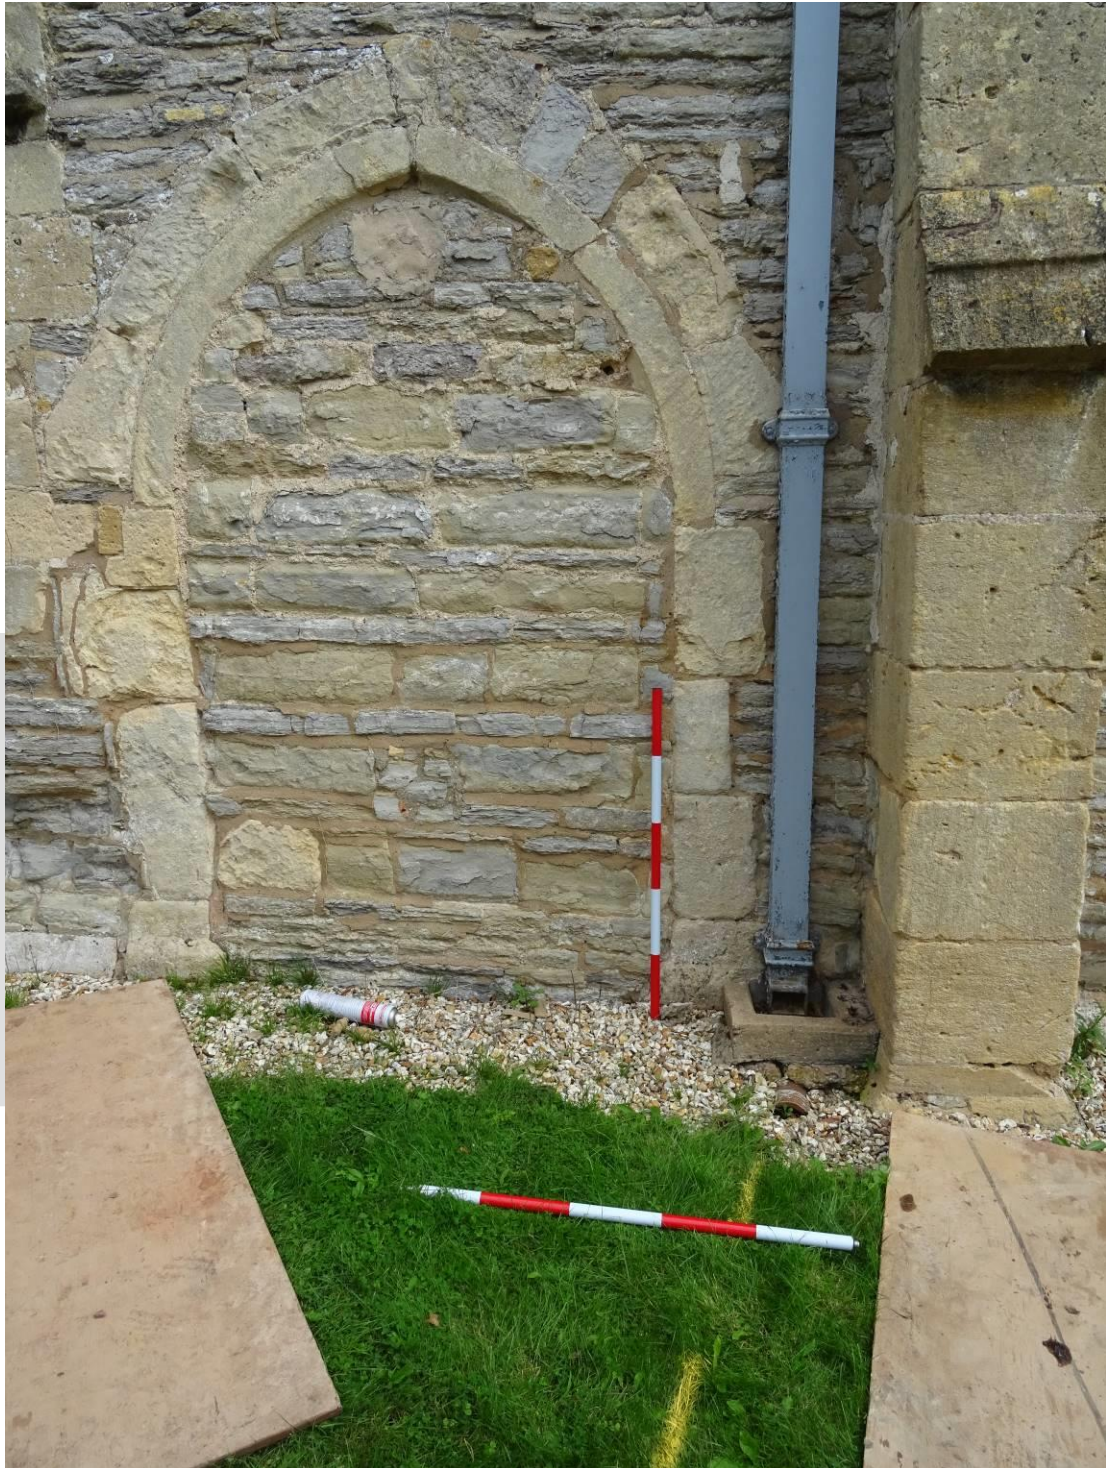
Plate 3. Historic door and the trajectory of the linear trench marked in yellow paint, looking north

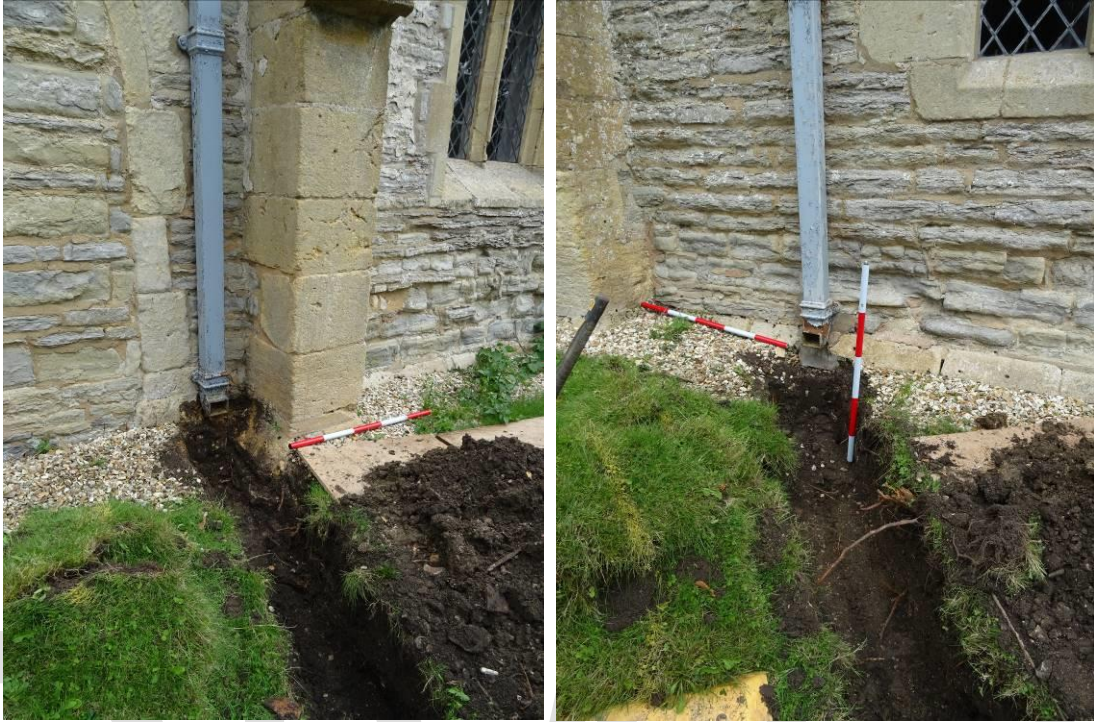
Plate 4. The northern linear trench terminus, looking north
Plate 5. The NW spur terminus, looking NNW

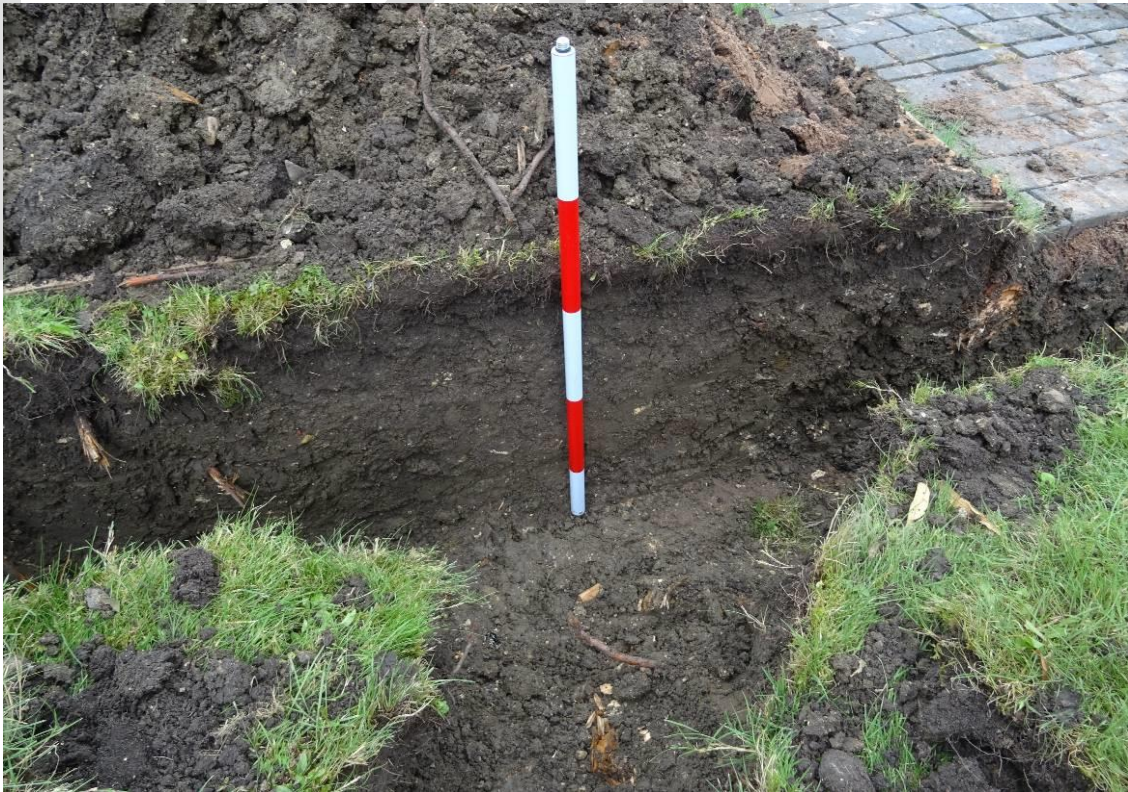
Plate 6. Eastern section of the eastern spur, looking east

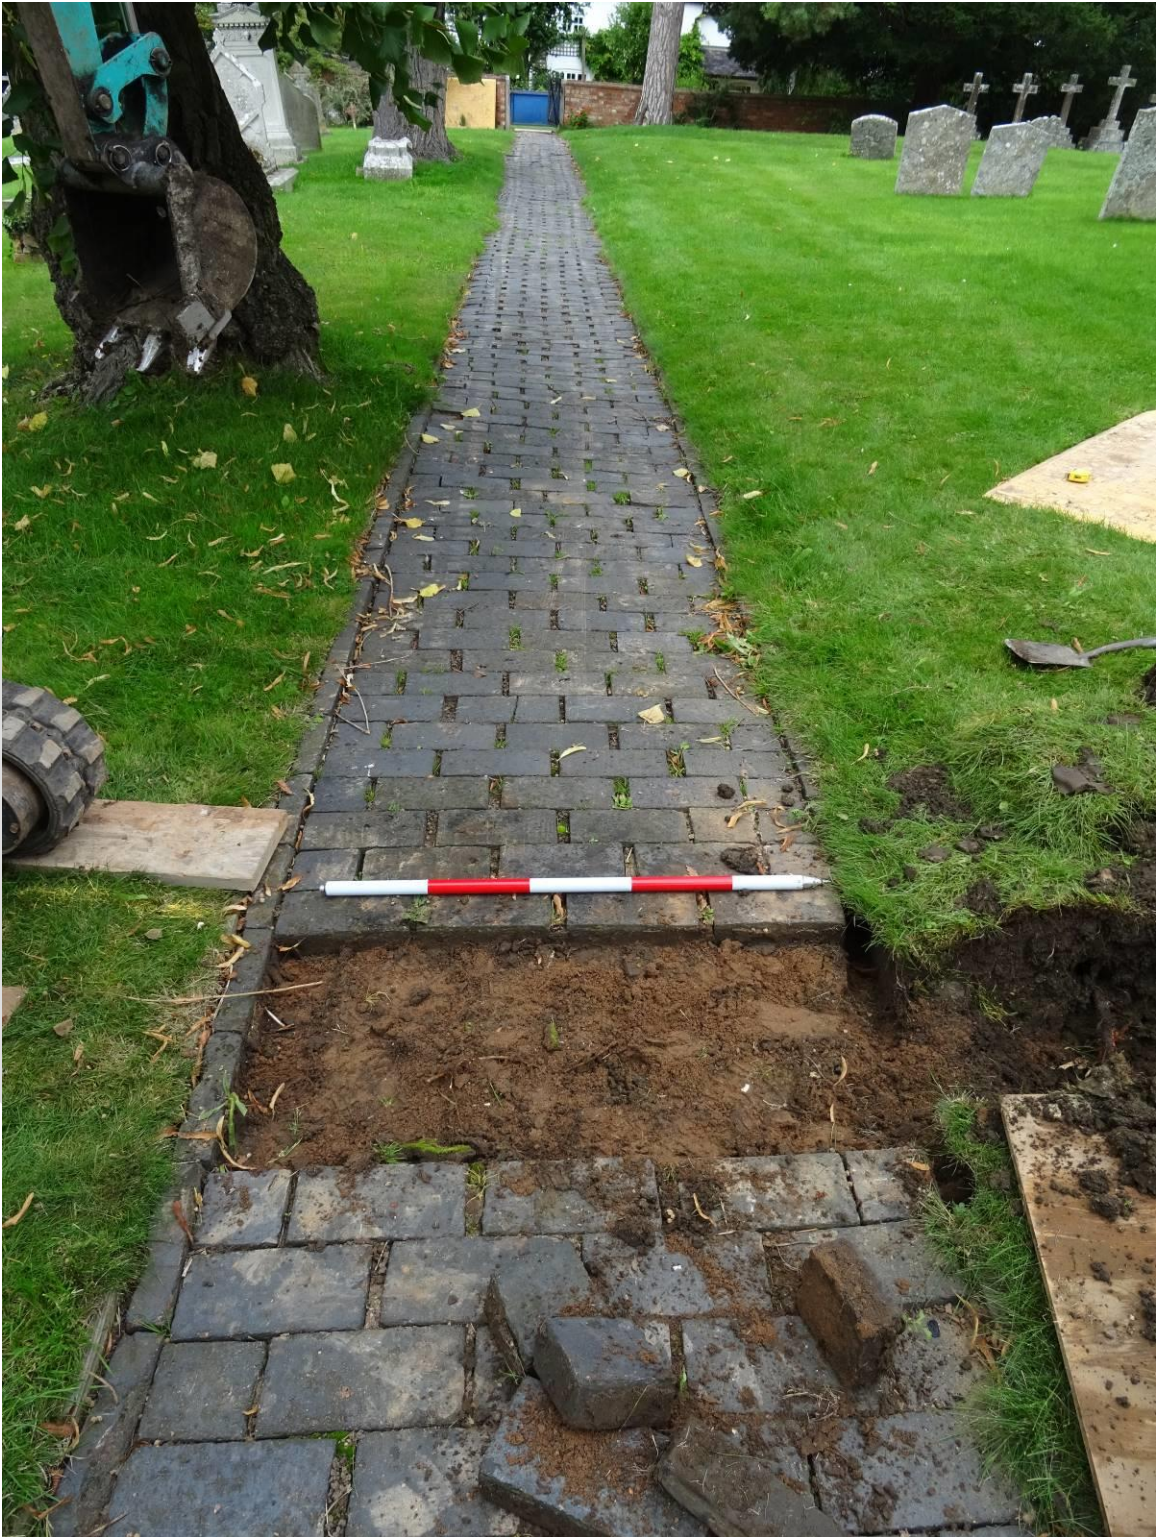
Plate 7. Initial removal of the pathway brickwork, looking east

A small trench section was excavated across the E-W churchyard pathway (**Plates 7 & 8**). The stratigraphy was identical to that found in trenching to the north of the pathway,

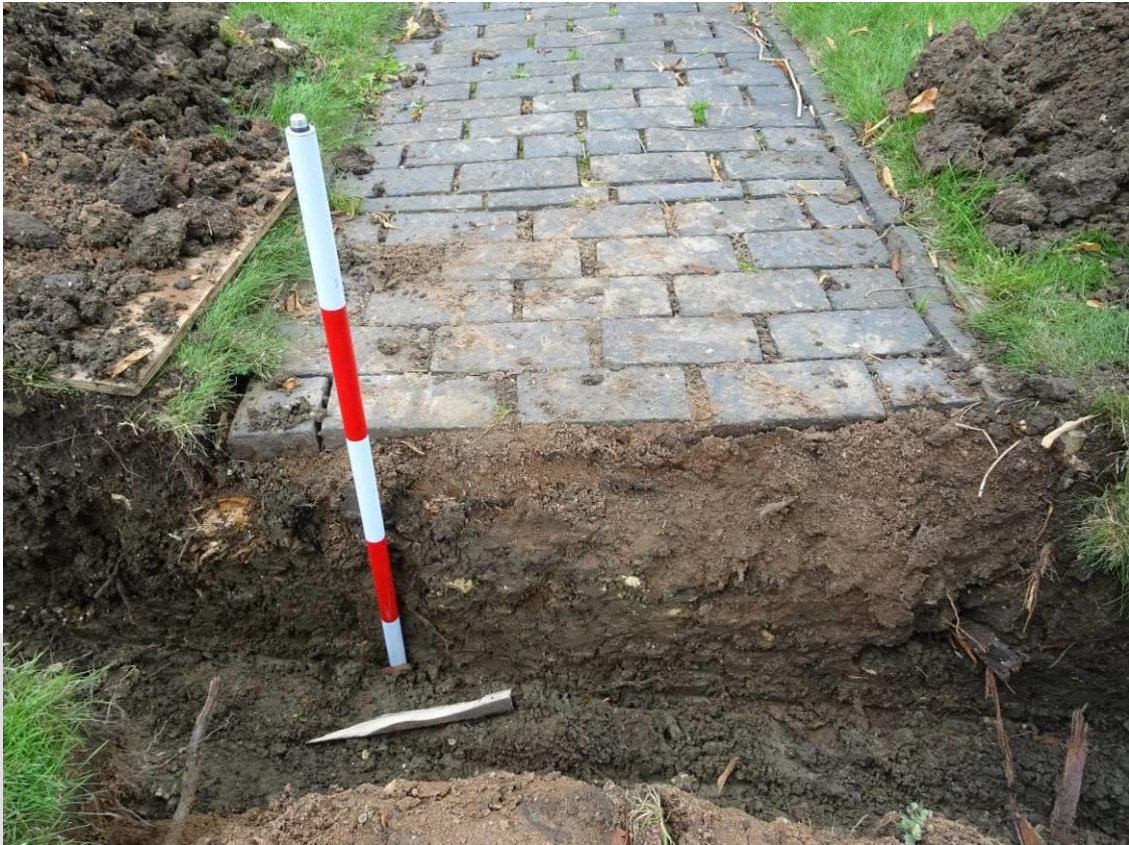
Plate 8. Trench section below a pathway, revealing eastern section

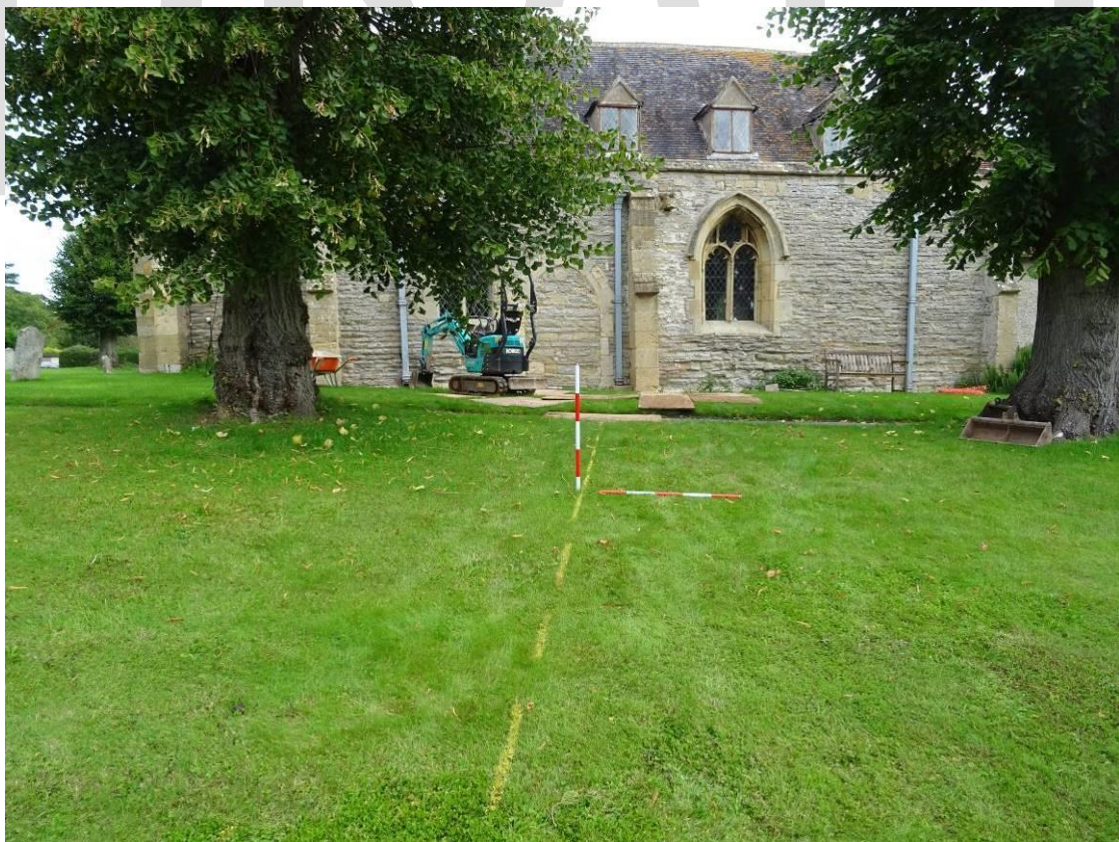
Plate 9. Trajectory of the linear trench, looking north

The trajectory of the trenching from the E-W pathway to the soakaway was maintained, despite potential root system from a nearby avenue of pollarded lime trees (**Plate 9**). It was within the section between the pathway and the soakaway that a large dumping deposits was uncovered (**Plate 10**).

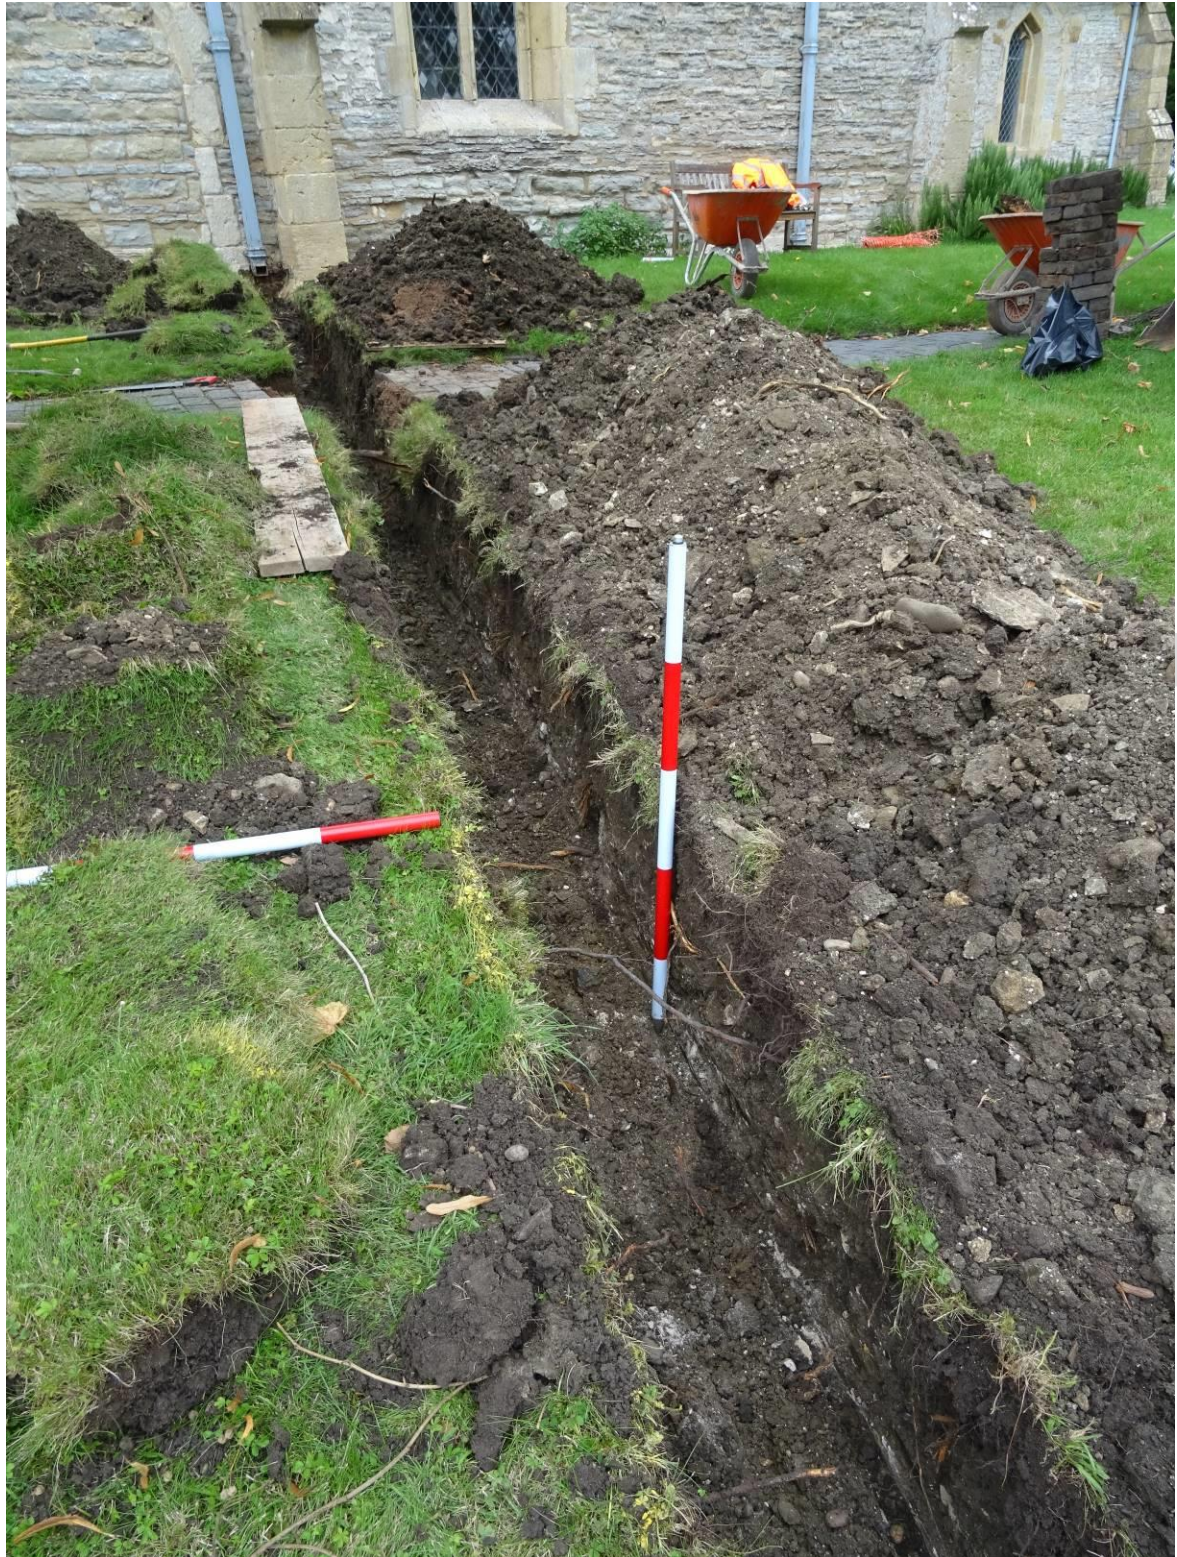
Plate 10. Northern section of the trenching regime, looking north

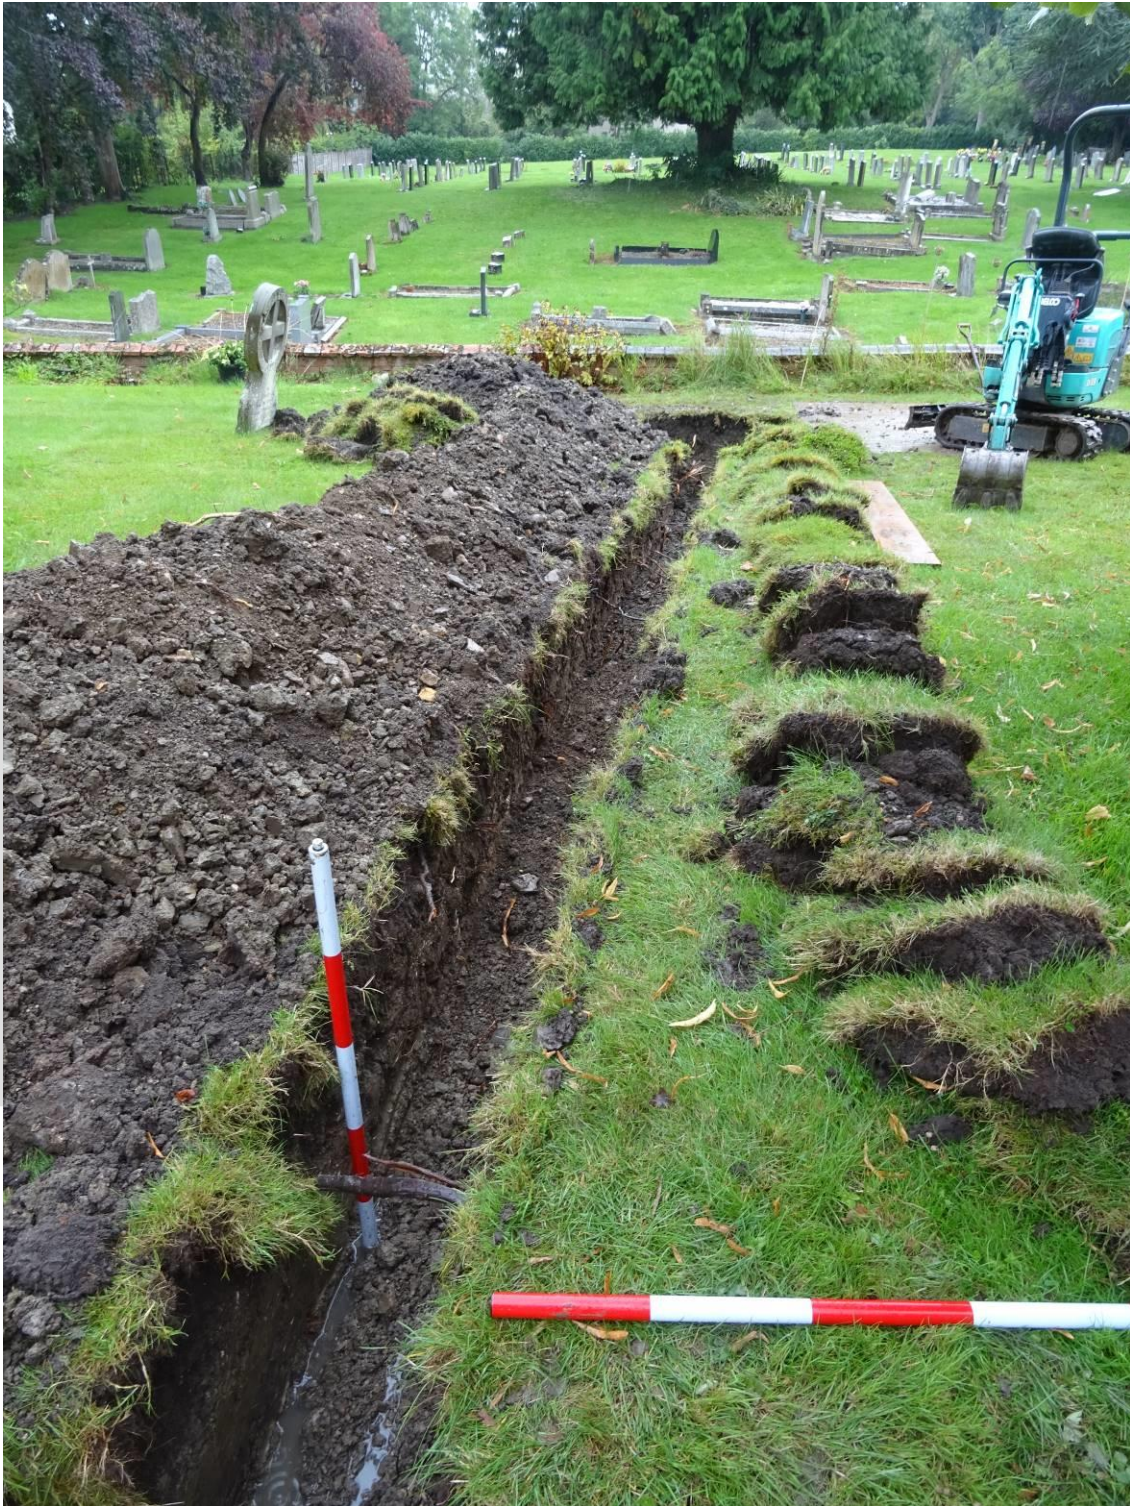
Plate 11. View of the linear trench, looking south towards the soakaway

Surprisingly, the excavation within the linear trench section south of the E-W pathway encountered limited root action and therefore, the stratigraphy within the east and western section of the trench were well-defined (**Plates 11 & 12**).

The soakaway marks the southernmost extent of the trenching regime and was located c. 1m north of an E-W revetment wall. The wall marks the original boundary of the medieval churchyard. Immediately south is a recent churchyard extension (see **Plate 11**). The soakaway measured 1.5 x 1.5 m and extended to a depth of c. 1m. Two deposits were recorded within this feature. The uppermost deposit extended to a depth of 0.70m below the existing ground level and comprised of a local [Blue Lias] limestone derivative soil. Immediately below this was a natural deposit, considered to represent a B/C-horizon soil. Only one cultural artefact was recovered from the uppermost deposit – a small red brick fragment which, based on the impurities within its fabric was 18th century or earlier in date.

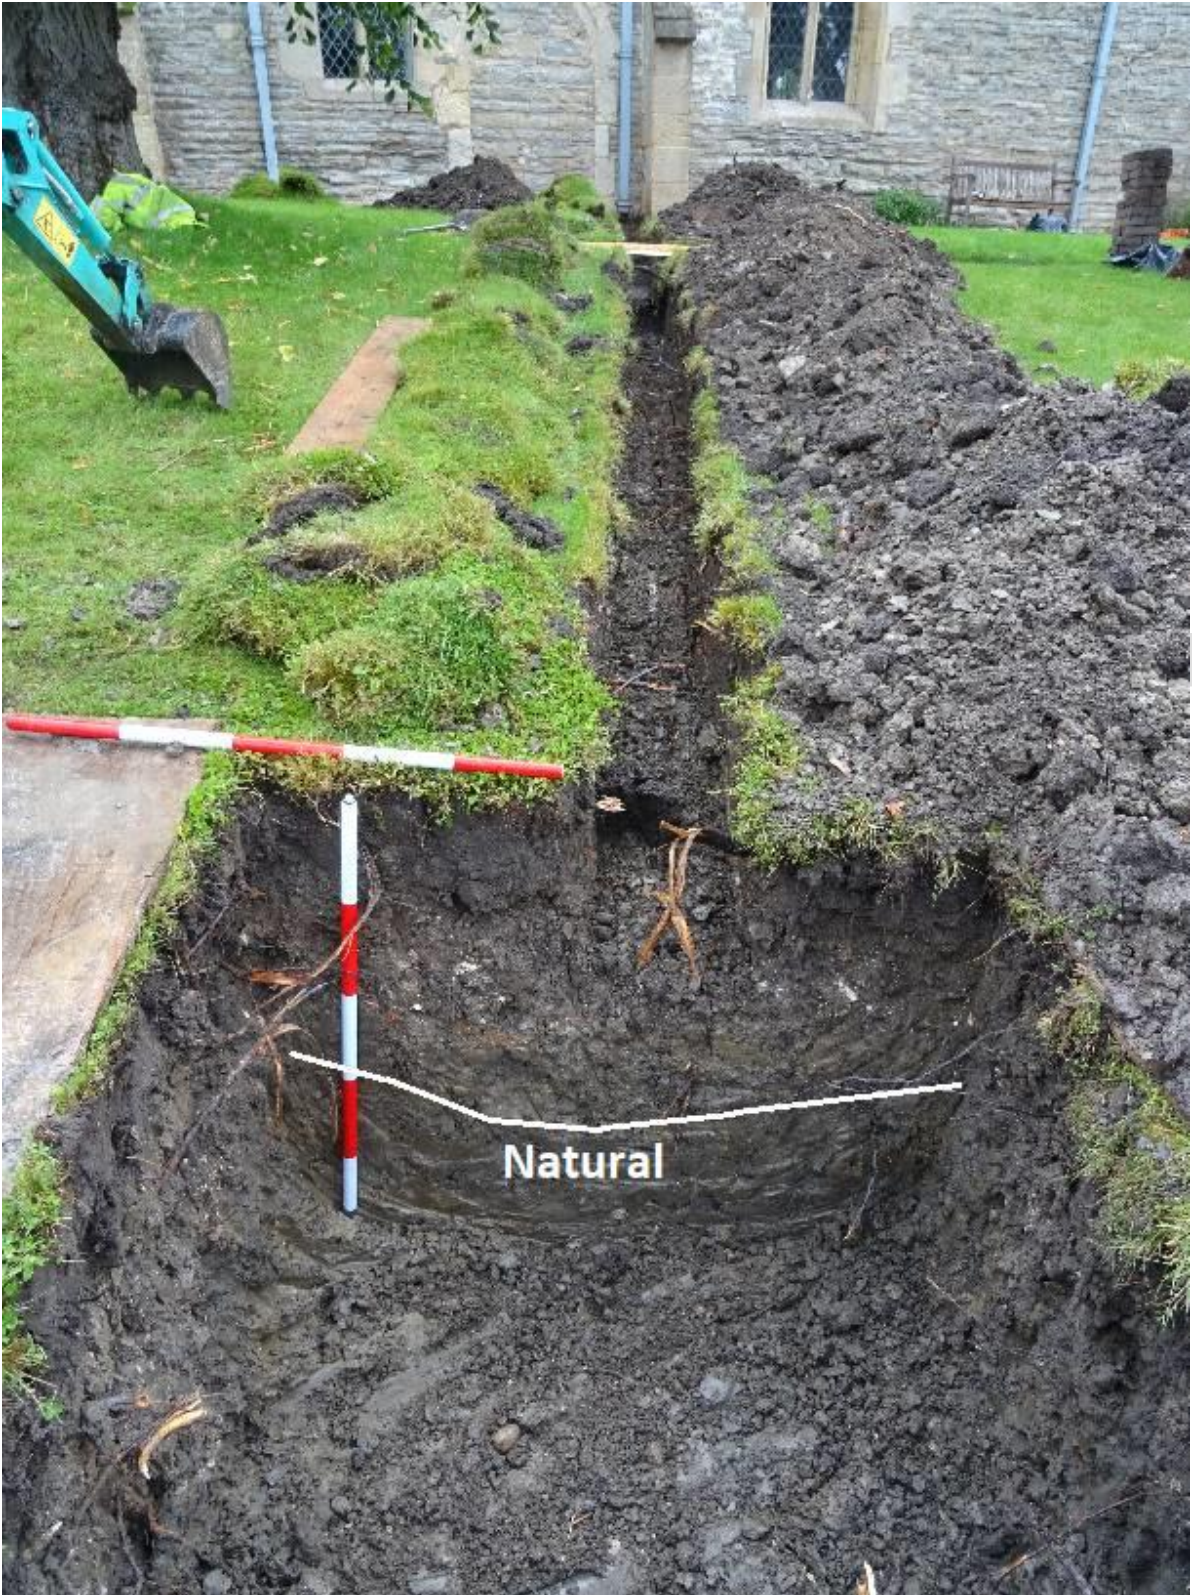
Plate 12. Full excavation of the soakaway, looking north

The soakaway, measuring 1.5 x 1.5m and extending to a depth of c. 1m below the existing ground level revealed two deposits, the upper most deposit contained several fragments of brick (of unknown date) and no human bone (**Plate 12**). Immediately below this deposit was a B/C soil horizon which was considered natural. This deposit extended from 0.7m to 1.1m below the existing ground level. No artefactual evidence derived from this deposit.

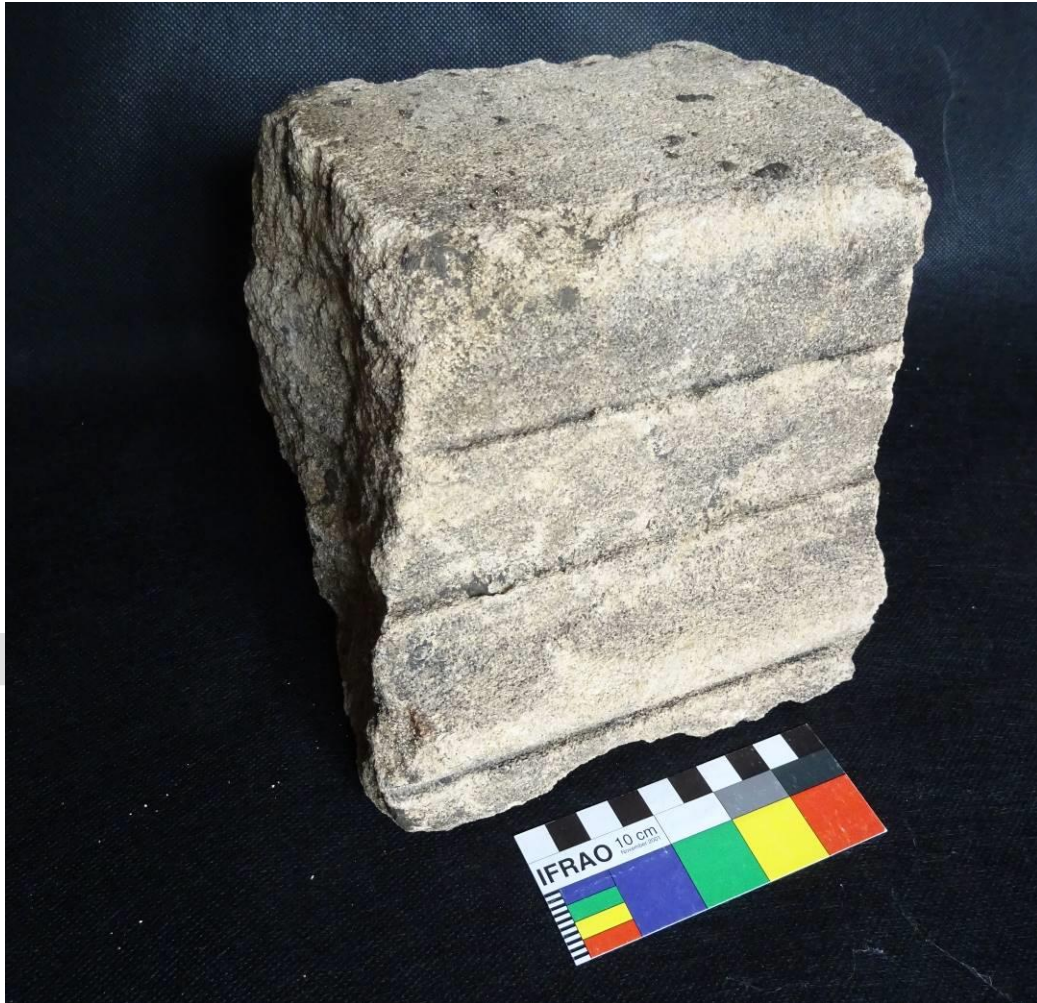
Plate 13. Large dressed masonry stone found, within the northern section of the eastern spur trench

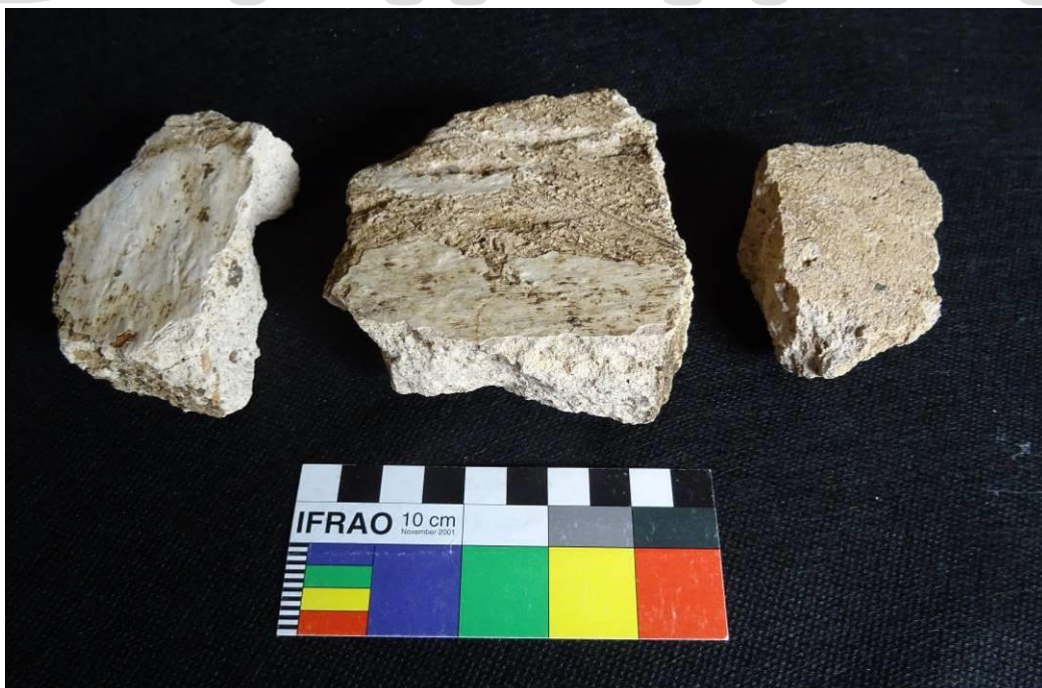
Plate 14. Probable medieval plaster found within the central section of the linear trench

Within this deposit were recovered a small assemblage of artefacts including 19th century ceramics, 19th century glass, undated metal objects and plaster (see **Plates 14 to 18**). The dumping deposit is probably the result of a late 19th century or early 20th century restoration event. The presence of probable internal medieval or post-medieval wall plaster suggests that the restoration event was from within the church. The ceramics and window glass recovered suggests that the date of this restoration event is within the past 150 years.

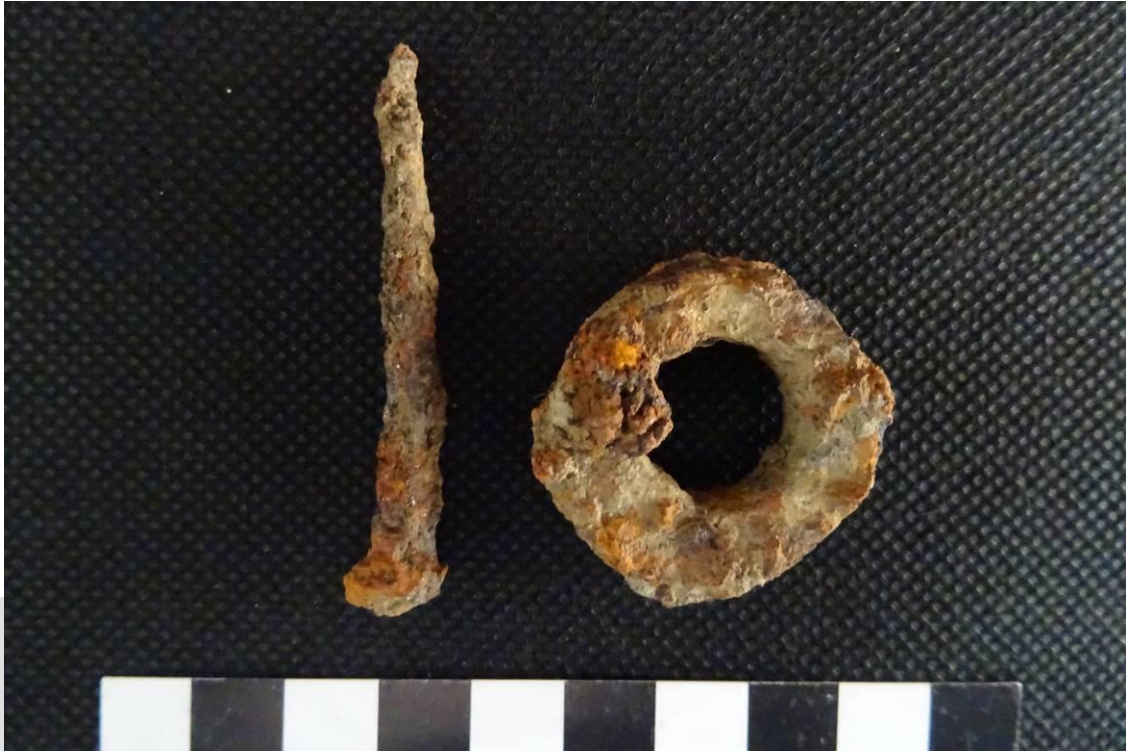
Plate 15. Several metalwork artefacts found within the upper section of the soakaway

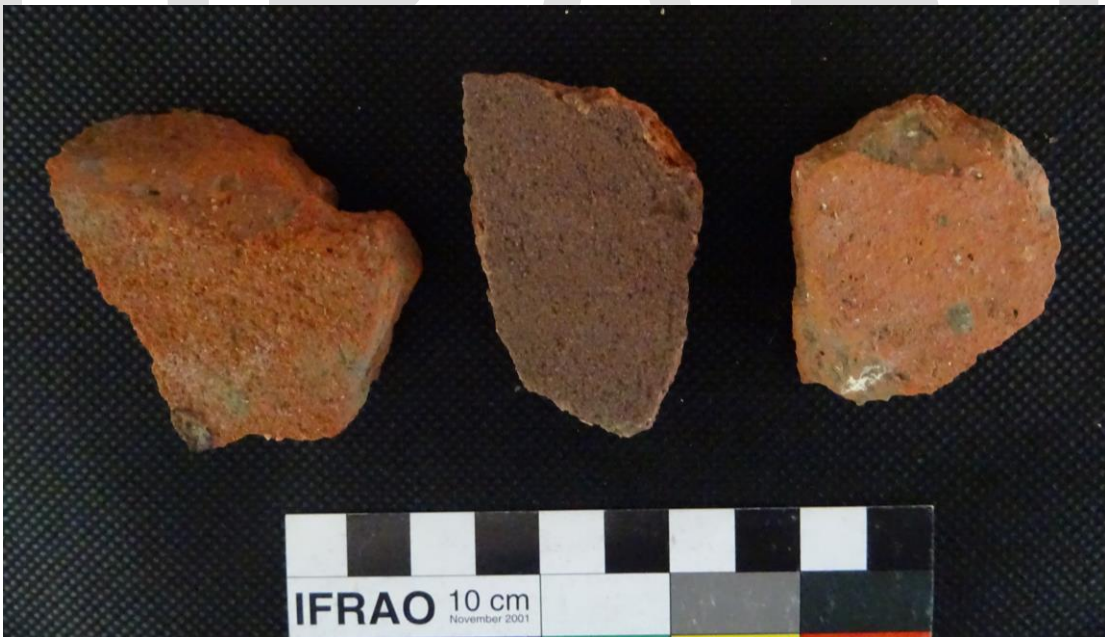
Plate 16. Small assemblage of ceramic sherds found within the central section of the linear trench
