St Peter's Church, Rylstone, North Yorkshire

Archaeological Watching Brief Report

Report Title: St Peter's Church, Rylstone. Archaeological Watching Brief Report.

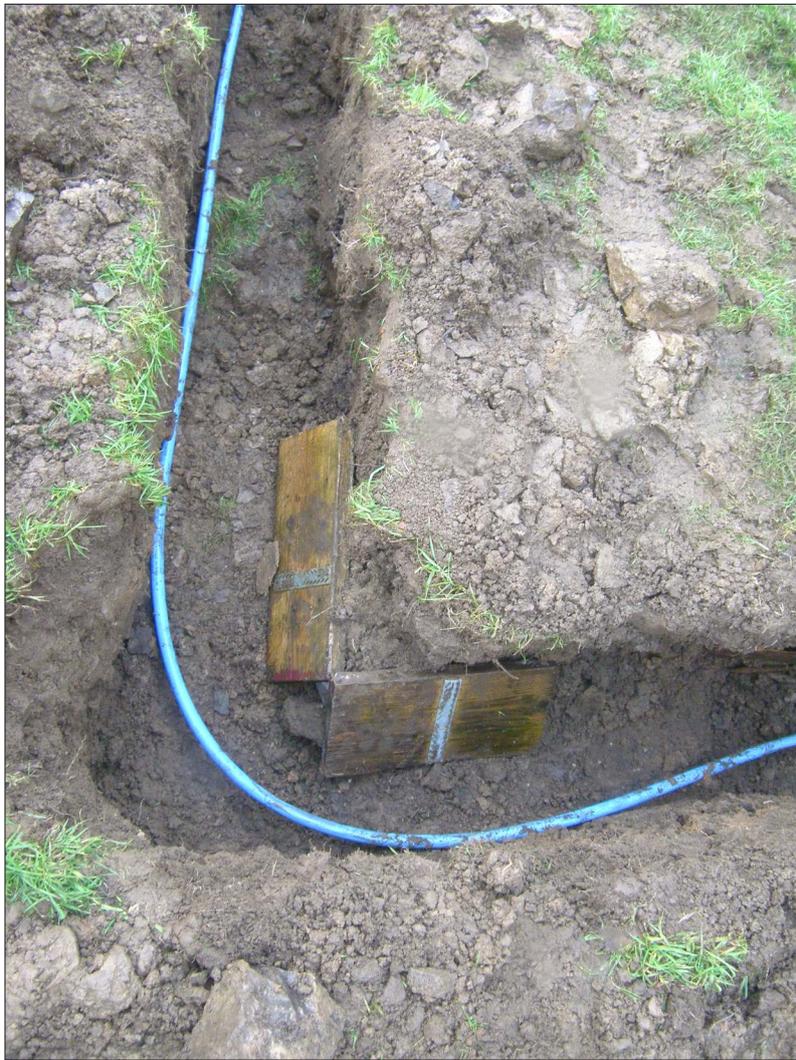
St Peter's Church, Rylstone: remediation measures for reinterment of SK01 Plate 1

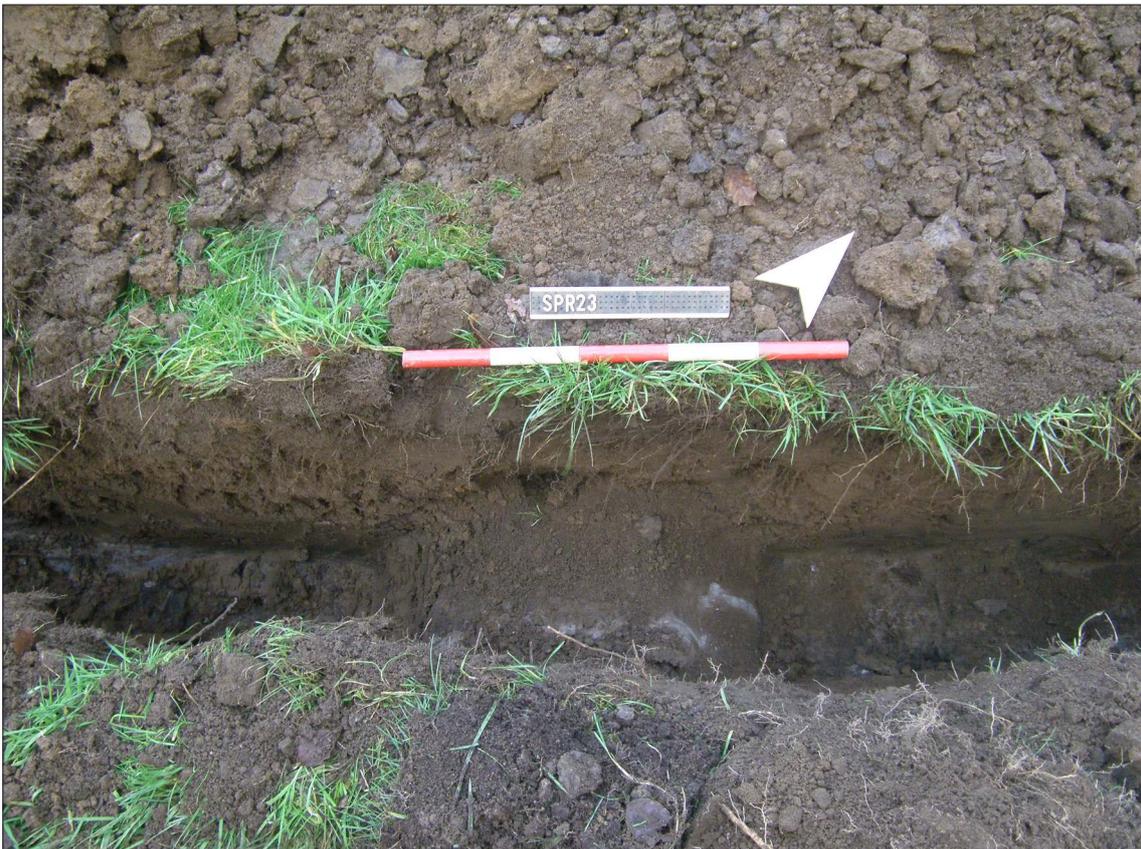
Plate 2

St Peter's Church, Rylstone: topsoil, subsoil and natural clay and bedrock

- 4.2.2 No archaeological remains were encountered within the majority of the north-east to south-west stretch of the pipeline route. The limestone bedrock (**05**) was encountered at a depth of between 0.4m and 0.7m and was covered by a thin deposit of natural orange-brown clay (**04**), up to 0.12m thick. Above the natural clay a subsoil deposit (**03**) of mid reddish-brown silty clay, of up to 0.3m thick, had accumulated, this was overlain by 0.25m of topsoil (**02**) along the length of the pipe trench (Plate 2).

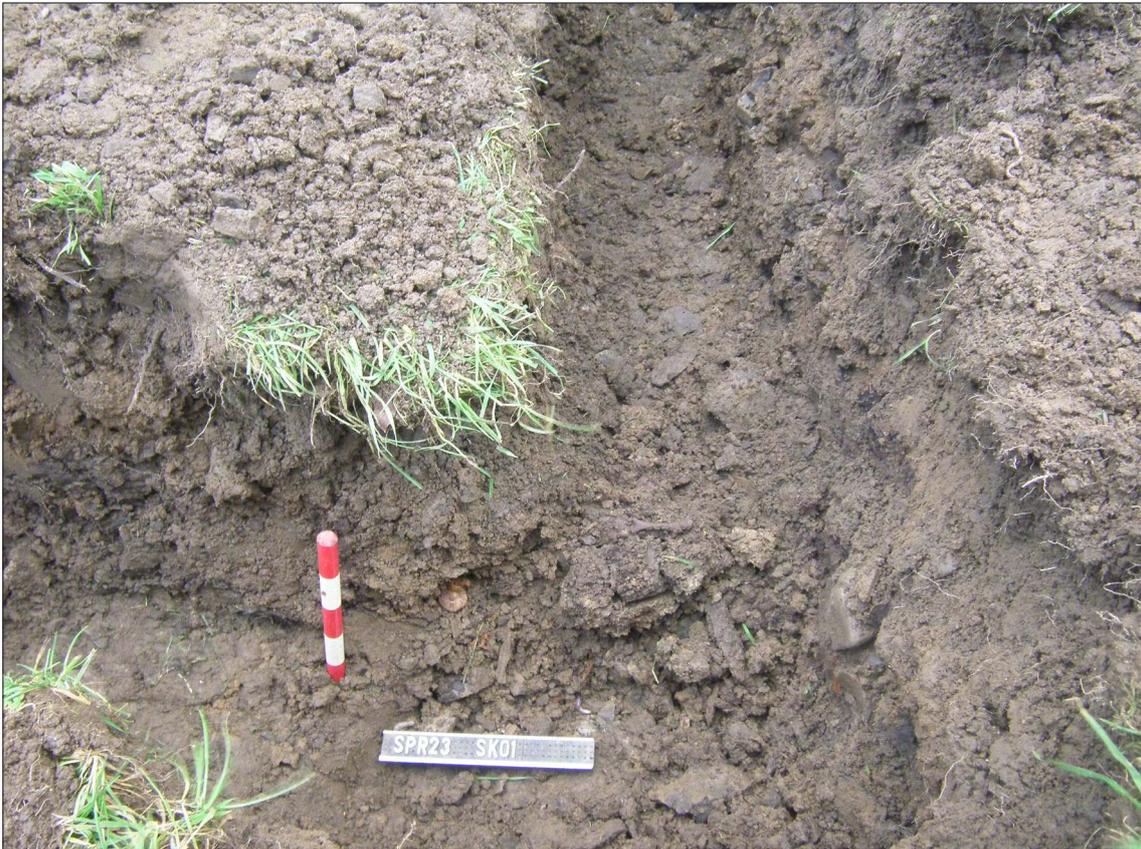
Plate 4

St Peter's Church, Rylstone: the disturbed remains of SK01, looking south

- 4.2.5 Both graves lay directly beneath the topsoil (**02**) and were cut through the subsoil (**03**) and natural deposits (**04, 05**) beneath.
- 4.2.6 The first grave to be encountered was that of an infant (**SK01**), which was located directly at the south-western corner of the pipe trench, approximately 3.5m north-west of the church (Plate 4). The grave cut (**06**) measured 0.35m in width, 0.6m in length by 0.23m deep and was orientated north-east to south-west, parallel with the church building. A band of dark reddish-brown staining around the edges of the grave cut indicated that **SK01** had been buried in a container made from

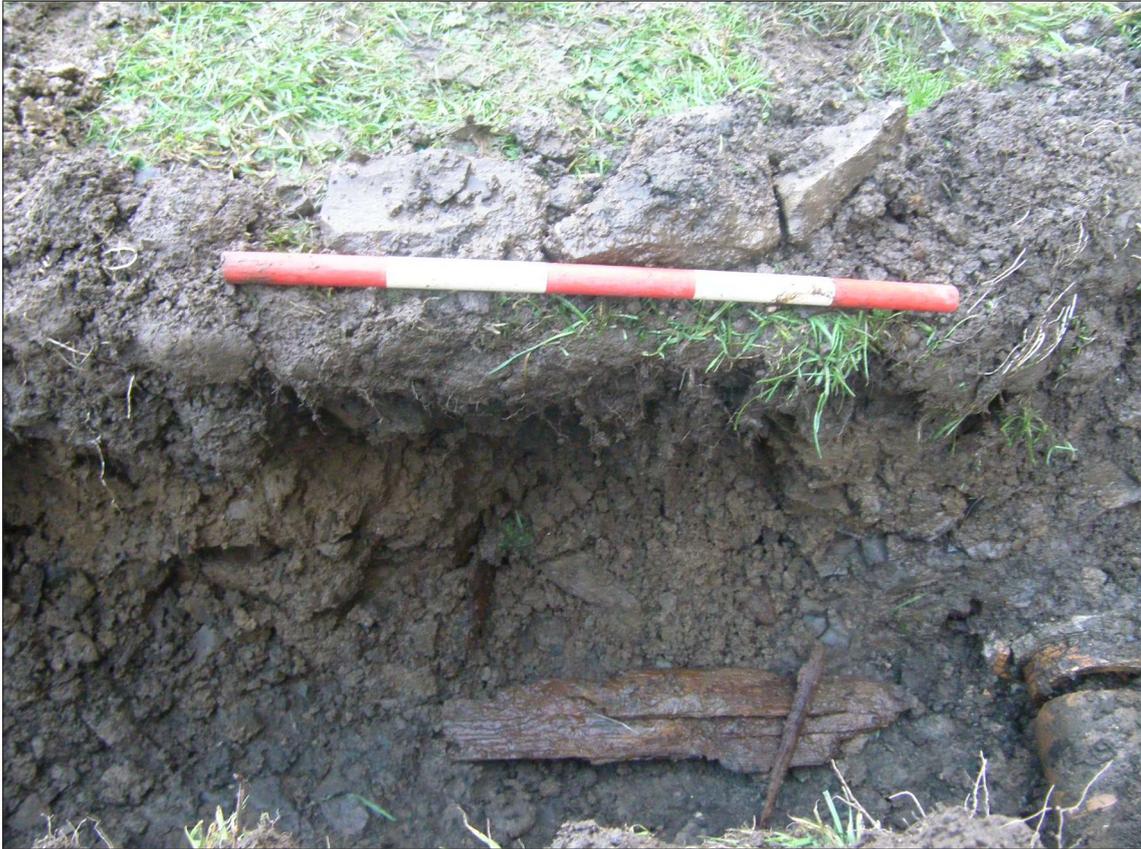
Plate 5

St Peter's Church, Rylstone: western end of Grave 08,
with displaced coffin board

4.2.7 The second grave (**08**) was located approximately 0.4m to the south-east of grave **06**. Only the western end of the grave was disturbed by the excavation and no human remains were exposed (Plate 5). A fragment of wooden plank with an iron nail, probably representing the western end of a coffin, was displaced during the excavation. Grave **08** was over 1m in width at its upper edge and 0.5m in width at the base, with moderately sloping edges. It was 0.5m deep, the base excavated c.0.1m into the natural limestone bedrock (**05**), fragments of which were frequent within the loose mid orange-brown silty clay (**09**) backfill of the grave.

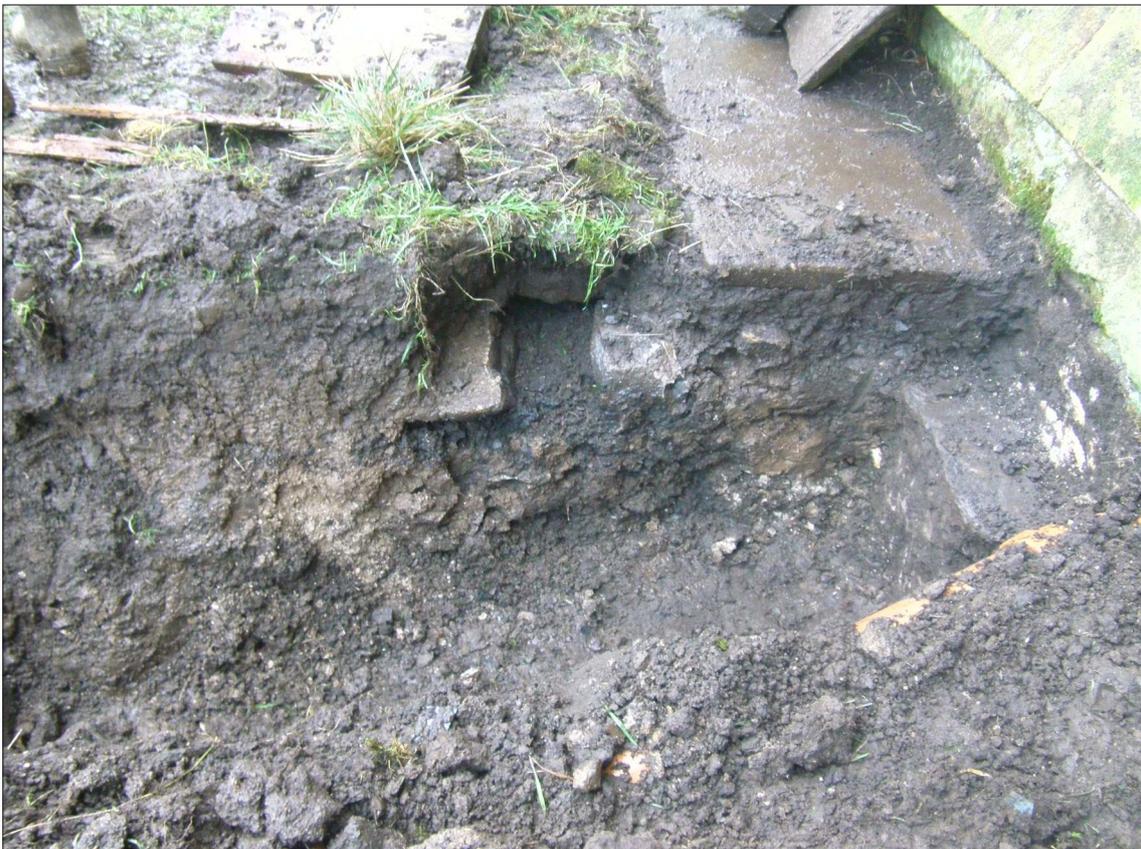
Plate 6

St Peter's Church, Rylstone: construction features relating to
the church building. Foundation course, construction cut,
backfill and sandstone culvert.

4.2.9 The final group of recorded features related to the construction of the current church building (Plate 6). The new pipe trench was excavated up to the northern wall of the church and revealed its foundation course, through which a hole would be drilled to admit the new water pipe. The foundation course (**17**) was made of finely-tooled sandstone blocks and stepped outwards from the main building by 0.15m. The foundation exposed within the new pipe trench was 0.5m in height and had been constructed on the natural limestone bedrock. It sat within a 1.3m wide cut (**12**), 0.5m deep, which had a sharply sloping northern edge, and had been backfilled by a deposit of compacted sandstone rubble, clay and lime mortar (**13**). A 0.5m wide culvert constructed of sandstone slabs (**15**), had been installed within a steep-sided cut (**14**) excavated centrally within the backfill of construction cut **12**. The culvert consisted of two courses of roughly-squared sandstone blocks, 0.15m apart, capped with a sandstone slab, the culvert cut was backfilled with a dark bluish-black deposit of fine silty-sand (**16**).

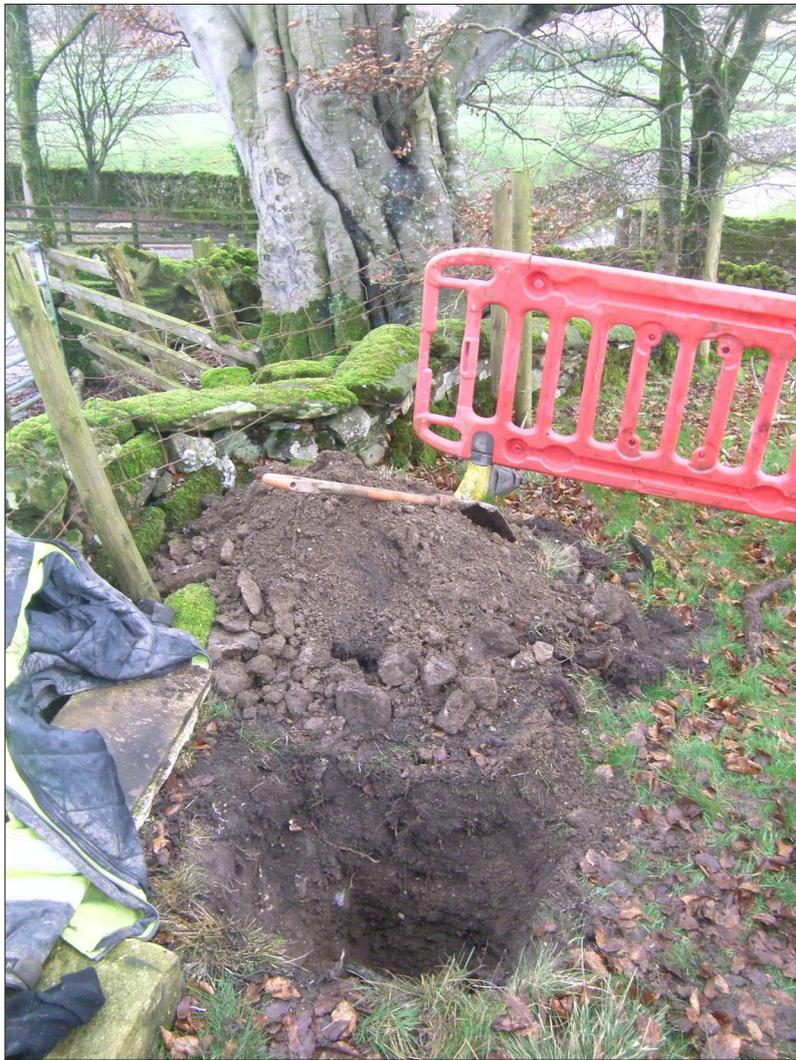
Plate 7

St Peter's Church, Rylstone: Pit 1, looking south-east, showing backfill within the service trench

4.3.1 Pit 1 measured 0.7m by 0.7m and was located in the eastern corner of the churchyard. The pit was sited to locate and expose the original water supply to the church, a galvanised metal pipe at a depth of 0.7m. The pit was dug through 0.3m of topsoil into the backfill of the original service trench, the pit was recorded by photograph (Plate 7).

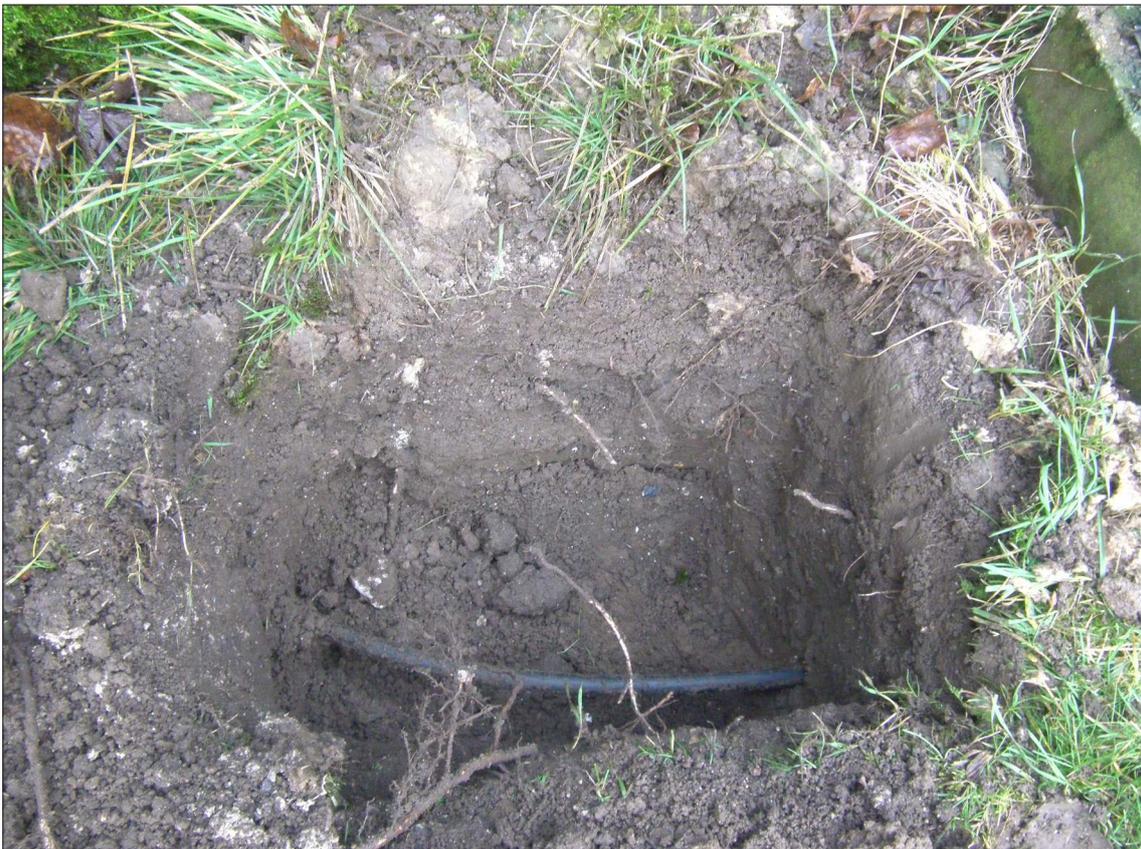
St Peter's Church, Rylstone: Pit 2, looking north-west, showing existing water pipe and backfill within the service trench

3.4.8 Two hand-dug pits were excavated by the contractor over the location of existing water pipes (Fig. 2). They were monitored by the archaeologist, but as they were located within previous service trenches, no archaeological deposits were encountered.
