# St Mary's Church, Hopesay, Shropshire

## Archaeological Watching Brief

### **Acer Archaeology & Heritage**

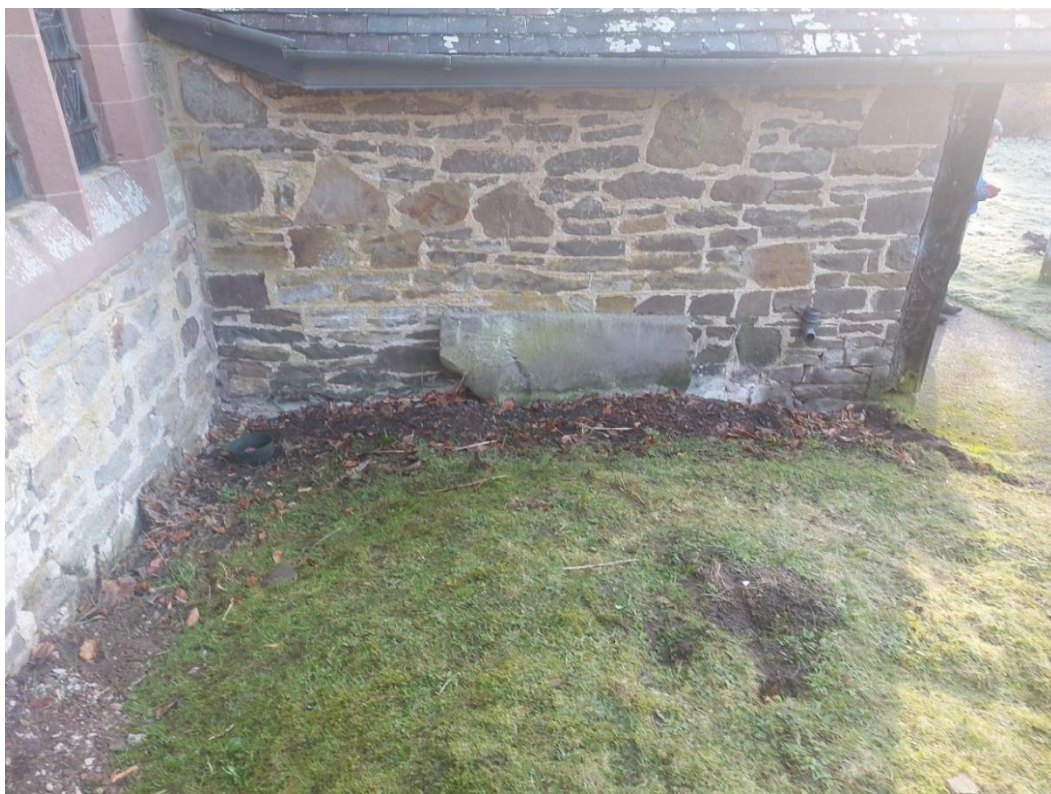
*Plate 1 Photograph looking east showing the western elevation of the porch and, to the left, the southern elevation of the church prior to excavation.*

A service trench was excavated by hand and had a width of 0.5m and was 4m in length east west and 4m in length north south located along the western elevation of the porch and then continuing west along the southern elevation of the church (Plates 1 and 2). It was excavated to a maximum depth of 0.85m in the west and 0.55m in the south. The soil comprised an upper topsoil layer, (100), a dark-brown humic soil with a significant component of twig-type debris (particularly in the corner where the two lengths of trench met) between 0.3 and 0.2 m thick. Context (100) overlays a churchyard soil deposit, (101), of a mid-greyish brown silty loam with frequent small and medium sized subangular and subrounded stones. The majority of artefacts collected derived from the topsoil deposit (100) in the junction where the two lengths of trench met. Apart from one piece of possible medieval tile (see Appendix Plate 15), the finds from this area were all post-medieval or modern.

Along the western elevation of the porch was a large piece of stone (see Plate 1). This was removed to facilitate digging the service trench here. On the reverse side there was a headstone inscription (Plate 5). It is intended that the headstone is placed back in this position once works are complete to further protect the inscription from weathering.

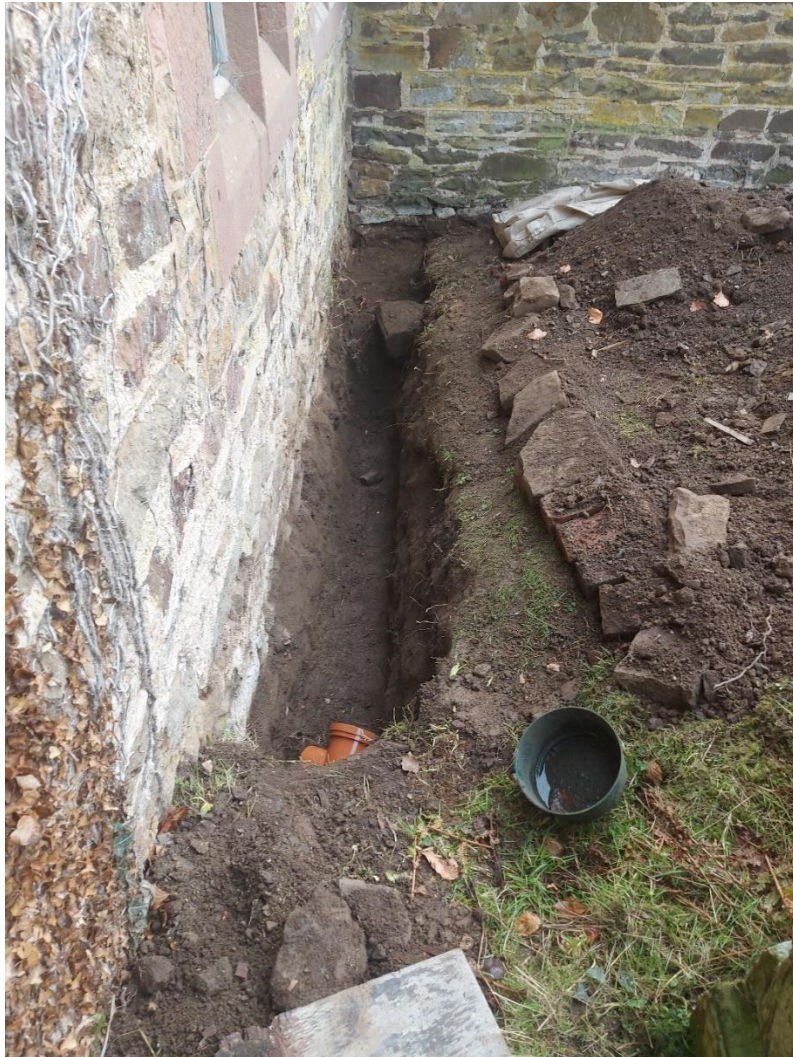
*Plate 2 Photograph showing the east-west orientated trench along the south wall of the church. Looking east.*

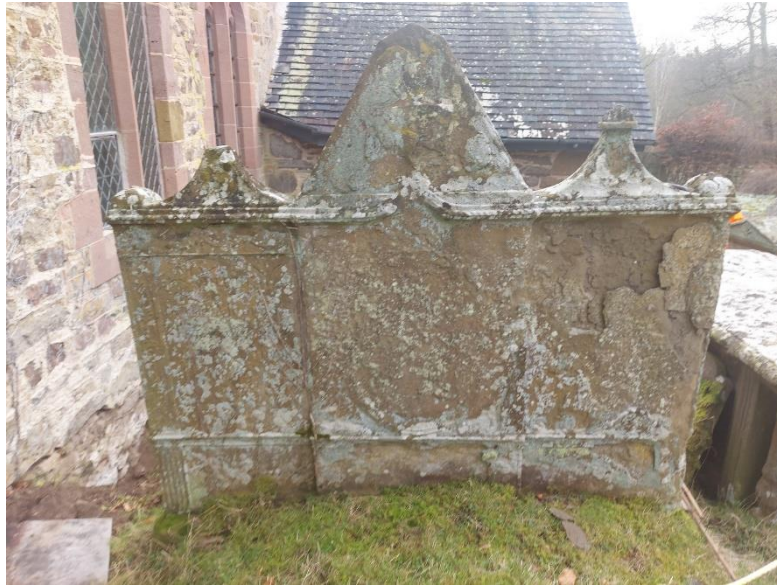
*Plate 3 Photograph showing the headstone immediately to the south of the east-west orientated trench along the southern church wall. Looking east.*

Disturbed human remains were encountered in the east west orientated trench near its western extent. The bones were positioned in broad anatomical position and the parts of the skeleton revealed were the pelvis area and the lower limbs. However, previous disturbance of these remains was evident, possibly from burrowing animals. Immediately adjacent to this east west oriented trench was a large headstone and it is likely that this disturbed burial was an interment associated with it (Plates 3 and 4). The date on the inscription nearest the disturbed burial is from the 1790s.

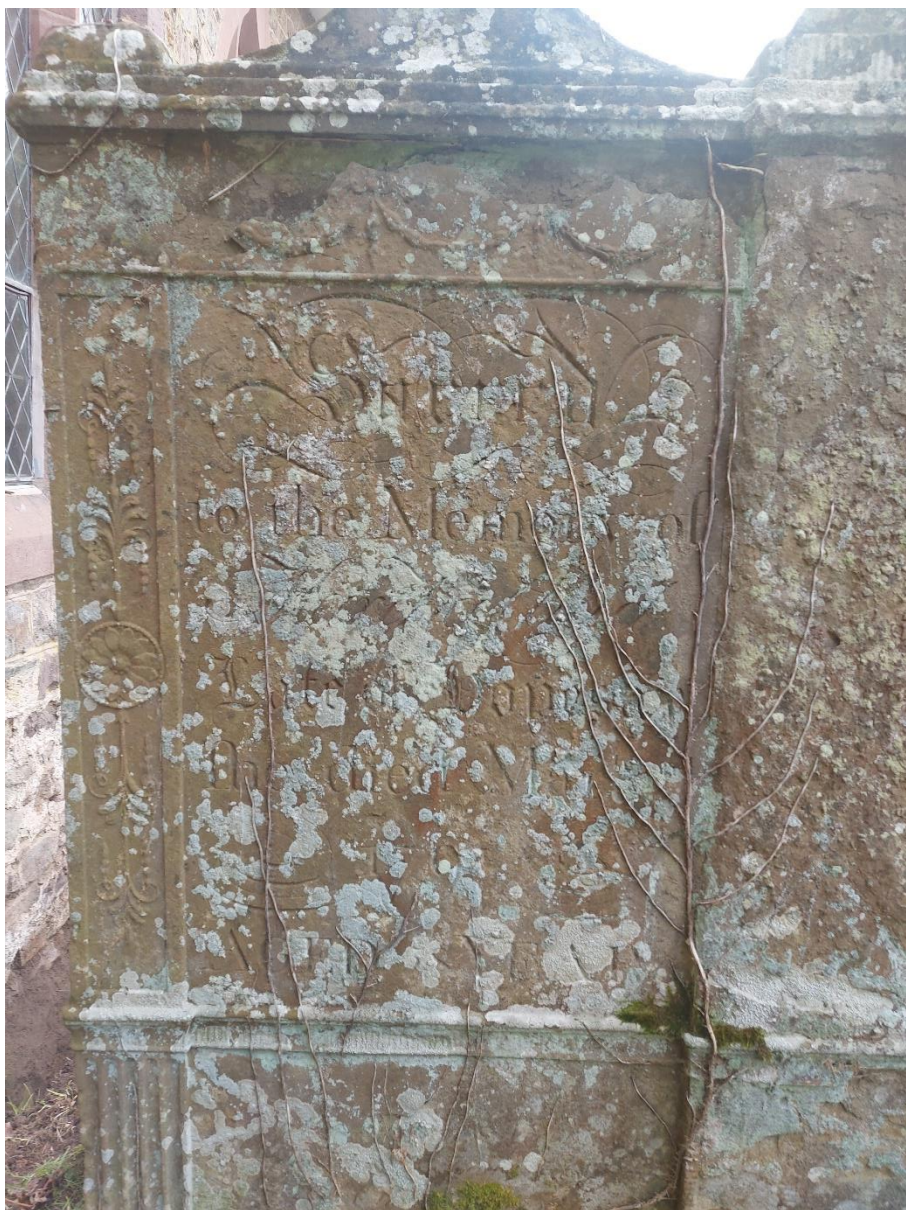
*Plate 4 Photograph showing the headstone inscription which may relate to the disturbed burial found immediately adjacent to it. Looking east.*

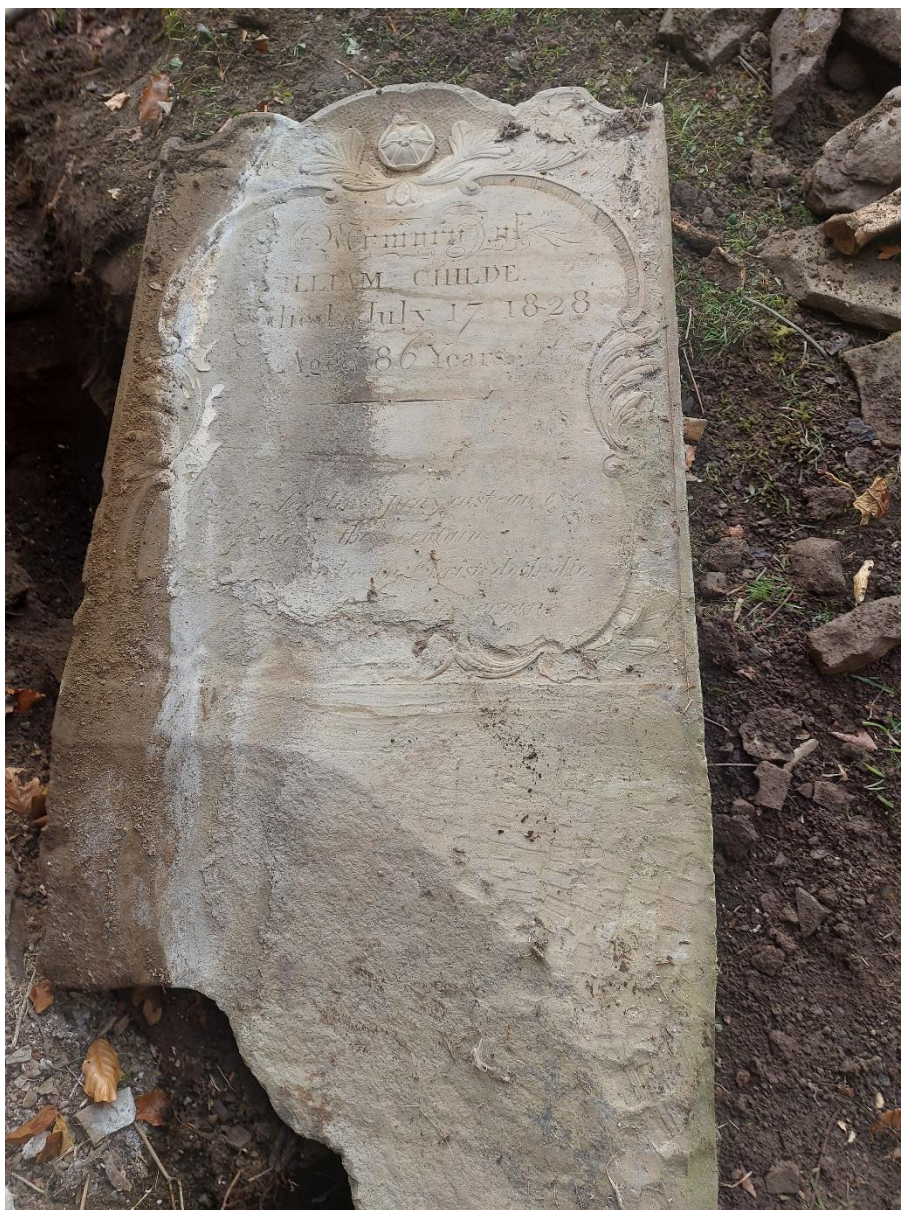
*Plate 5 Photograph of the inscription of the headstone leaning up against the western elevation of the porch.*

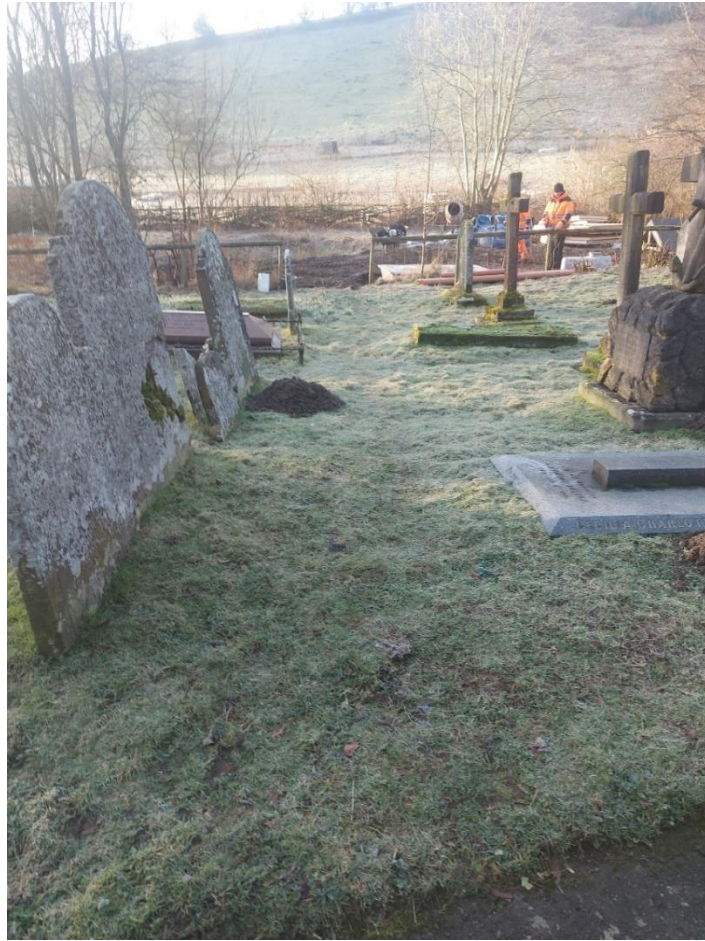
*Plate 6 Photograph looking south showing the location of the new path prior to excavation.*

A new path 1m wide was excavated from the church porch south to the churchyard boundary (Plate 6). Within this 1m wide area approximately 0.15-0.20m of turf and topsoil was removed. The topsoil (102) comprised of a dark-brown humic soil. Directly in front of the church porch was a tarmacked

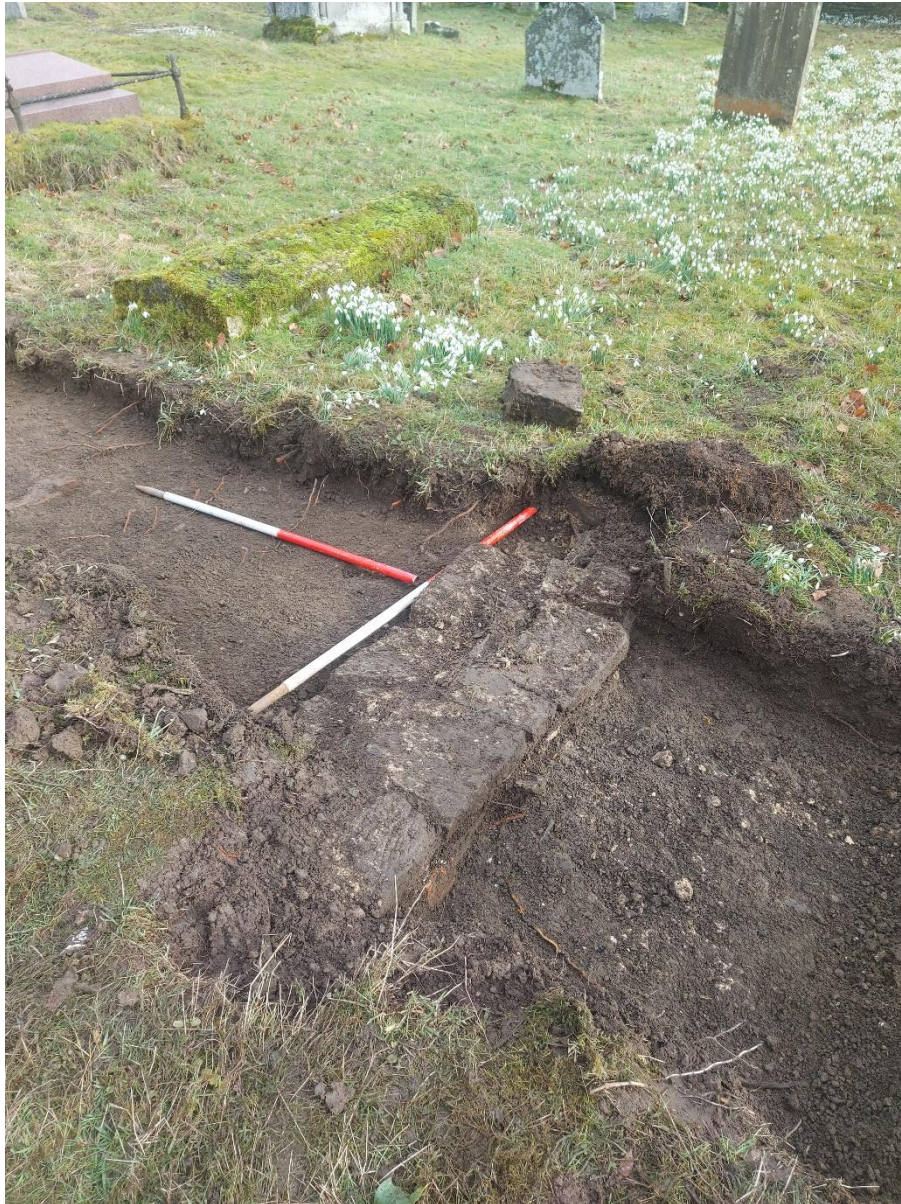
*Plate 7 Photograph of the foundation courses of the former stone-built churchyard boundary wall. Looking east-northeast.*

The excavation of the topsoil material along the length of the path revealed the foundation courses of a former stone-built boundary wall of the churchyard (Plate 7). This wall was 0.5m wide and orientated east west. The surviving wall comprises one or two courses with a height of at least 0.10ms. It was built from dressed facing stones with a small rubble core and a brick was observed in the lower course of the south facing elevation (Plate 8). It was located 1m to the north of the current churchyard boundary which is now marked by an agricultural wire fence. Its position and orientation suggest that it lined up with the stone wall currently present between the churchyard and the Old Rectory (Plate 9).

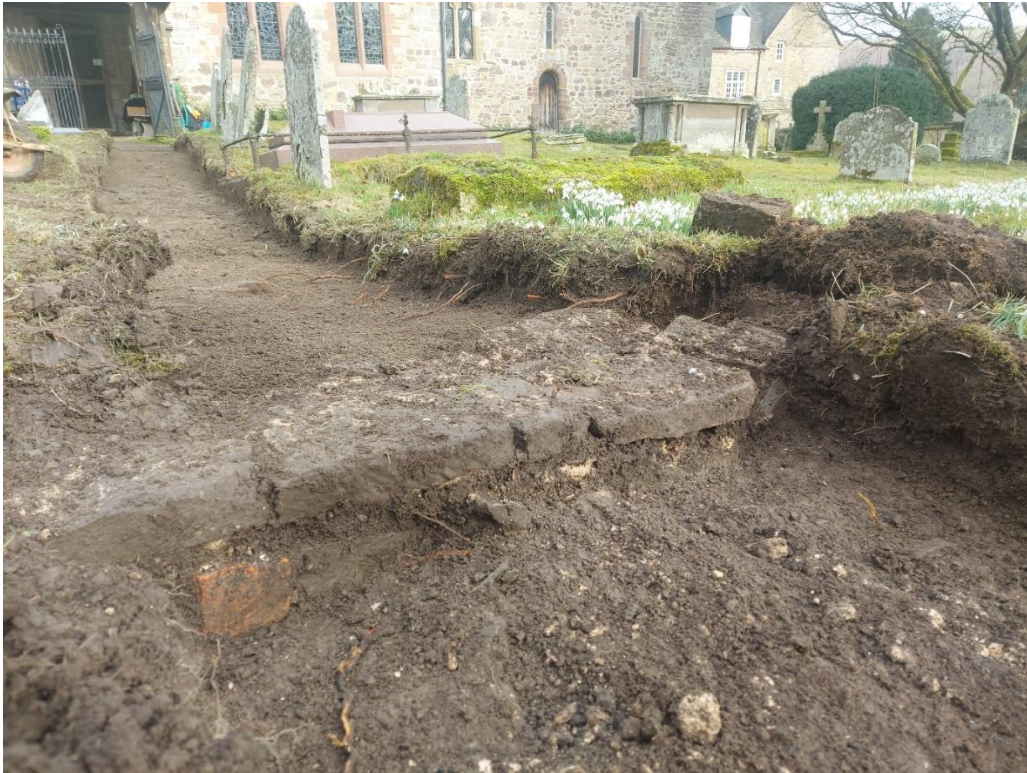
*Plate 8 Photograph of the former stone-built churchyard boundary wall showing what remains of its south-facing elevation.  
Looking north-northeast.*

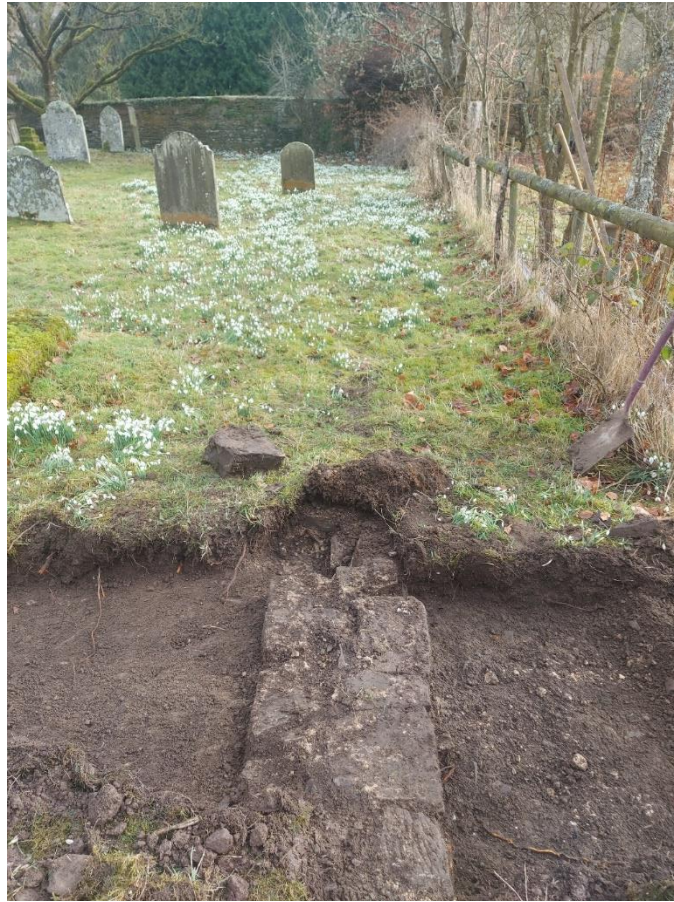
*Plate 9 Photograph looking east showing how the former churchyard boundary wall lines up with the eastern boundary wall (extant) of the churchyard.*

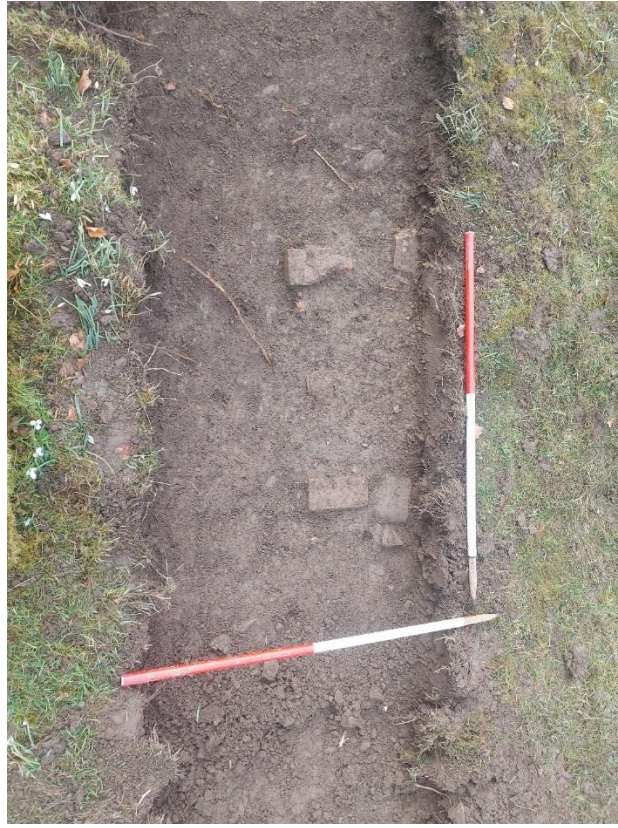
*Plate 10 Photograph showing the plan view of the brick lined grave observed after topsoil stripping for the new path.*

The presence of a grave was also detected after this topsoil strip. The grave was located to the north of the former church boundary wall. The soil within the grave cut is a slightly lighter colour than the surrounding subsoil substrate. In plan, this grave measured 0.8m in width and 0.45m in length, though it was only partially revealed. This grave also has some bricks lining the edge of the grave (Plate 10). The headstone associated with this grave dates to 1882 (Plate 11). The service trench dug through the centre of this path was moved to the east slightly to avoid disturbing this grave.

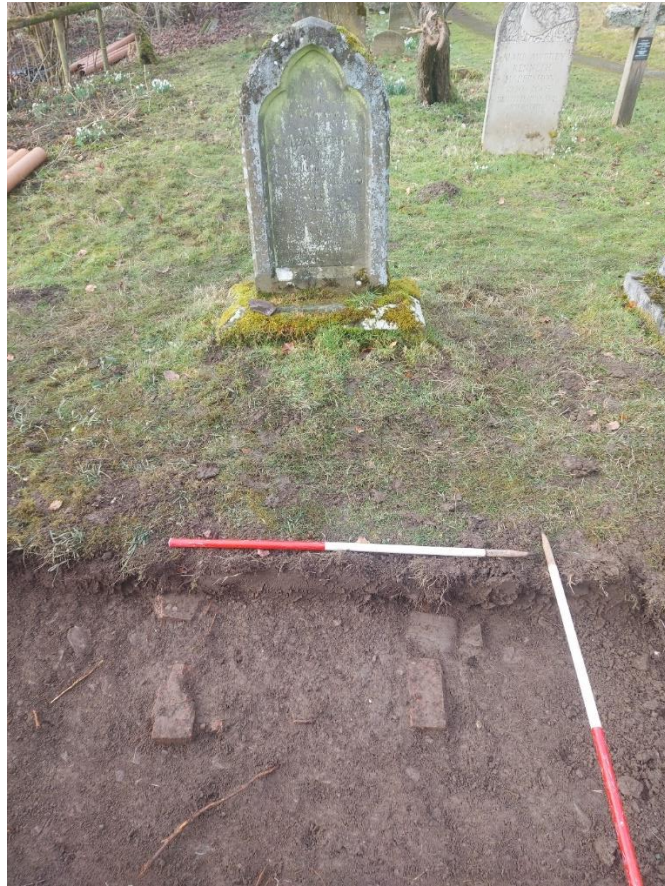
*Plate 11 Photograph looking west showing the brick lined grave and its associated headstone.*

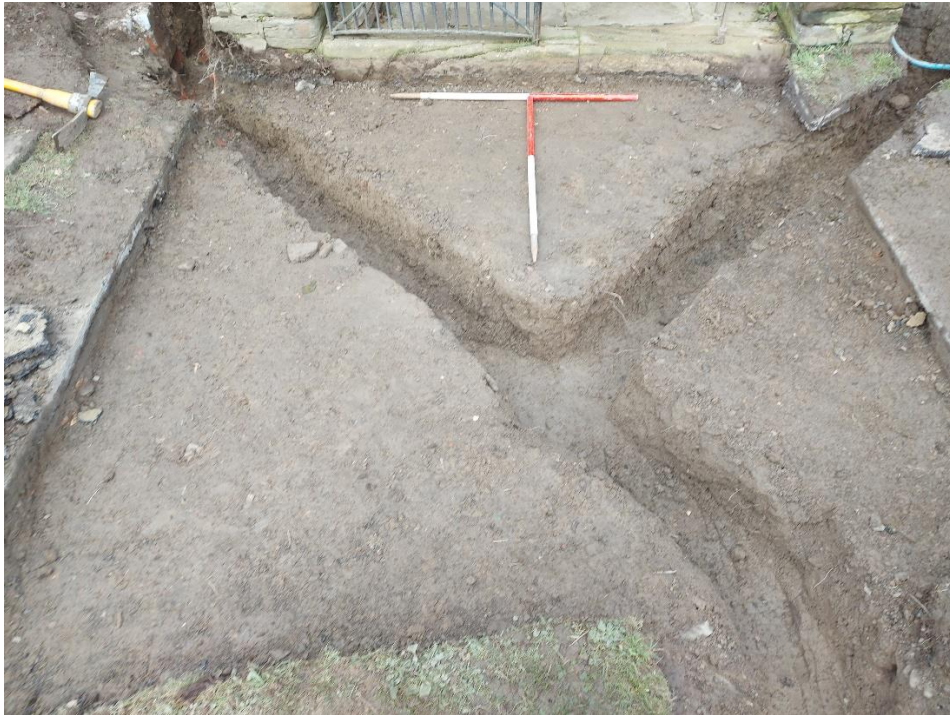
*Plate 12 Photograph showing the service trenches immediately south of the porch. Looking north.*

The tarmac immediately to the south of the porch was removed and two narrow service trenches were excavated (Plate 12). This area produced the majority of the fragmented human bone found on the site. It is possible that when this tarmac path was installed, any human remains encountered were reburied beneath this path. The service trench continued down the new path towards the field and the new compositing toilet system (Plate 13).

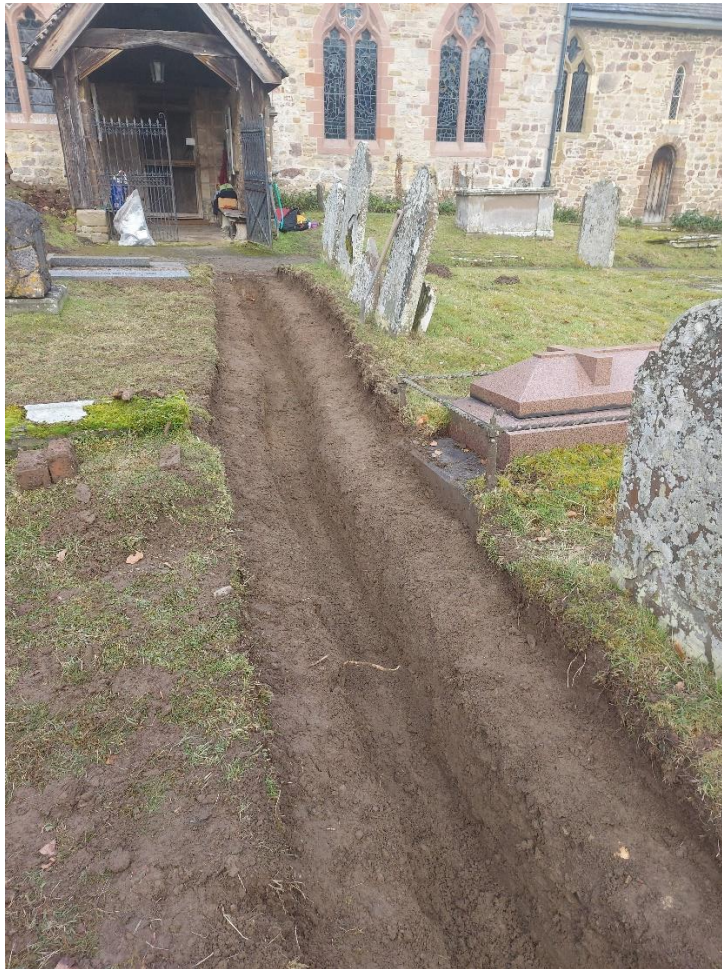
*Plate 13 Photograph showing the service trench running down the centre of the new path from the porch to the new composting toilet system. Looking north.*

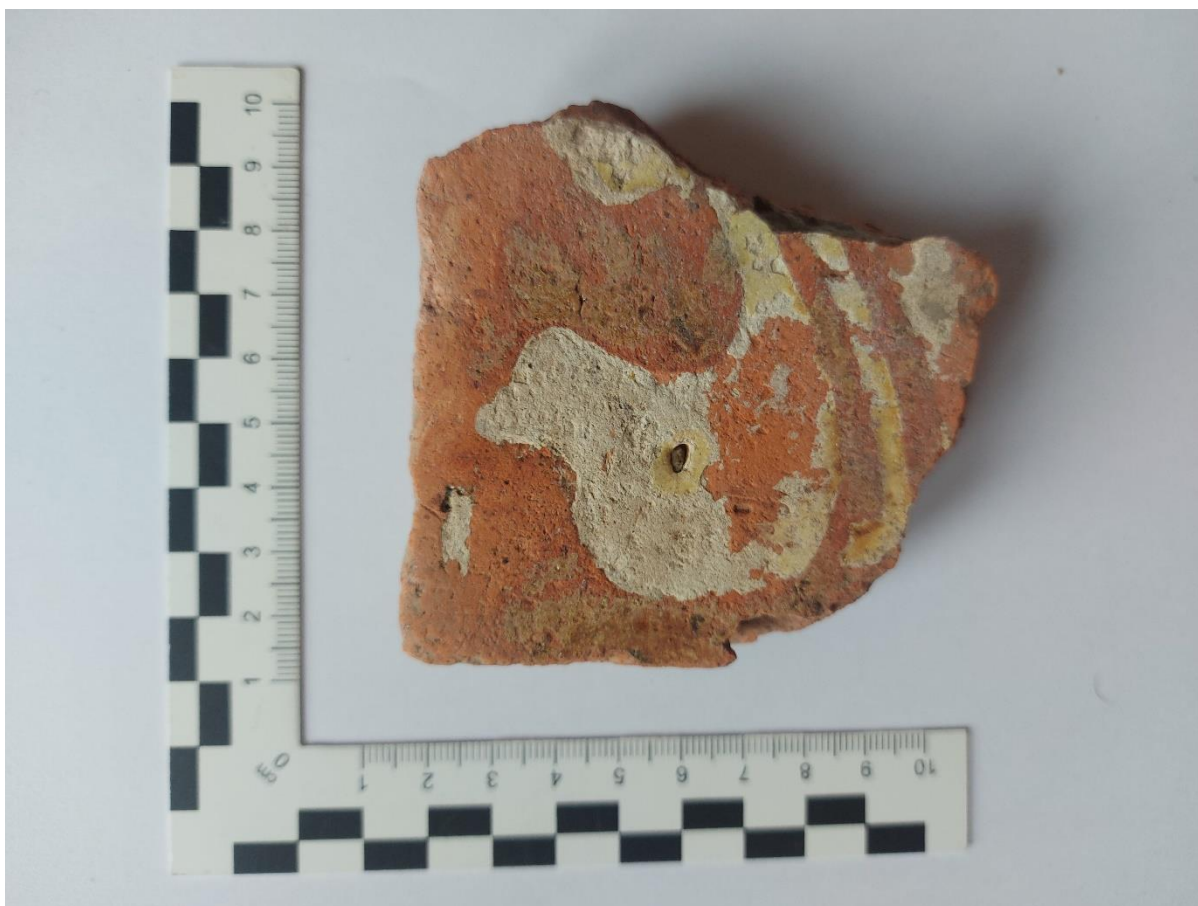
*Plate 15 Possible medieval tile from trench to the west of the church porch.*
