St Mary Magdalene's

Proposed North Elevation

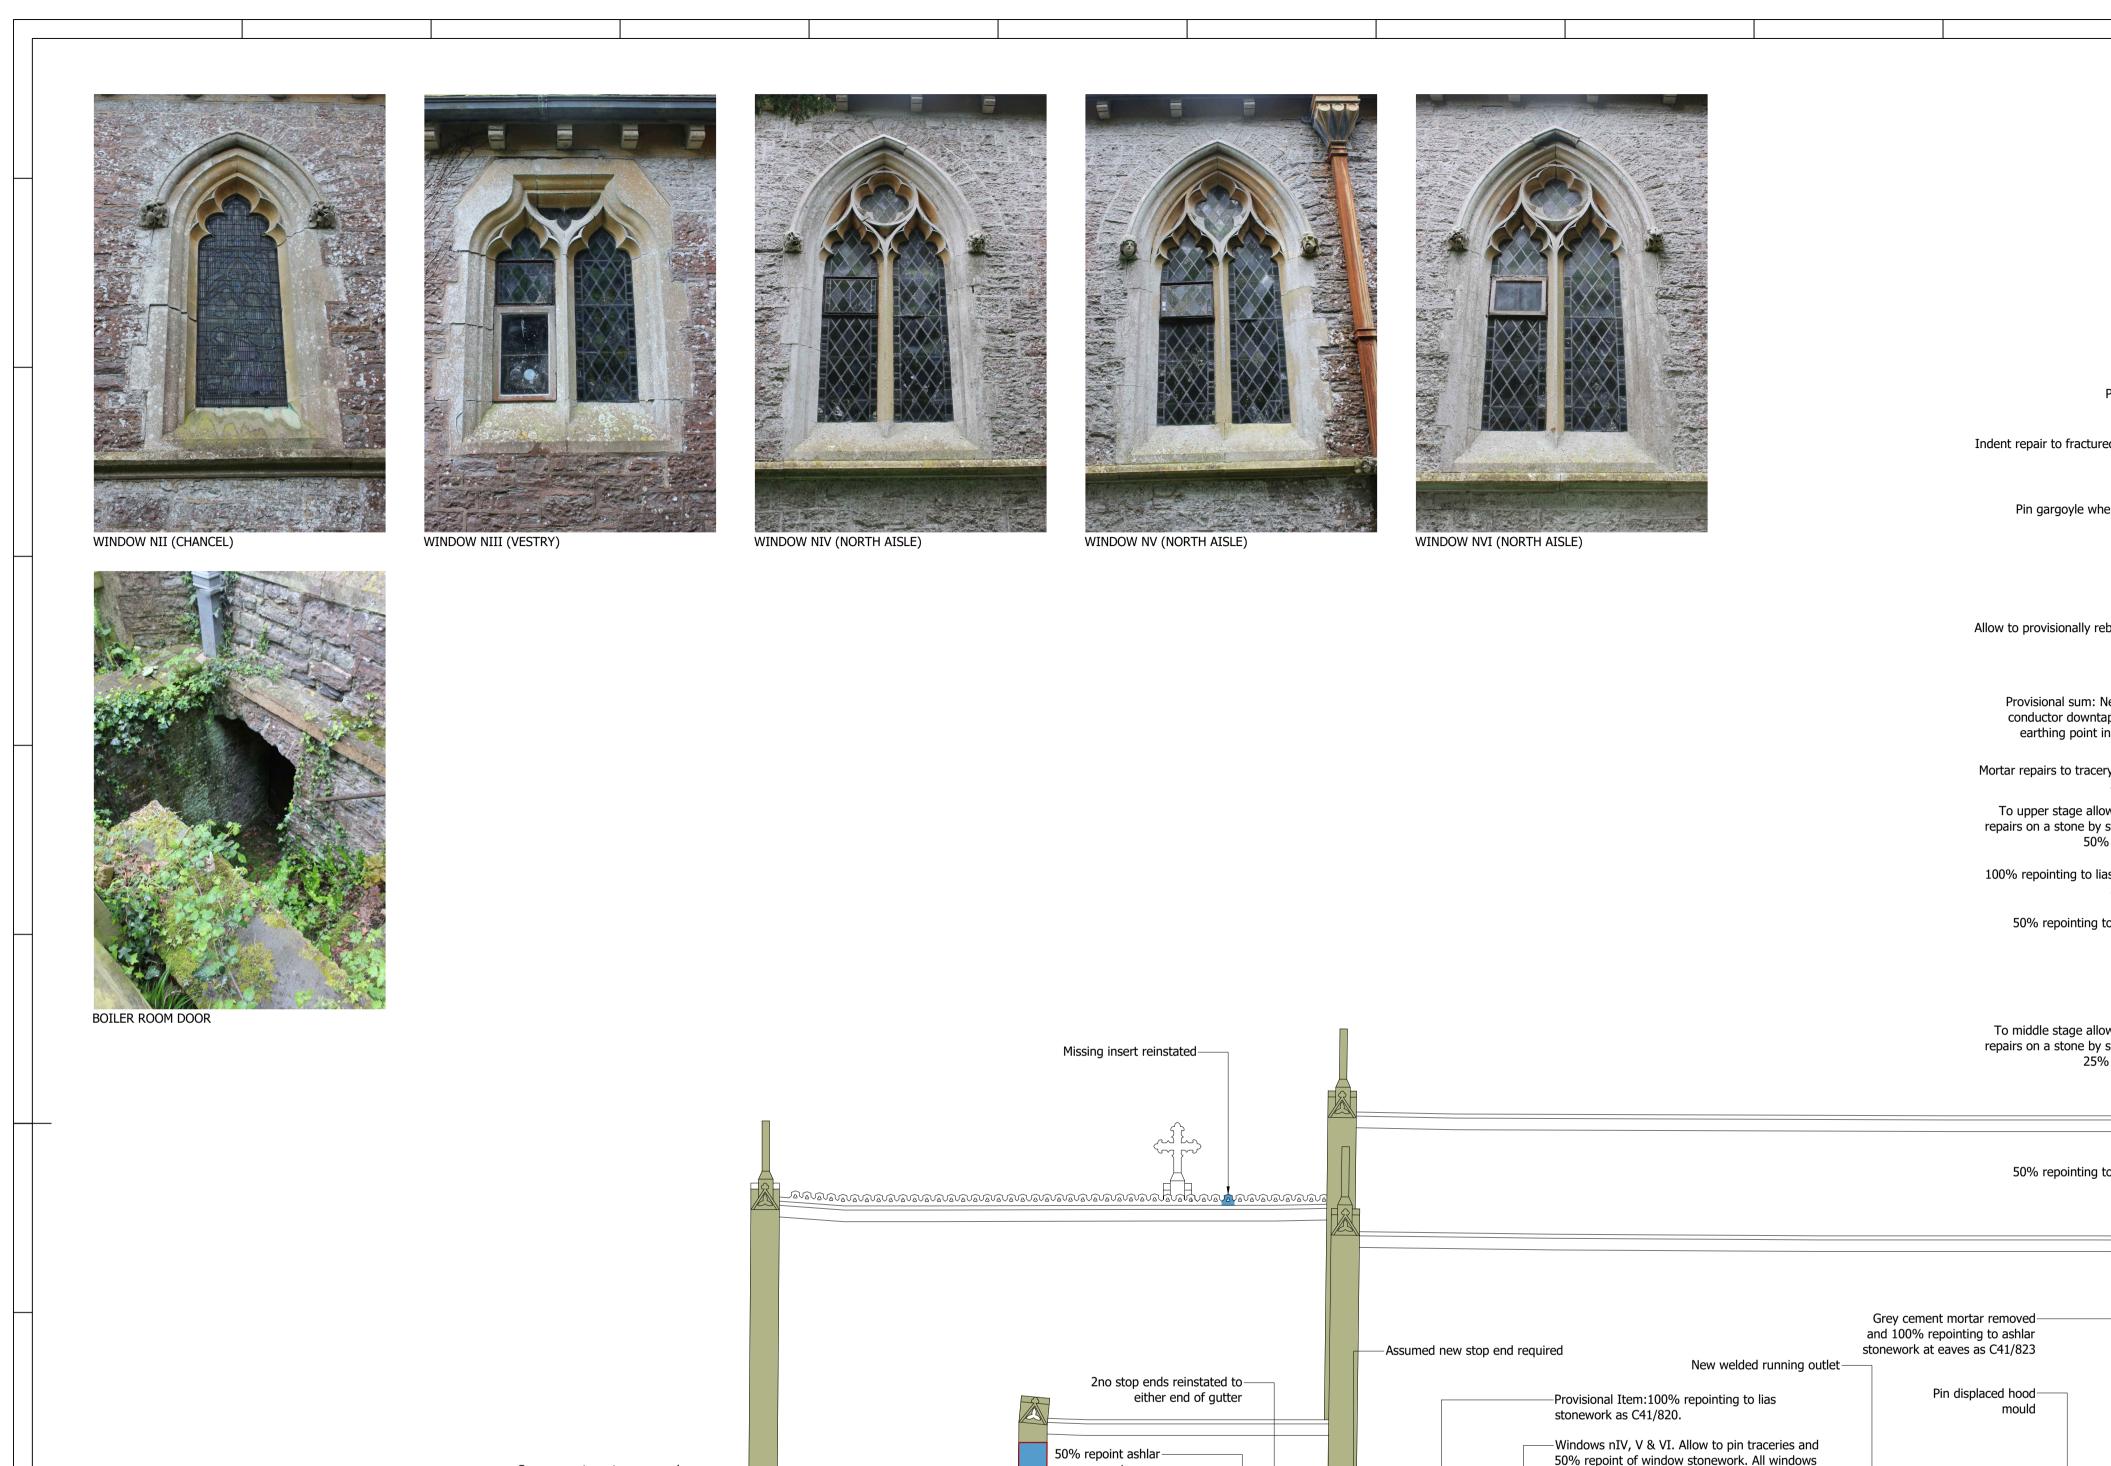
50% repointing to-

window stonework

New leaded light.—

New steel gate—

100% repointing—

and defrass as

to lias stonework

Other lights releaded as L40/16

Hopper overhauled

Pin fracture to plinth stone——

Pieced in lias stone as—

New stainless steel tie bars as—L40/18 and glass cleaned.
