# KEYNSHAM CEMETERY

## STATEMENT OF SIGNIFICANCE

### Section I

#### **Chapels and Cemetery as built and in setting**

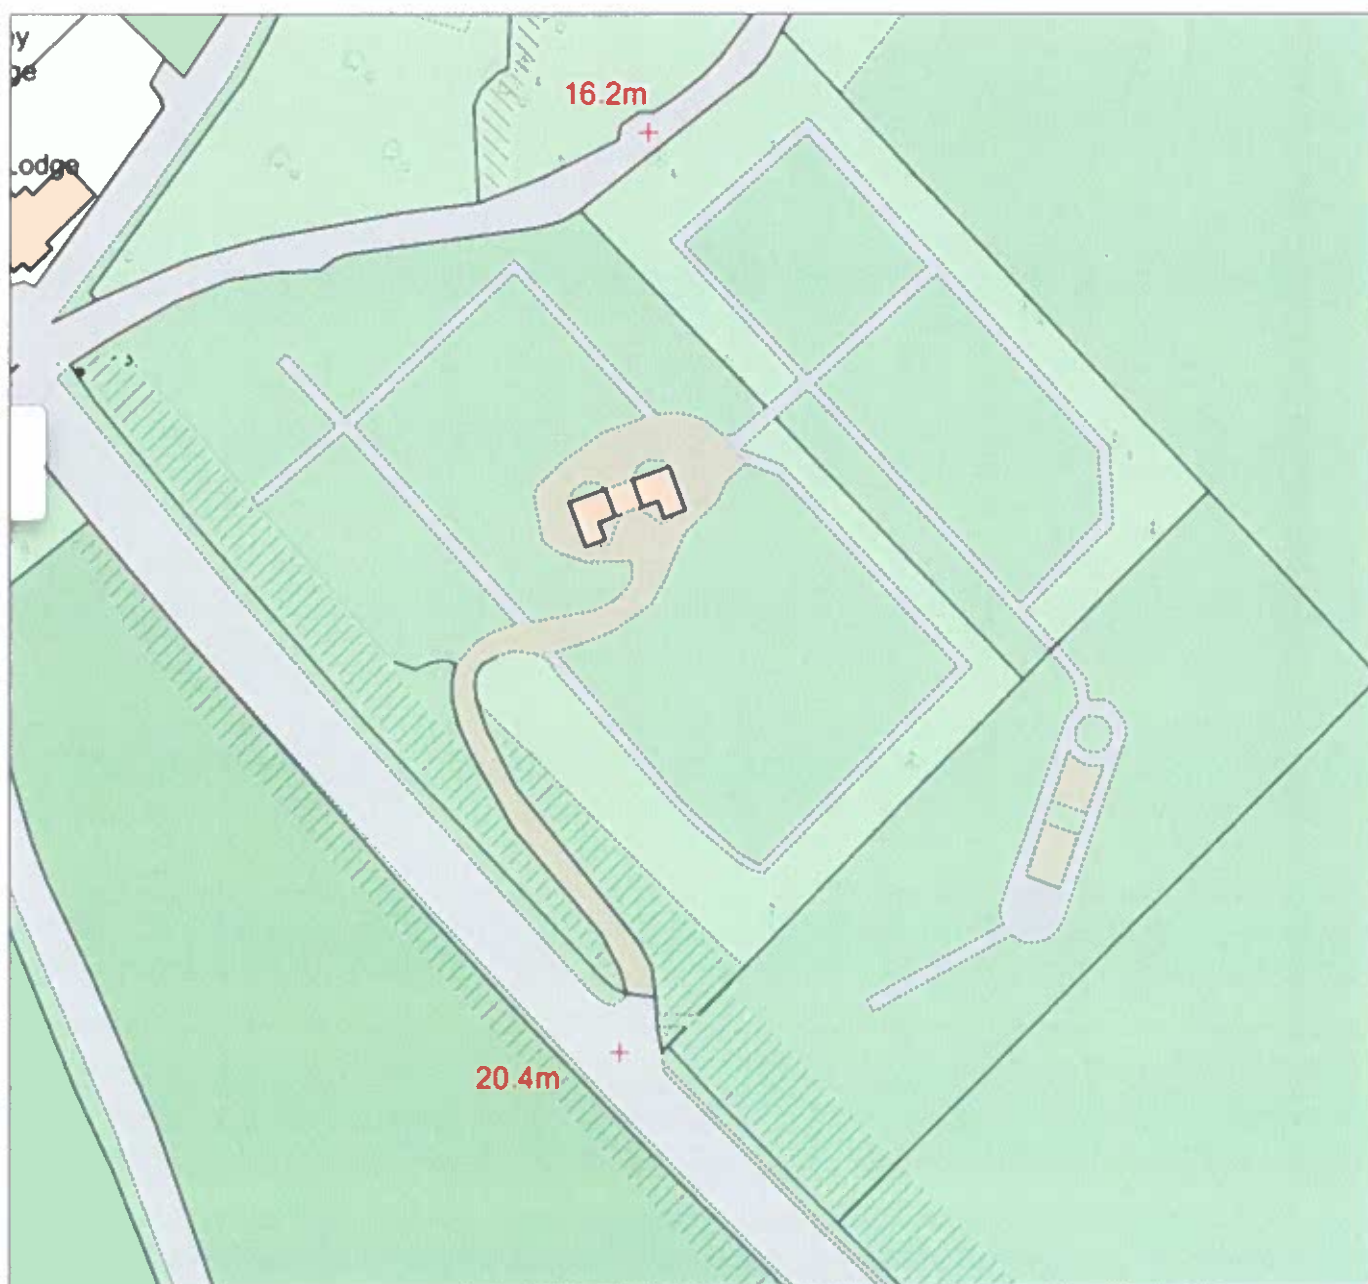
Here is a schematic plan showing the original cemetery with both its extensions:

The Cemetery had an extension purchased in 1918 which began use for burials in the late 1940's and a second extension in 1996, with burials commencing there after 2000.

There was a gap in the boundary wall North East of the Chapels opened in the late 1940's, shown on the plan above to permit access to the extension and from that extension into the new second; first used in 2000 for burials.

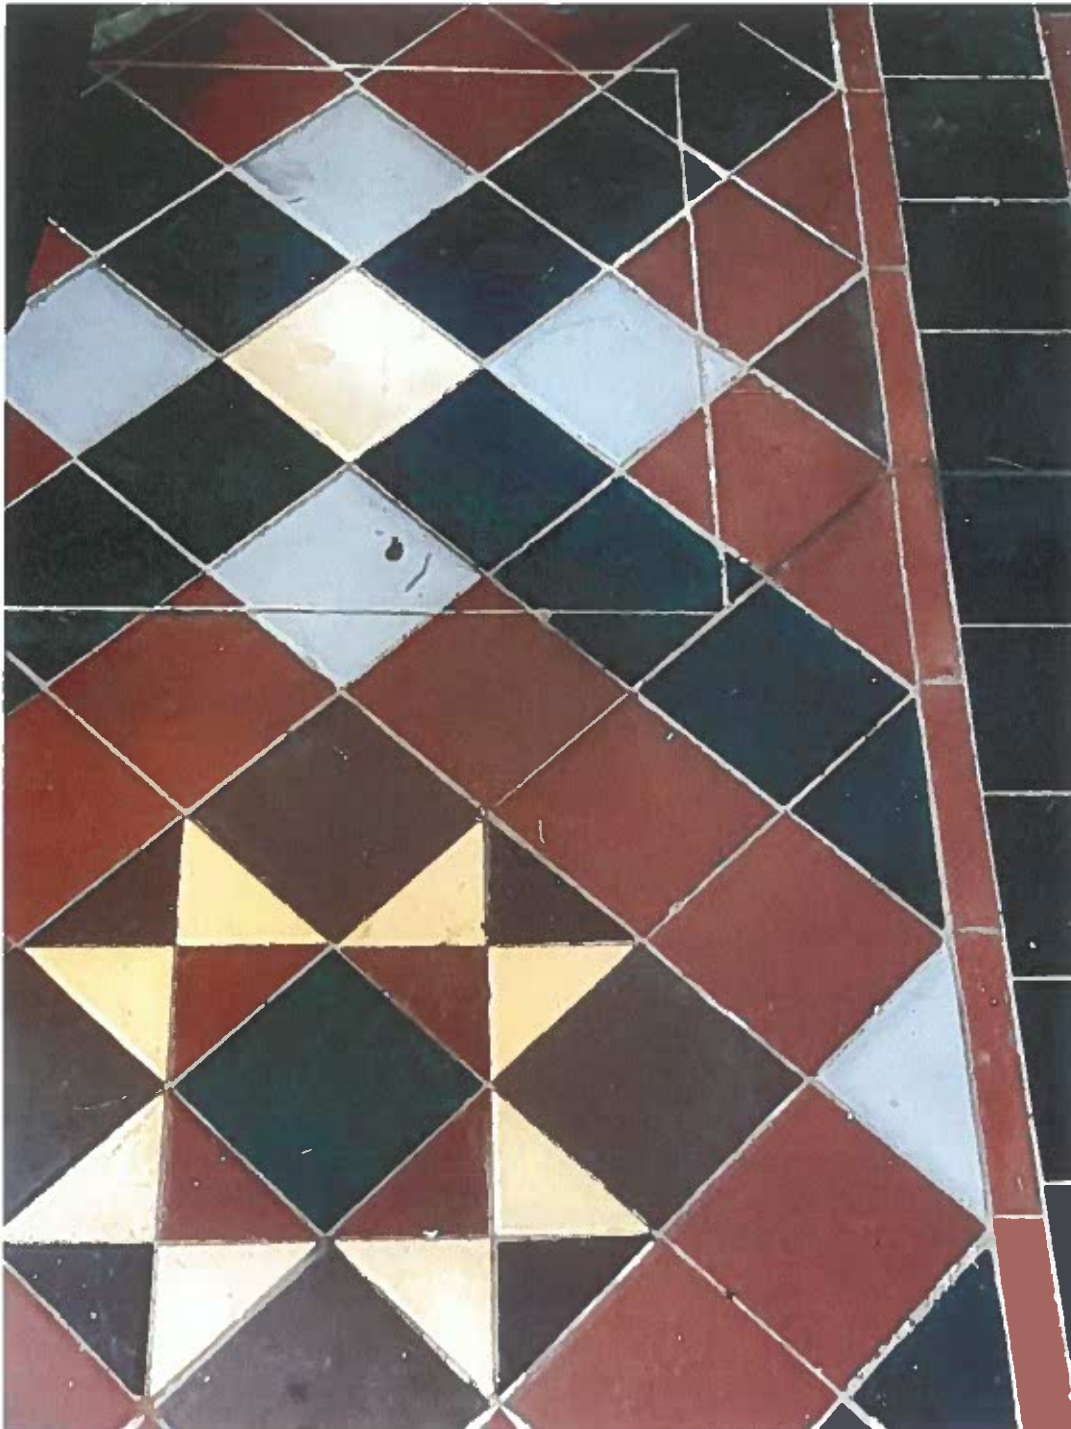
Here is a picture of the tiles on the new suspended floor following the archaeological investigation showing one of the inspection hatches fitted to permit inspection of the preserved archaeology beneath the floor.

The West Chapel has a new suspended timber floor constructed 2005 with access hatches to view below ground archaeology that was examined by archaeologists during new external drainage works created because the West Chapel which was suffering from damp. On page 108
