STATEMENT OF SIGNIFICANCE
DRAFT V25 15th September 2024

St.Dubricius Church, Porlock

Diocese of Bath and Wells
Taunton Deanery

Grade 1 listed church in West Somerset
Grid reference: SS88642 4665

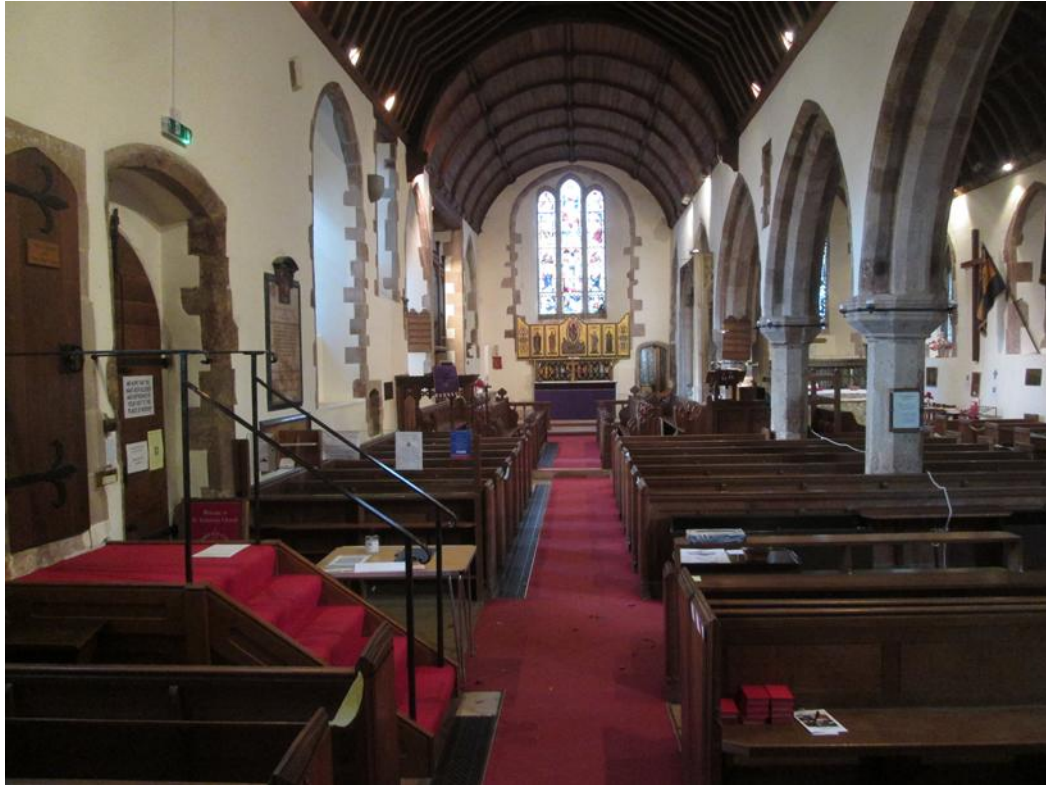
View of Interior of Church

The nave roof structure is of A frame trusses with straight braces, forming the effect of a canted ceiling. There is boarding between the trusses sitting on a simple chamfered wall plate.

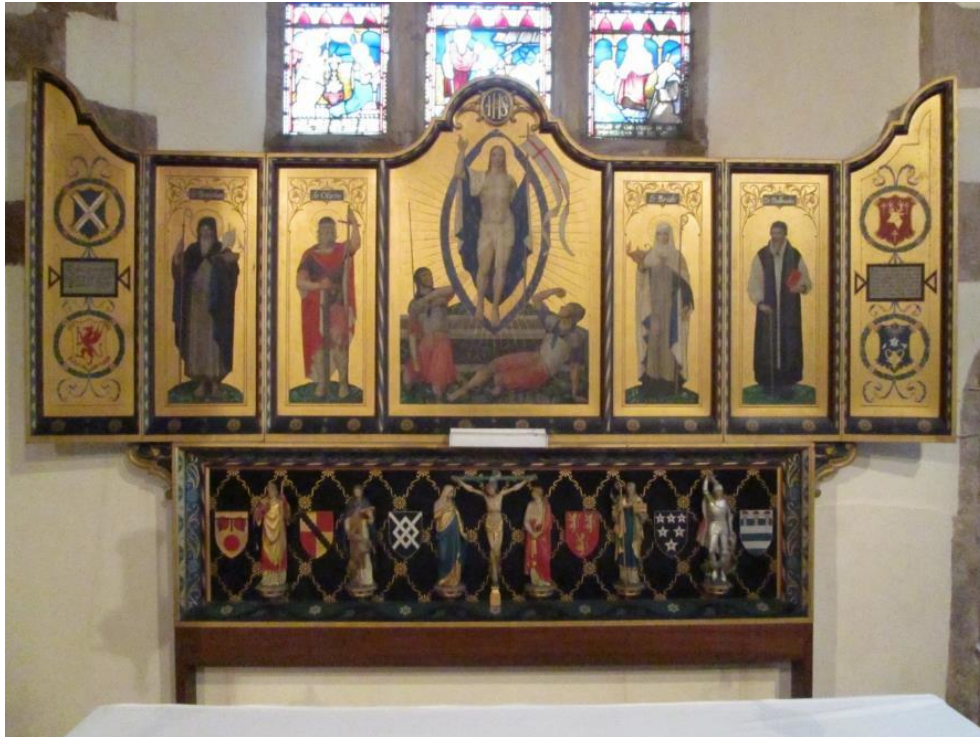
2.14.1.1 Reredos and Triptych

The beautiful Reredos and Triptych which adorns the High Altar was dedicated in 1931. The Reredos is carved in wood and painted, with Triptych above.

It was designed in the Voisey style by the distinguished ecclesiastical architect Mr. W.H.R. Blacking. The finely carved wooden figures of the Reredos were made by Mowbray. They represent the early saints connected with the district;

The work on the Reredos is expected to be done in situ, although this will not be confirmed until the conservator has conducted a more thorough examination of the works required. In situ working may require that the altar be moved slightly to provide a sufficient work space. Undertaking the work in situ is the preferred plan as it will enable members of the public to observe the restoration work as it is undertaken. This is expected to be of great interest to visitors, local community and the congregation members as well. It is one of the elements of the NLHF application highlighted as a means of drawing new audiences to view our heritage.
