**St. Mary's – Deane Parish Church**  
**Confirmatory Faculty Application**  
**Following Interim Faculty granted 9/10/17**  
**Removal of upper finials from the four tower pinnacles**

**Background**

**Workscope**

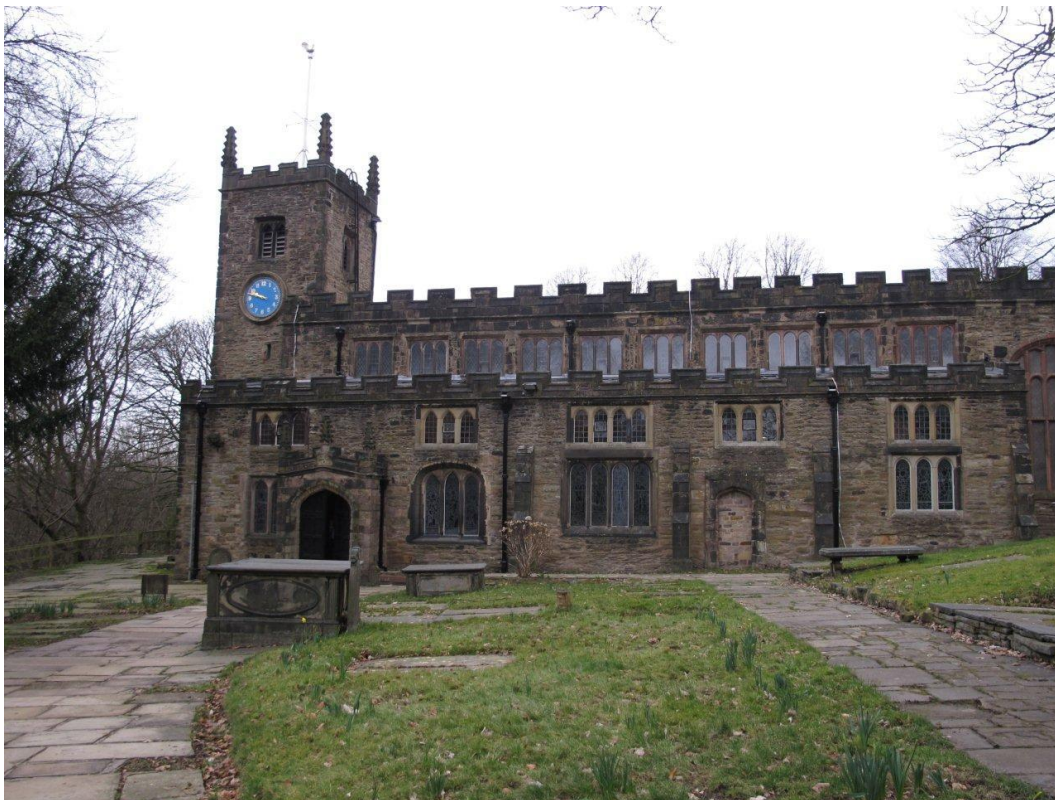
External south elevation showing the pinnacles without their caps

Owing to ongoing worksopes and inclement weather, work commenced on 24<sup>th</sup> January 2018 and was completed on 26<sup>th</sup> January 2018.

- 1) Provide and erect the necessary scaffolding to the pinnacles to provide a safe working platform.
- 2) Then proceed to carefully wrap and label each Finial stone before being removed.
- 3) Once prepared ready for removal, cut, using cutting disc the joint below the Finial.
- 4) Once removed carefully lower to belfry for safekeeping.
- 5) Apply new lead cap to each pinnacle to protect exposed stonework and steel dowel from the elements.
- 6) Upon completion, remove all scaffolding and leave clean and tidy.

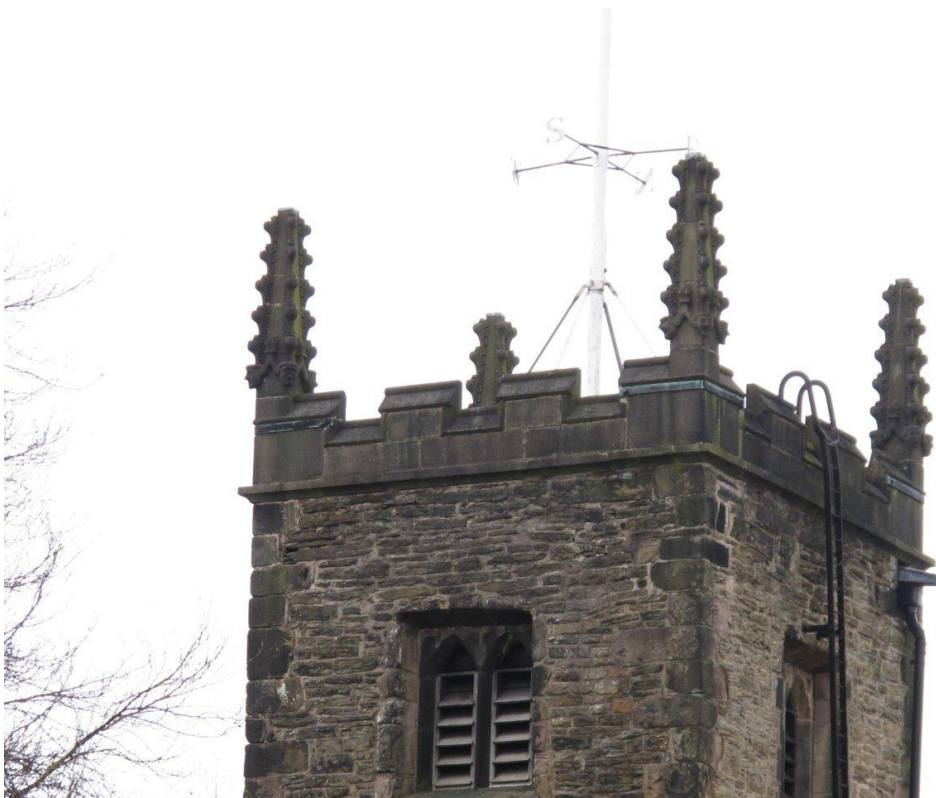
Close up of Tower with all four finials in view

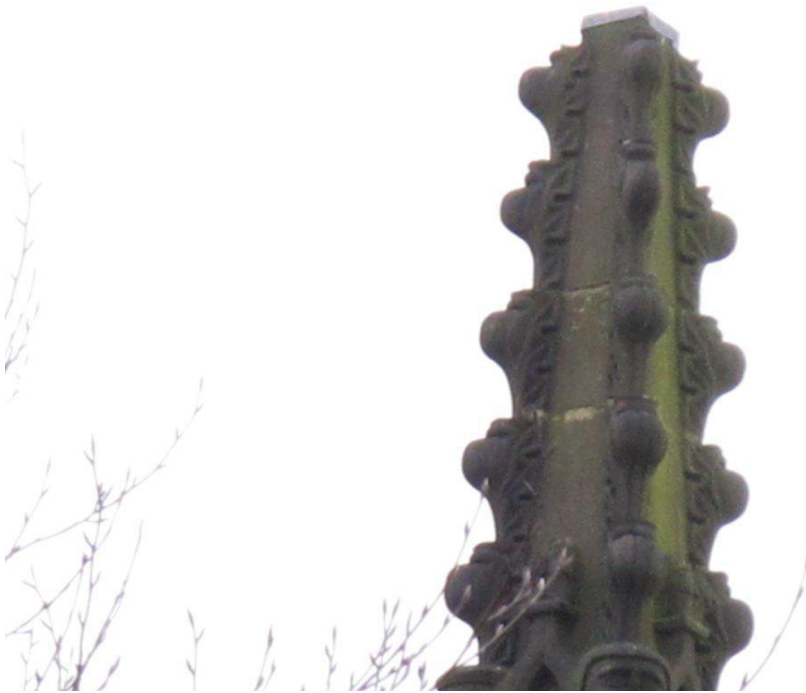
Pinnacle showing new lead cap to protect exposed dowel and masonry

I confirm that the work appears to have been carried out to a good standard and the exposed tops of the finials have been neatly dressed with a lead cover flashing to protect from water ingress.

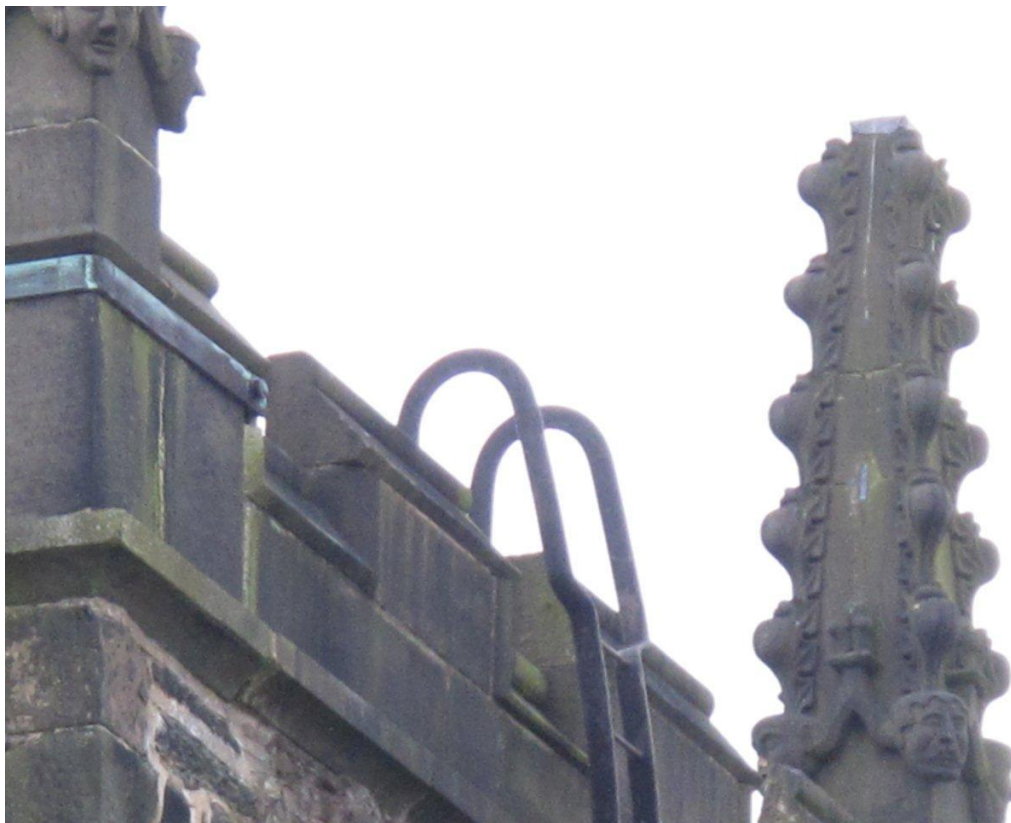
NE Pinnacle showing lead cap

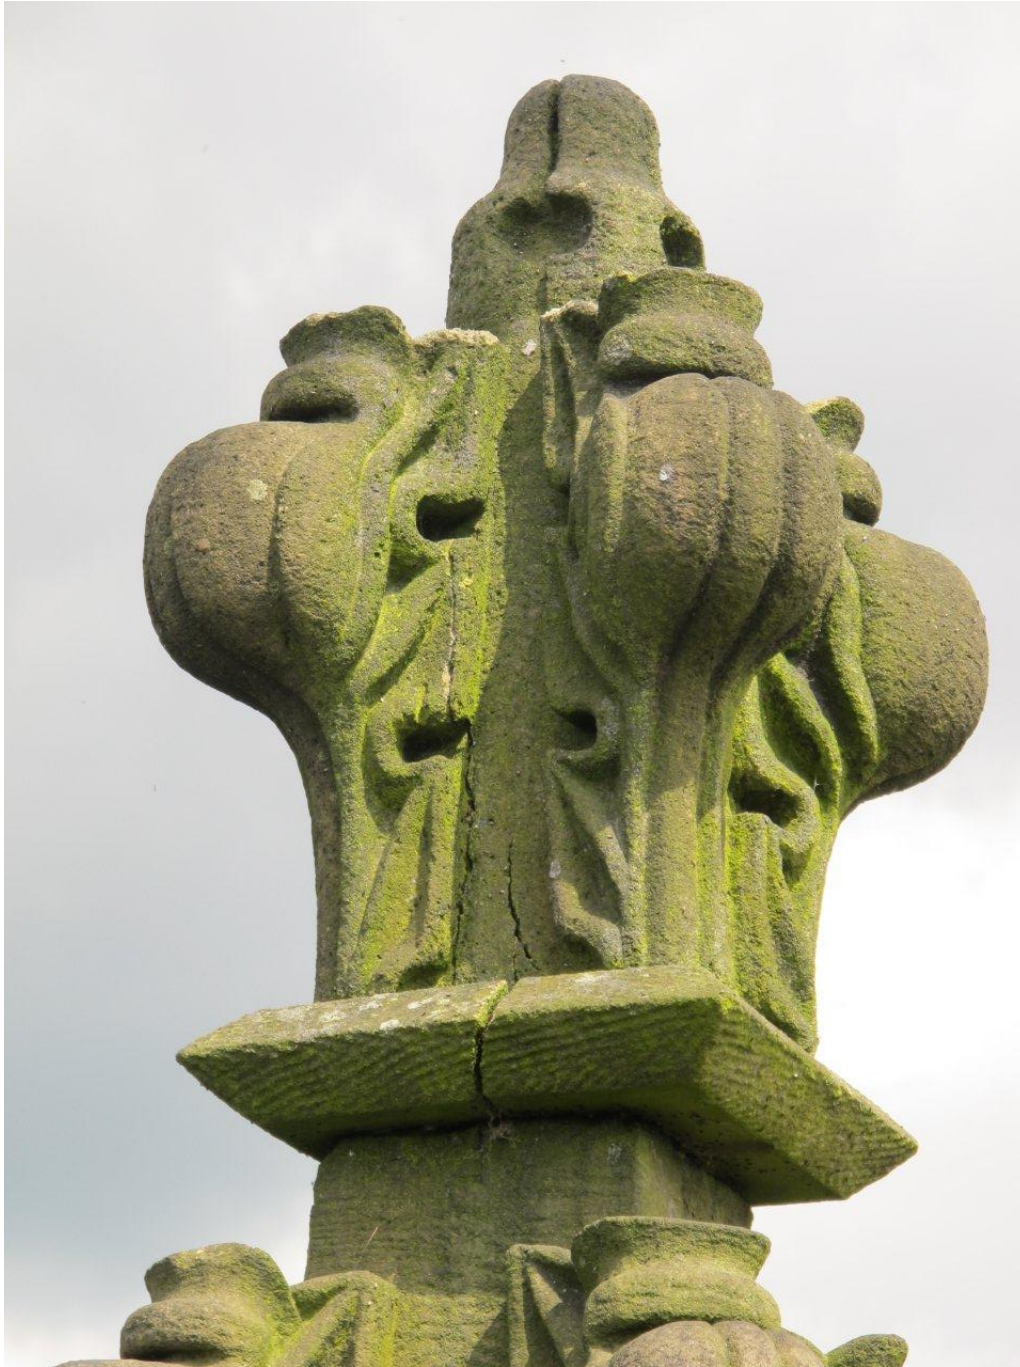
Example of Finial cap – now removed and safely stowed

The four caps are now protectively wrapped, labelled and safely stowed in the Belfry of the tower.

Each of the lead caps has had a smart water application performed.

The finial caps will remain safely stowed in the belfry until funding is secured and a refurbishment / repair plan put in place.
