## Energy Audit Report for St. Martin's Church

| Site Address | St. Martin's Church, Stockport, SK4 2JE |
| Author | Tim Mawby Graduate Consultant |
| Date | 17 <sup>th</sup> December 2019 |

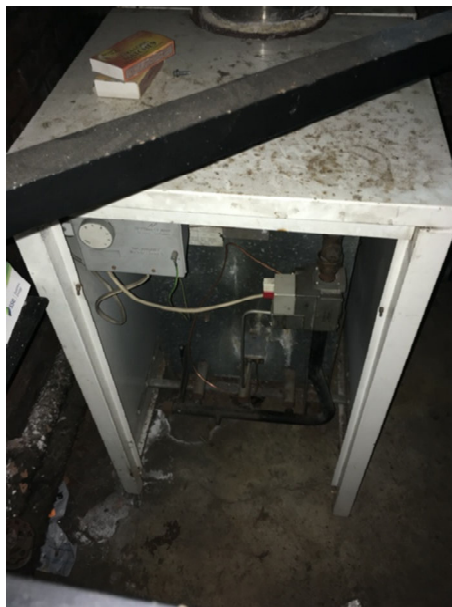
**Photograph 2: Church Boiler**

Heating is provided to the church via Concord gas fired boiler located in the basement plant room. The boiler's heating schedule is programmed weekly to suit upcoming occupancy hours. It is unclear how old the boiler on-site is, however during the site visit it was noted that the unit is approaching the end of its serviceable life, (assumed to be at least 20 years old). Based on this, it is assumed that the efficiency of the boiler may have dropped to as little as 60%. As such, it is recommended that the boiler is replaced with a high efficiency gas condensing boiler.

During the site visit, it was noted that the boiler was scheduled to be operational for 71 hours, despite the weekly plans only showing 16 hours of usage. It is understood that due to the age of the boiler, it takes a considerable amount of time to heat the church to the desired level. This further reinforces the recommendation to source a new efficient boiler replacement.

It is recommended that the existing gas boiler be replaced with a modern alternative. Additionally, the client may consider exploring the possibility of installing an air source heat pump heating system in order to move towards the goal of decarbonising energy consumption.

| Category | Actions | Potential Annual Savings | | | Investment (£) | Simple payback (yrs.) |
|---|---|---|---|---|---|---|
| Heating | Replace existing boiler with a new condensing boiler (90% efficiency) | 14,175 | £425 | 2.9 | £6,000 | 14.1 |

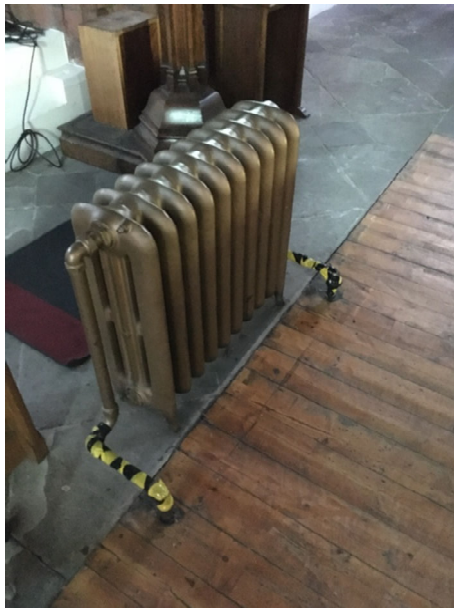
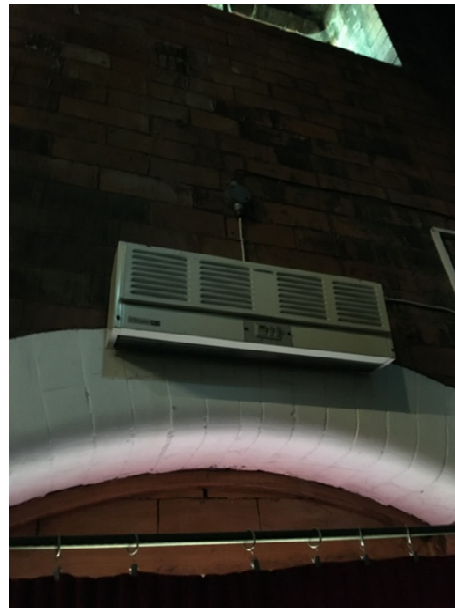
**Photographs 3 & 4: Church Heat Emitters**

Heating to the church is served by 13no. cast iron radiators, supplied by heating pipes running in floor trenches covered with grilles. There are also 2no. Dimplex electric curtain heaters located above the vestry's entrances/exits.

A range of portable plug-in heaters are also present throughout the building and are used to provide additional heating to the smaller rooms when required. This can be an ineffective, inefficient and poorly controlled means of providing space heating, and can easily be left on when unoccupied. It is recommended that a more permanent heating solution be provided to these spaces if and when heating upgrades are undertaken.

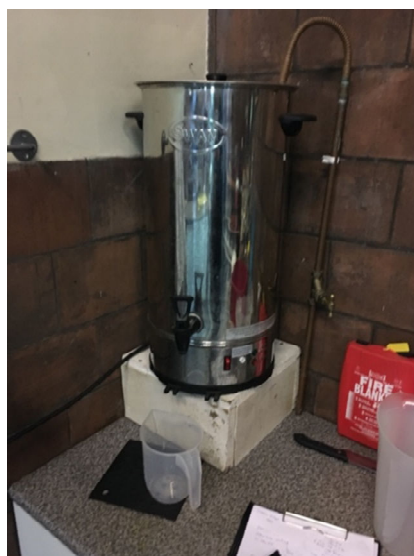
**Photograph 5: Electric Point of Use Water Heater**

There is no central hot water system. Hot water is supplied to the building via a Swan electric point of use water heater. Hot water consumption is considered to be nominal.

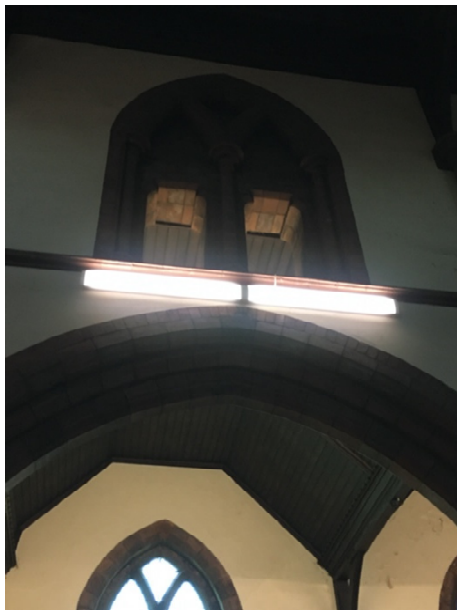
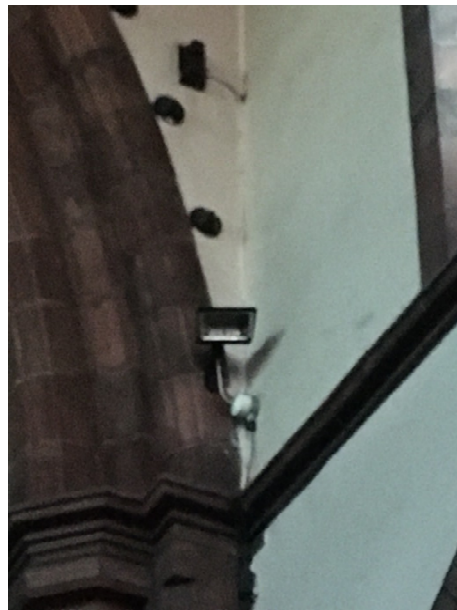
**Photographs 6 & 7: Twin Fluorescent Tubes and Halogen Floodlights**

- ▲ 32no. twin 58W T8 fluorescent tubes – recommended to be replaced with 22W LED alternatives.
- ▲ 6no. 58W T8 fluorescent tubes – recommended to be replaced with 22W LED alternatives.
- ▲ 4no. 200W halogen floodlights – recommended to be replaced with 60W LED alternatives.

| Category | Actions | Potential Annual Savings | | | Investment (£) | Simple payback (yrs.) |
|---|---|---|---|---|---|---|
| Lighting | Church – replace 58W fluorescent tubes with 22W LED alternatives. | 1,917 | £192 | 0.6 | £640 | 3.3 |
| Lighting | Church – replace 200W halogen floodlights with 60W LED alternatives. | 466 | £47 | 0.1 | £200 | 4.3 |

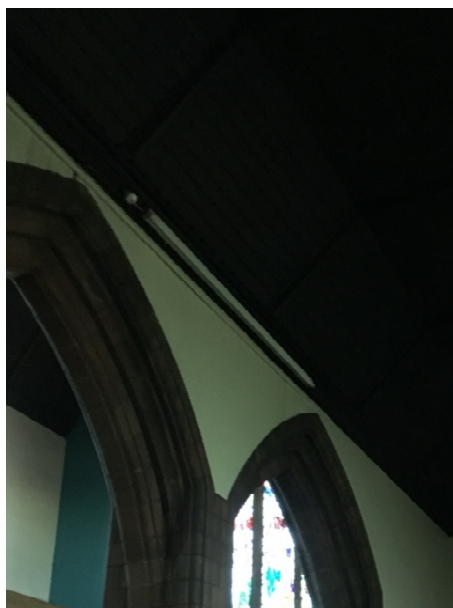
**Photograph 8: Fluorescent Tubes**

- ▲ 2no. 58W T8 fluorescent tubes – recommended to be replaced with 22W LED alternatives.

| Category | Actions | Potential Annual Savings | | | Investment (£) | Simple payback (yrs.) |
|---|---|---|---|---|---|---|
| Lighting | Side Chapel – replace 58W fluorescent tubes with 22W LED alternatives. | 60 | £6 | <0.1 | £20 | 3.3 |

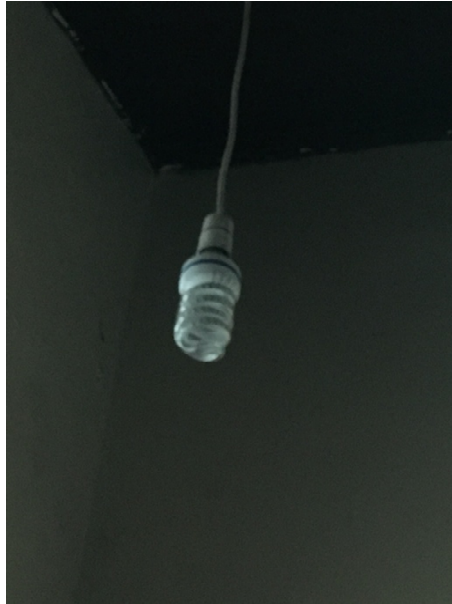
**Photograph 9: LED Lamp**

- ▲ 3no. 58W T8 fluorescent tubes – recommended to be replaced with 22W LED alternatives.
- ▲ 1no. LED lamp

| Category | Actions | Potential Annual Savings | | | Investment (£) | Simple payback (yrs.) |
|---|---|---|---|---|---|---|
| Lighting | Vestry – replace 58W fluorescent tubes with 22W LED alternatives. | 90 | £9 | <0.1 | £30 | 3.3 |

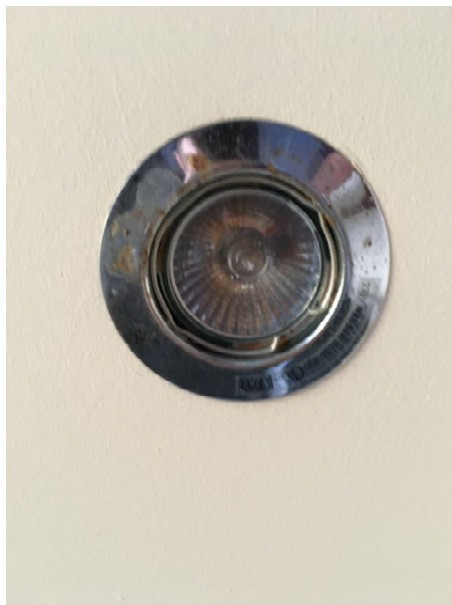
**Photograph 10: Fluorescent Spotlights**

- ▲ 8no. 50W fluorescent spotlights – recommended to be replaced with 7.5W LED alternatives.

| Category | Actions | Potential Annual Savings | | | Investment (£) | Simple payback (yrs.) |
|---|---|---|---|---|---|---|
| Lighting | Entrance – replace 50W fluorescent spotlights with 7.5W LED alternatives. | 283 | £28 | 0.1 | £80 | 2.9 |
