## Energy Audit Report for Christ Church Friezland

Site Address	Christ Church Friezland, OL3 7LQ
Church Code	624270
Author	Tim Mawby Graduate Consultant
Date	18 <sup>th</sup> December 2019
Version	1.0

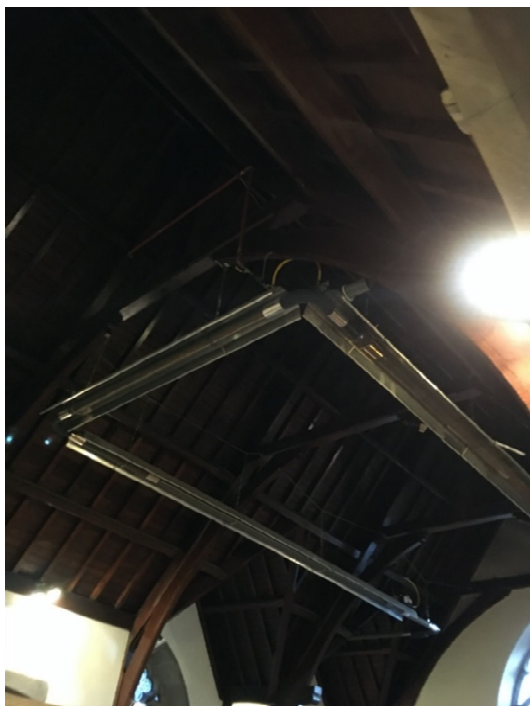
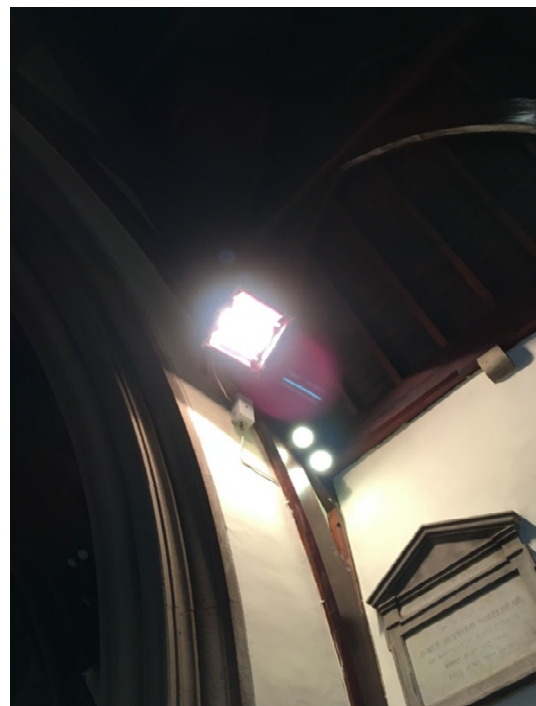
**Photographs 2 & 3: Gas Radiant Heating System & Electric Wall Heater**

Heating to the church is served via a gas radiant heating system suspended from the church ceiling. The system is served by 7no. Noravike Ambirad gas burners mounted on the heat emitters. It is unclear how old this heating system is, however whilst on-site it was noted that the system is well maintained and in good condition. This system is operated via a control panel located in the main body of the church and is switched on and off when required. It is recommended that the timer function is programmed weekly to match the church's schedule, as this will lessen the chance of the system being left on whilst the church is unoccupied.

The church also contains 2no. 3-bar (each 3x1.5kW) electric wall heaters. A range of portable plug-in heaters are also present throughout the building and are used to provide additional heating to the smaller rooms when required. This can be an ineffective, inefficient and poorly controlled means of providing space heating, and can easily be left on when unoccupied. It is recommended that a more permanent heating solution be provided to these spaces if and when heating upgrades are undertaken.

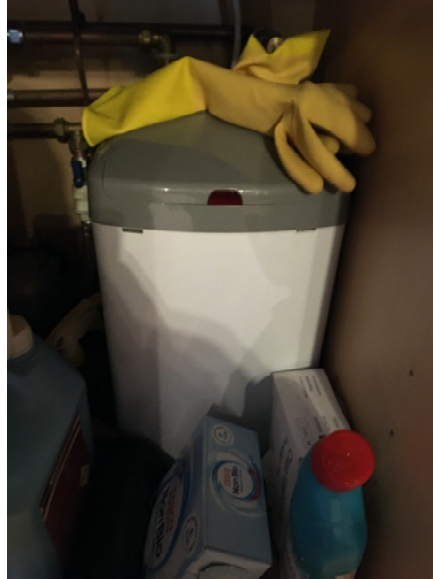
**Photograph 4: Electric Water Heater**

Hot water is provided to the building a 3kW Optima electric water heater, serving kitchen and WC areas. There is also a 10-litre Buffalo Autofill CF357 electric point of use water heater located in the kitchen. Hot water consumption is considered to be nominal.

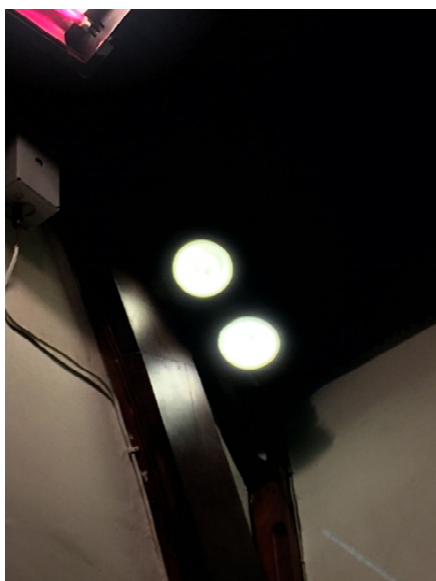
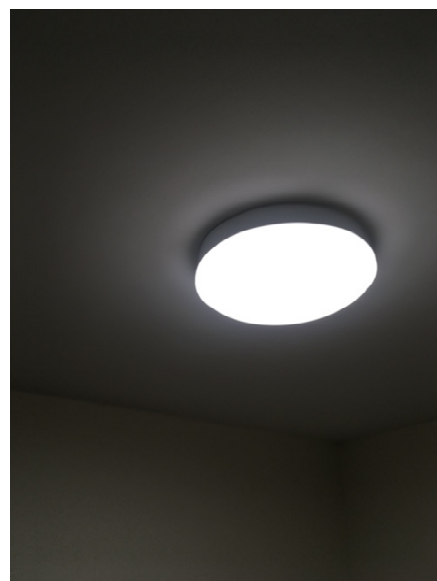
**Photographs 5 & 6: Church Light Fittings**

There is no lighting control system, motion detectors or daylight dimming controls. All light fittings are controlled via manual on/off switches.

- ▲ 61no. 20W low-energy fluorescent spotlights – recommended to be replaced with 7.5W LED alternatives.
- ▲ 2no. 38W compact fluorescent lamps – recommended to be replaced with 7.5W LED alternatives.

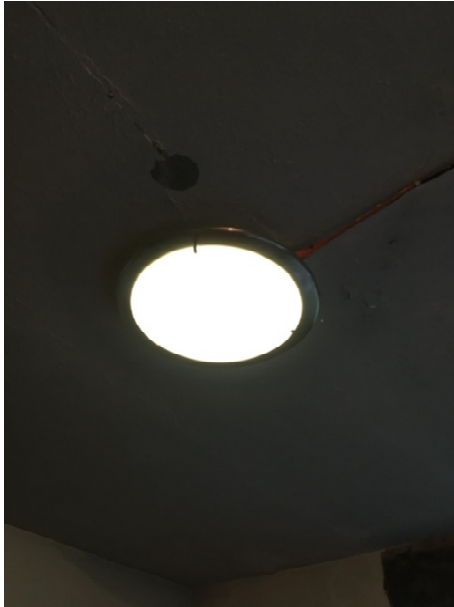
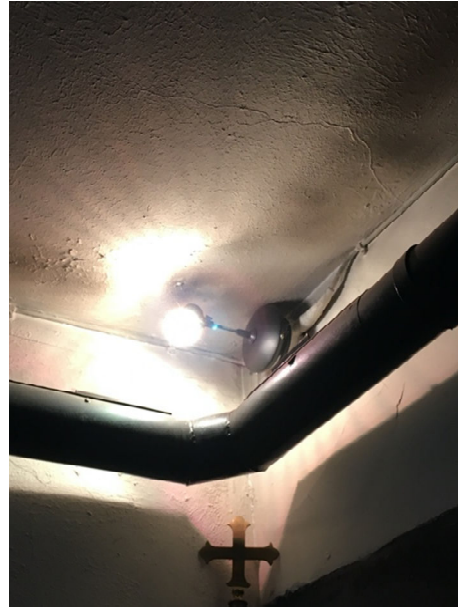
**Photographs 7 & 8: Church Hall Light Fittings**

- ▲ 1no. 38W compact fluorescent lamp – recommended to be replaced with a 7.5W LED alternative.
- ▲ 1no. 20W fluorescent spotlight – recommended to be replaced with a 7.5W LED alternative.
