Energy Audit Report for Christ Church Friezland – Church Hall

Site Address	Christ Church Hall, Friezland, OL3 7LQ
Church Code	624270
Author	Tim Mawby Graduate Consultant
Date	21 st January 2020
Version	1.0

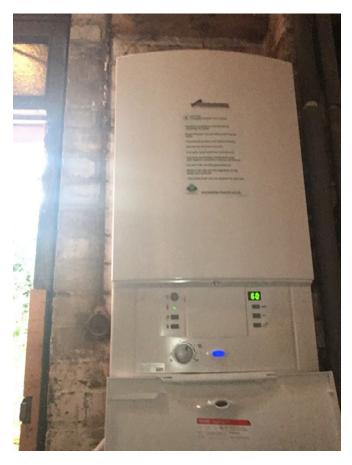
Photograph 2: Church Boiler

Heating is provided to the church by a Worcester gas combination boiler (installed in early 2019) located in the plant room. This boiler provides heating to all areas and is operated using a Hive application that allows the user to control the system from their mobile phone, as well as the control panel situated in the main hall. The boiler is currently programmed to be operational for 50 hours per week.

As the boiler is considered to be a new efficient model suitable for the heating demand of the church, no recommendations are made for the replacement of alternative technologies. However, it is recommended that the controls are reviewed regularly to prevent unnecessary usage.

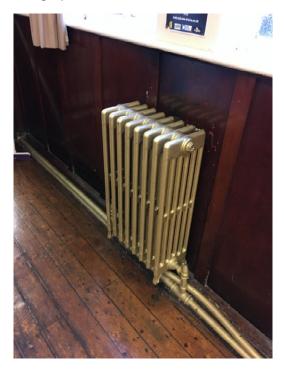
Photograph 4: Church Hall Iron Radiators

Heating to the main church hall is provided via 8no. iron radiators supplied by heating pipes fixed to the walls. There are also 3no. radiators in WC areas, 2no. radiators in the entrance corridor, 2no. radiators in the small hall and 2no. radiators in the storeroom.

A range of portable plug-in heaters are also present throughout the building and are used to provide additional heating to the smaller rooms when required. This can be an ineffective, inefficient and poorly controlled means of providing space heating, and can easily be left on when unoccupied. It is recommended that a more permanent heating solution be provided to these spaces if and when heating upgrades are undertaken.

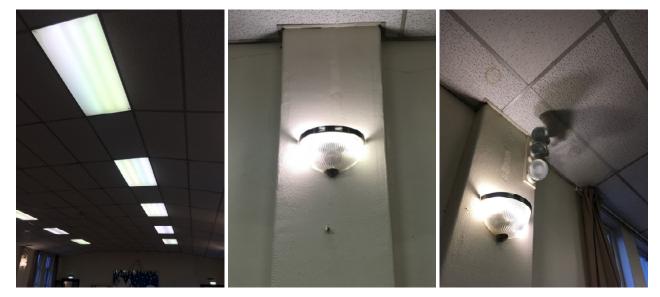
Photographs 6, 7 & 8: Church Hall Lighting

There is no lighting control system, motion detectors or daylight dimming controls. All light fittings are controlled via manual on/off switches.

- ▲ 10no. fluorescent ceiling panels each containing 4no. 58W T8 fluorescent tubes recommended to be replaced with 22W LED alternatives.
- 8no. fluorescent wall fittings each containing 2no. 20W fluorescent bulbs recommended to be replaced with 3.5W LED alternatives.
- ▲ 6no. 50W halogen spotlights recommended to be replaced with 12.5W LED alternatives.

Actions	Potential Annual Savings			Investment	Simple
Category		Elec/Gas (kWh)	Cost (£)	(tCO ₂)	(£)	payback (yrs.)
Lighting	Church Hall – replace 4x58W ceiling panels with 22W LED alternatives.	3,295	£329	1.0	£400	1.2
Lighting	Church Hall – replace 2x20W fluorescent wall fittings with 3.5W LED alternatives.	604	£60	0.2	£80	1.3
Lighting	Church Hall – replace 50W halogen spotlights with 12.5W LED alternatives.	515	£51	0.2	£90	1.8
Lighting	Small Hall – replace 58W fluorescent tubes with 22W LED alternatives.	330	£33	0.1	£40	1.2
Lighting	Small Hall – replace 2x20W fluorescent lamps with 3.5W LED alternatives.	302	£30	0.1	£40	1.3
Lighting	Kitchen – replace 2x58W fluorescent tubes with 22W LED alternatives.	165	£16	<0.1	£20	1.3
Lighting	Entrance Corridor – replace 100W halogen lamps with 12.5W LED alternatives.	801	£80	0.3	£60	0.8
Lighting	WC – replace 36W CFLs with 7.5W LED alternatives.	522	£52	0.2	£80	1.5
