Energy Audit Report for St Luke's Church

Site Address	St Luke's Church, Wythenshawe, M22 4PT
Church Code	624167
Author	Ros Harwood, Graduate Consultant
Date	21st February 2020
Version	1.0

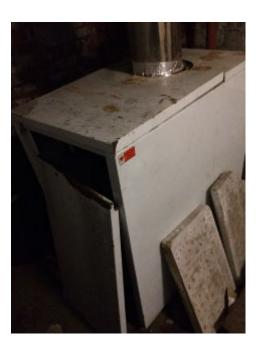
Photograph 2-4: Church Boilers

Heating is provided to the church via 3no. boilers, each serving a different area of the church. The main church space is served by an IDEAL Concord boiler located in the basement, the back of the church is heated via a Glowworm boiler and an Ideal Logic+ System 24 boiler located in the Footprints room heats the Footprints room, the chapel and the community room. The boilers are programmed on a timer to the building use schedule however manual override is possible using the 1-hour boost function, to allow the building the be heated to the desired temperature for when the demise is scheduled to be occupied. Control panels are located on each of the boilers. The temperature and the schedule are kept the same, however manual override is possible if required so that the system can be switched on outside of the programmed hours, as well as the changing of the temperature set point.

While the boilers appear to be in good order, the client may wish to explore the possibility of installing an air to water heat pump heating system in order to move towards the goal of decarbonising energy consumption.

The heating systems' pipework is generally good, however there was no insulation lagging on the pipework for either boiler. It is recommended that insulating lagging is fitted to the boilers' pipework to reduce heat loss. The pipework is evident in Photograph 2-4.

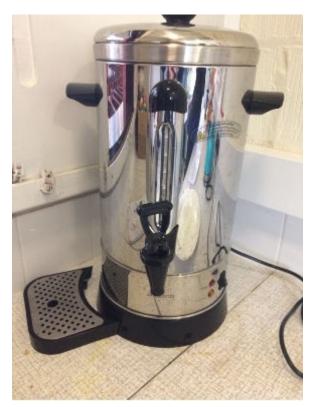
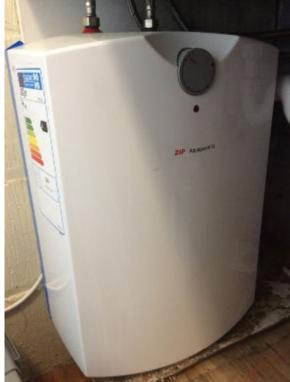
Photograph 6 & 7: Electric Point-of-Use Water Heater and Aquapoint Water Heater

Hot water is provided to the building via an Aquapoint III hot water heater, located in the kitchen, which is switched on as required. There is also an Ambiano 1650W point of use water heater in the church kitchen. Hot water consumption is considered to be nominal.

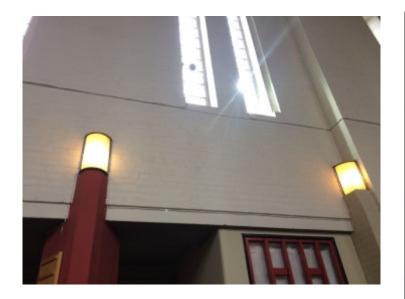
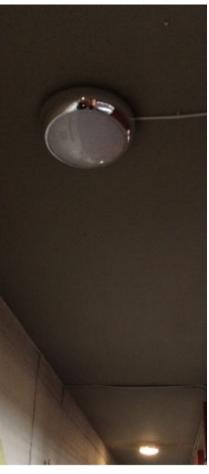
Photographs 7, 8 & 9: Church Light Fittings

There is no lighting control system, motion detectors or daylight dimming controls. All light fittings are controlled via manual on/off switches.

- ▲ 16no. 100W halogen spotlights recommended to be replaced with 12.5W LED alternatives.
- ▲ 14no. 28W uplights recommended to be replaced with 7.5W LED alternatives.
- ▲ 6no. 100W halogen floodlights recommended to be replaced with 60W LED alternatives.
- ▲ 9no. 28W compact fluorescent lamps recommended to be replaced with 7.5W LED alternatives.

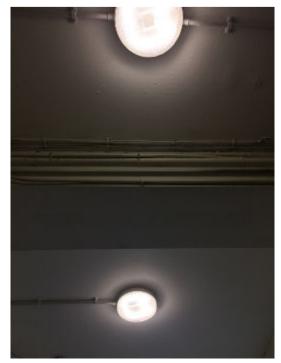
Photographs 10: Compact Fluorescent Lamps (CFLs)

▲ 5no. 28W compact fluorescent lamps – recommended to be replaced with 7.5W LED alternatives.

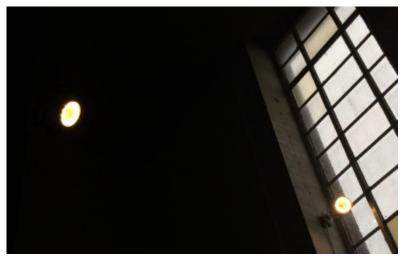
Photograph 13: Halogen Spotlights

- ▲ 4no. 100W halogen spotlights recommended to be replaced with 12.5W LED alternatives.
- ▲ 1no. 28W compact fluorescent lamps recommended to be replaced with 7.5W LED alternatives.
