## Energy Audit Report for St. Mary's Church

Site Address	St. Mary's Church, Bury, BL9 0YB
Church Code	624204
Author	Tim Mawby Graduate Consultant
Date	18 <sup>th</sup> December 2019
Version	1.0

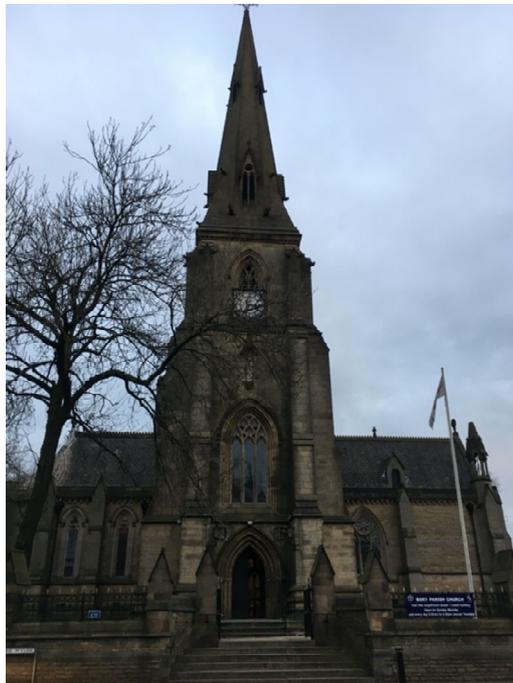
**Photograph 1: St. Mary's Church External View**

From visual inspection, the building envelope appears to be in a reasonable state of repair. It is unclear whether wall and roof insulation are present.

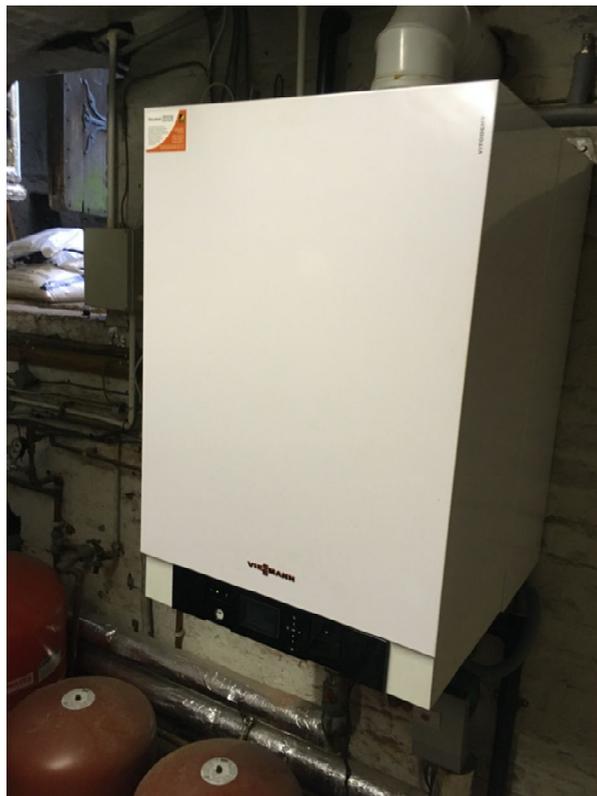
**Photograph 2: Church Boiler**

Heating is provided to the church by a Viessmann gas condensing boiler installed in 2011. The boiler is located in the basement plant room along with 2no. redundant boilers. This boiler serves all church heating and is programmed to be active for 8 hours a day, 6 days per week (not active on Mondays). Control panels are located throughout the church, allowing for manual overrides so that the system can be switched on outside of the programmed hours, as well as the changing of the temperature set point.

While the boiler appears to be in good order, and is not at the end of it's expected lifetime the client may wish to explore the possibility of installing an air source heat pump heating system in order to move towards the goal of decarbonising energy consumption.

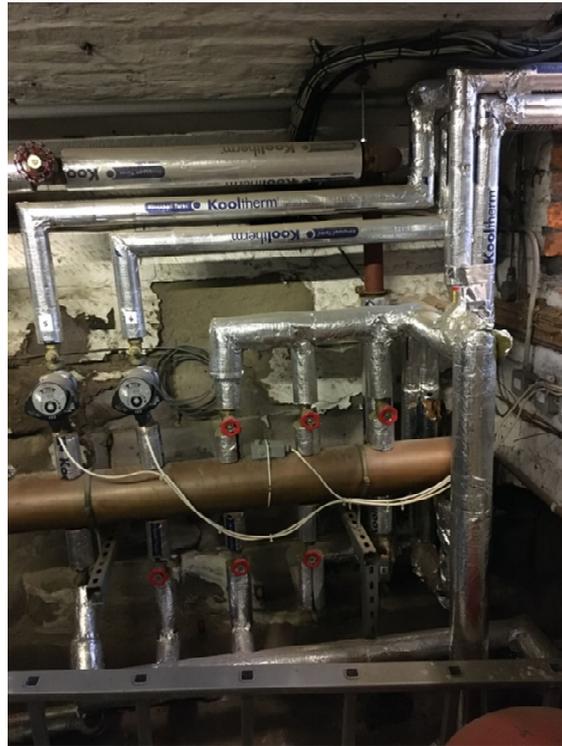
**Photograph 3: Heating Pipework**

The Main boiler's heating pipework is generally good, with insulating lagging well-maintained and in good condition. As such, no recommendations have been made in this area.

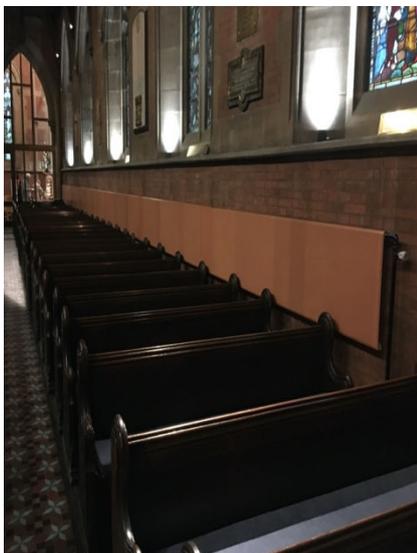
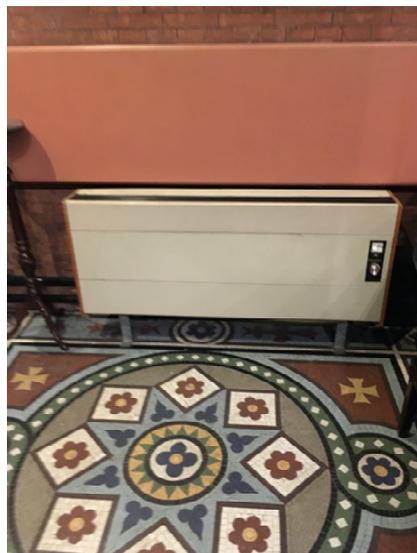
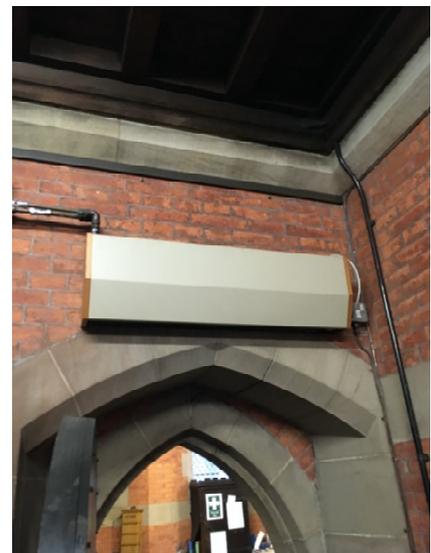
**Photographs 4, 5 & 6: Church Heat Emitters**

Heating to the church is served via 20no. cast-iron radiators, with 5no. of these enclosed in casing. There are 2no. radiators in the vestry and 3no. in the church cafe. Radiators in the main body of the church are supplied by pipes running in floor trenches covered with grilles.

2no. electric curtain heaters are located in the vestry.

A range of portable plug-in heaters are also present throughout the building and are used to provide additional heating to the smaller rooms when required. This can be an ineffective, inefficient and poorly controlled means of providing space heating, and can easily be left on when unoccupied. It is recommended that a more permanent heating solution be provided to these spaces if and when heating upgrades are undertaken.

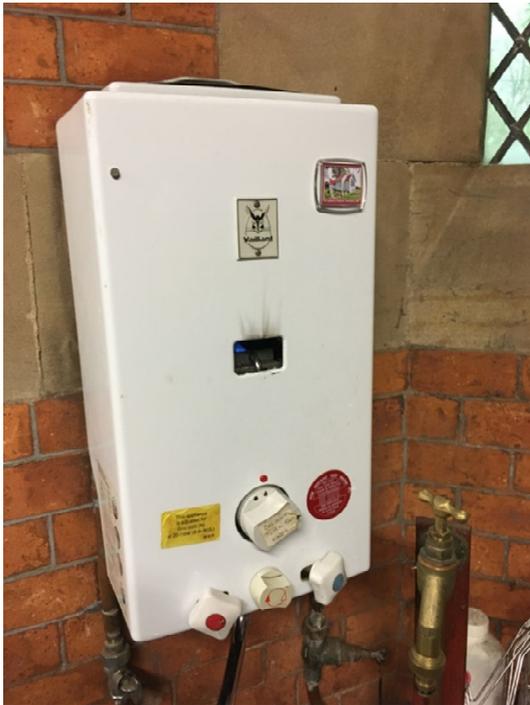
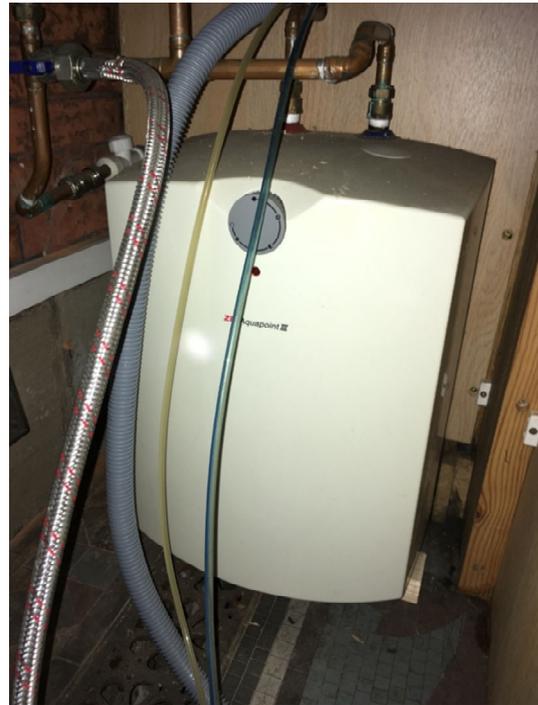
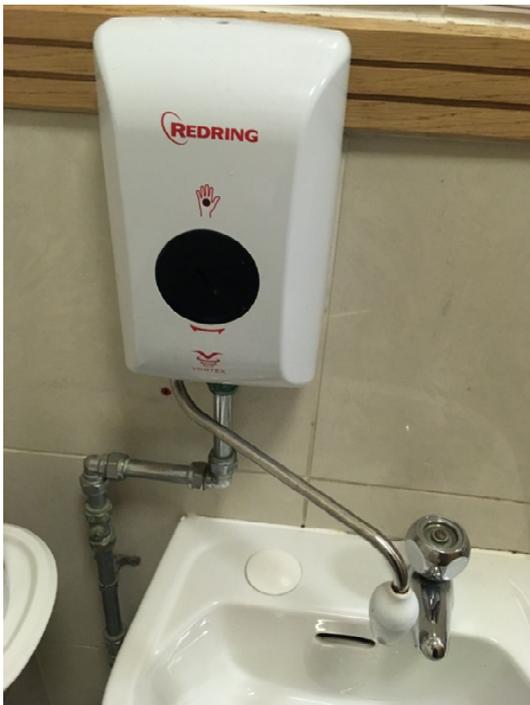
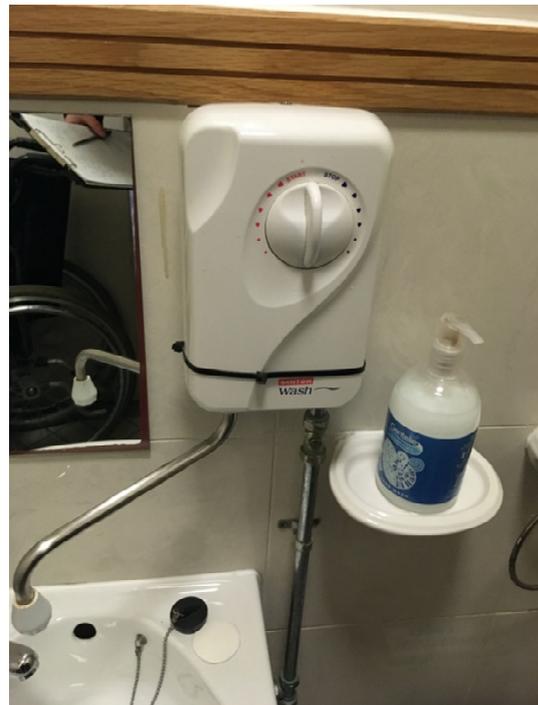
**Photographs 7, 8, 9 & 10: Water Heaters**

Hot water is provided to the vestry via a Valliant gas fired point of use water heater (photograph 7). Hot water is provided to the cafe via a Zip Aquapoint III electric water heater (photograph 8). WCs are supplied with hot water via 2no. Redring Vortex electric water heaters (photograph 9) and a Santon Wash electric water heater (photograph 10).

Hot water consumption is considered to be minimal.

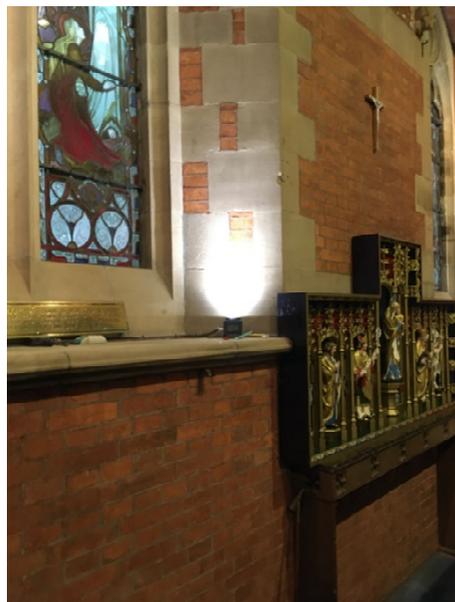
**Photographs 11, 12 & 13: Church Light Fittings**

There is no lighting control system, motion detectors or daylight dimming controls. All light fittings are controlled via manual on/off switches.

- ▲ 20no. 150W metal halide downlights (photograph 11) – recommended to be replaced with 60W LED alternatives.
- ▲ 20no. 70W metal halide uplights – recommended to be replaced with 12.5W LED alternatives.
- ▲ 14no. 75W metal halide spotlights (photograph 12) – recommended to be replaced with 12.5W LED alternatives.
- ▲ 24no. LED uplights (photograph 13).

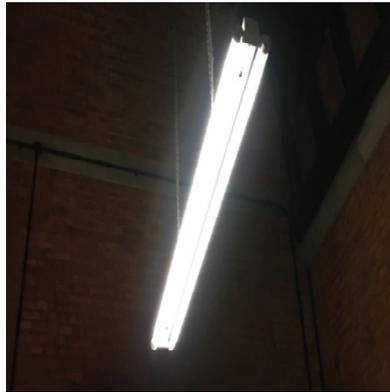
**Photograph 14: Twin Fluorescent Tube**

- ▲ 6no. twin 58W T8 fluorescent tubes – recommended to be replaced with 22W LED alternatives.

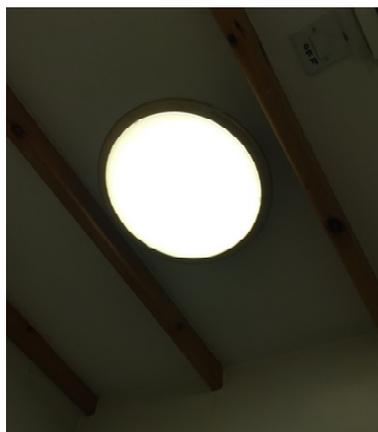
**Photograph 15: Compact Fluorescent Lamp**

- ▲ 4no. 35W compact fluorescent lamps – recommended to be replaced with 7.5W LED alternatives.
