Energy Audit Report for St. Nicholas' Church

Site Address	St. Nicholas' Church, Burnage, M19 1PL
Church Code	624168
Author	Tim Mawby Graduate Consultant
Date	17 th December 2019
Version	1.0

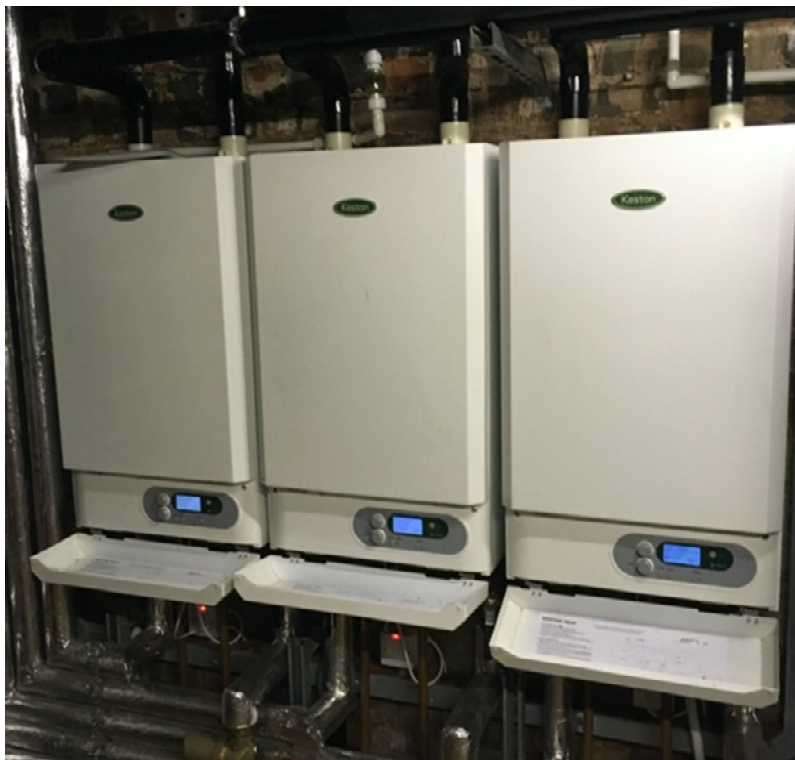
Photograph 2: Church Boilers

Heating is provided to the church via 3no. Keston gas condensing boilers (installed in 2018) located in the basement plant room. Each boiler serves a different area; the first serving the rear of the church; another serves the main body of the church, and the last serves the underfloor heating system. The boilers' heating schedule is currently programmed to be active for 40 hours per week. This is currently 10 hours longer than the building is occupied for to allow the building to be heated to the desired temperature for when the demise is scheduled to be occupied. Control panels are located throughout the church, allowing for manual overrides so that the system can be switched on outside of the programmed hours, as well as the changing of the temperature set point.

While the boiler appears to be in good order, and is not at the end of its expected lifetime the client may wish to explore the possibility of installing an air to water heat pump heating system in order to move towards the goal of decarbonising energy consumption.

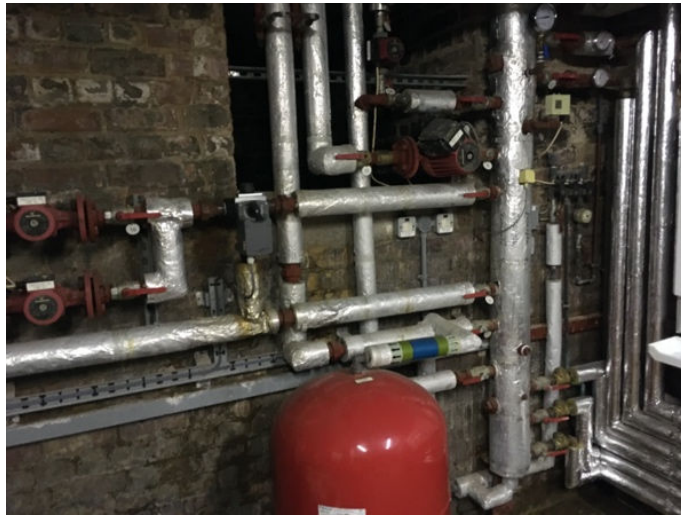
Photograph 3: Heating Pipework

The heating systems' plant room pipework is generally good, with insulating lagging in good condition. As such, no recommendations have been made in this area.

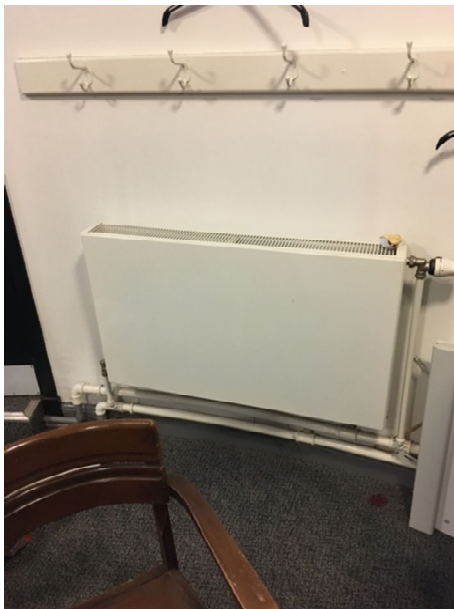
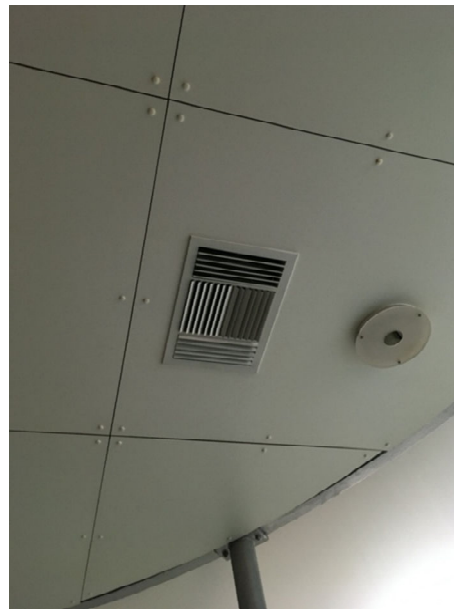
Photographs 4 & 5: Church Heat Emitters

Heating to the church is predominantly served via underfloor heating, however there are also 9no. radiators supplied by heating pipes fixed to the walls. There are also 4no. ceiling vents (photograph 5) that provide heating and ventilation to the first-floor meeting room.

A range of portable plug-in heaters are also present throughout the building and are used to provide additional heating to the smaller rooms when required. This can be an ineffective, inefficient and poorly controlled means of providing space heating, and can easily be left on when unoccupied. It is recommended that a more permanent heating solution be provided to these spaces if and when heating upgrades are undertaken.

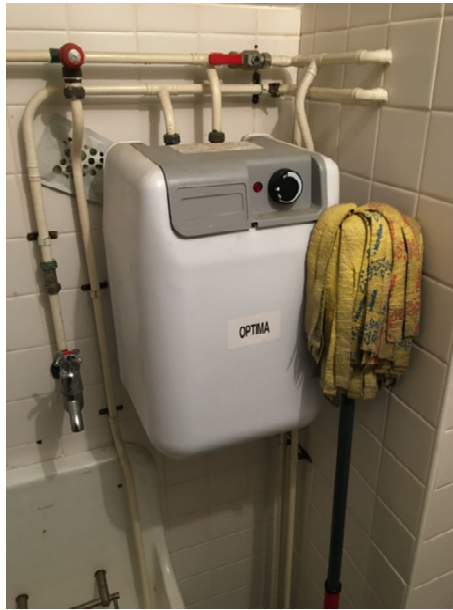
Photograph 6: Electric Water Heater

Hot water is provided to the building via 2no. Optima electric water heaters, serving kitchen and WC areas. There is also a 5-litre Instanta 1000-C electric point of use water heater located in the kitchen. Hot water consumption is considered to be nominal.

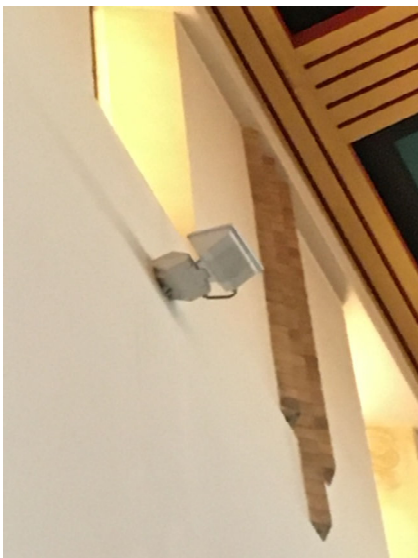
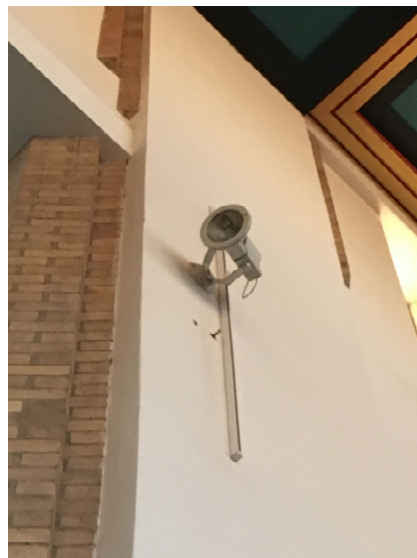
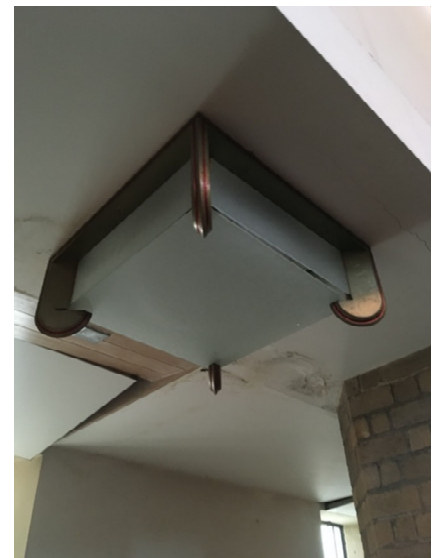
Photographs 7, 8 & 9: Church Light Fittings

There is no lighting control system, motion detectors or daylight dimming controls. All light fittings are controlled via manual on/off switches.

- ▲ 14no. 100W halogen uplights – recommended to be replaced with 12.5W LED alternatives.
- ▲ 6no. 200W halogen floodlights – recommended to be replaced with 60W LED alternatives.
- ▲ 5no. 28W compact fluorescent lamps – recommended to be replaced with 7.5W LED alternatives.
