Energy Audit Report for St. Stephen and All Martyrs Church

Site Address	St. Stephen and All Martyrs Church, Oldham, OL1 3QU
Church Code	624291
Author	Tim Mawby Graduate Consultant
Date	17 th December 2019
Version	1.0

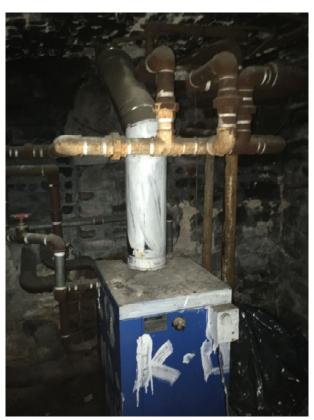
Photograph 2: Church Boiler – Disconnected

A gas fired boiler is located in the basement plant room, however this has been disconnected. There are no other boilers on-site.

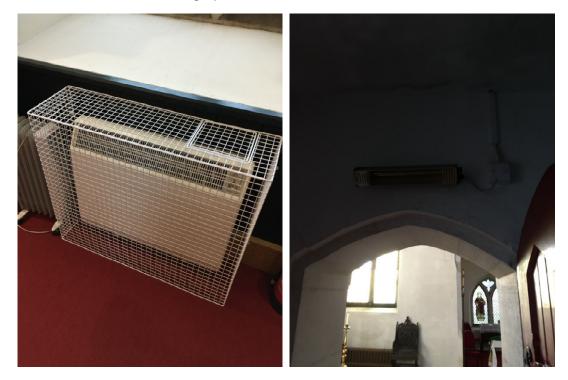
Photographs 3 & 4: Church Heat Emitters

Heating to the church is provided by 12no. plug-in electric radiators and 2no. Helios electric heaters. These are manually switched on and off when required. It is recommended that the heating timers are used to prevent the heaters being left on during unoccupied hours.

There are several cast iron radiators located in the church, however due to the gas fired boiler being disconnected, these radiators are not currently redundant.

A range of portable plug-in heaters are also present throughout the building and are used to provide additional heating to the smaller rooms when required. This can be an ineffective, inefficient and poorly controlled means of

providing space heating, and can easily be left on when unoccupied. It is recommended that a more permanent heating solution be provided to these spaces if and when heating upgrades are undertaken.

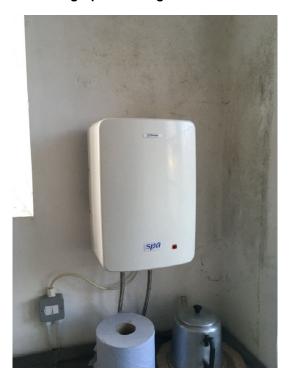
Photograph 5: Omega Water Heater

There is an Omega Spa electric water heater located in the kitchen, along with a Cygnet electric point of use water heater. There is a small, Elson electric point of use water heater in the WC. Hot water consumption is considered to be nominal.

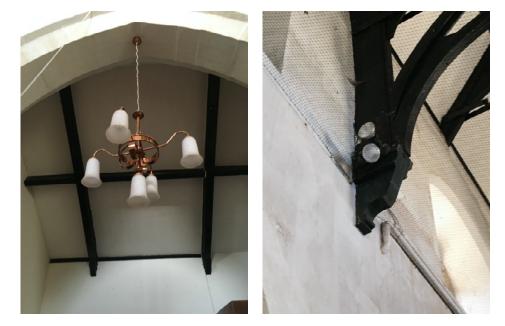
Photographs 6 & 7: Church Chandelier & LED Downlights

- ▲ 9no. chandeliers, each consisting of 5no. 20W fluorescent lamps recommended to be replaced with 3.5W LED alternatives.
- 12no. LED downlights
