Energy Audit Report for St. Thomas' Church

Site Address	St. Thomas' Church, Salford, M6 6PE
Church Code	624144
Author	Tim Mawby Graduate Consultant
Date	18 th December 2019
Version	1.0

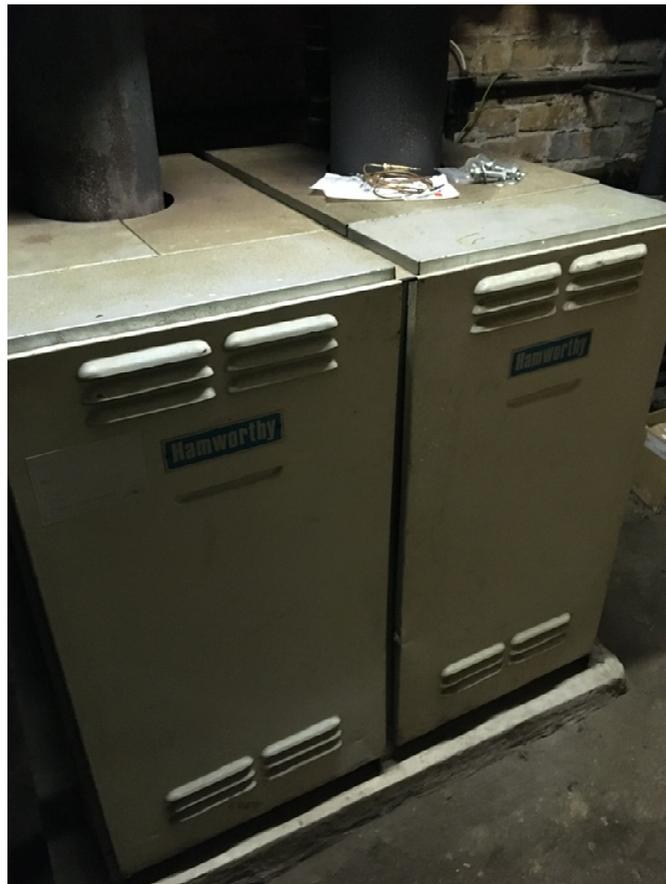
Photograph 2: Church Boilers

Heating is provided to the church via 2no. Hamworthy gas fired boilers (installed in 1976) located in the basement plant room. The boilers' heating schedule is currently programmed to be active for 14 hours per week. Control panels are located throughout the church, allowing for manual overrides so that the system can be switched on outside of the programmed hours, as well as the changing of the temperature set point. Based on this, it is assumed that the efficiency of the boiler may have dropped to as little as 60%. As such, it is recommended that the boiler is replaced with a high efficiency gas condensing boiler.

It is recommended that the existing gas boilers be replaced with modern alternatives. Additionally, the client may consider exploring the possibility of installing an air to water heat pump heating system in order to move towards the goal of decarbonising energy consumption.

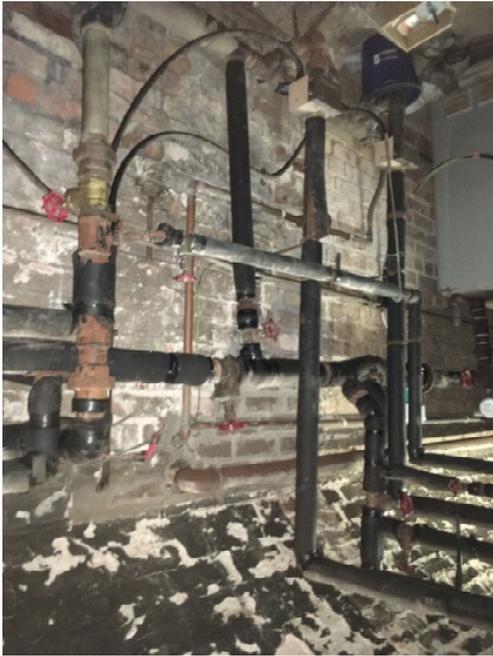
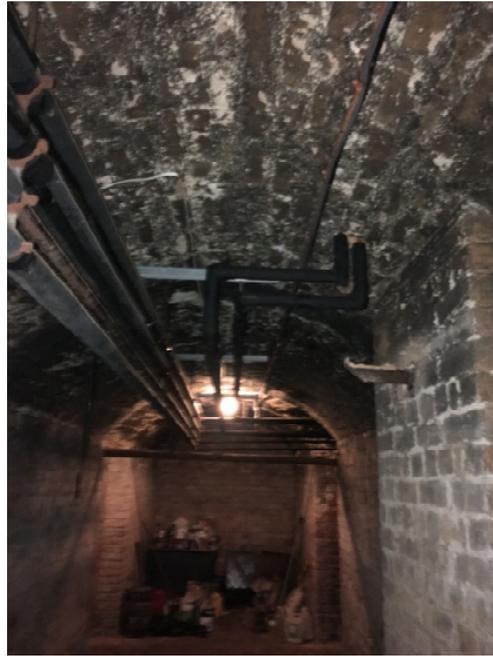
Photographs 3 & 4: Heating Pipework

The heating systems' plant room pipework is satisfactory, however some of the insulating lagging is in poor condition and sections are exposed. It is recommended that the existing lagging is removed, and the pipework is fitted with new lagging in order to reduce heat loss into the basement plant room.

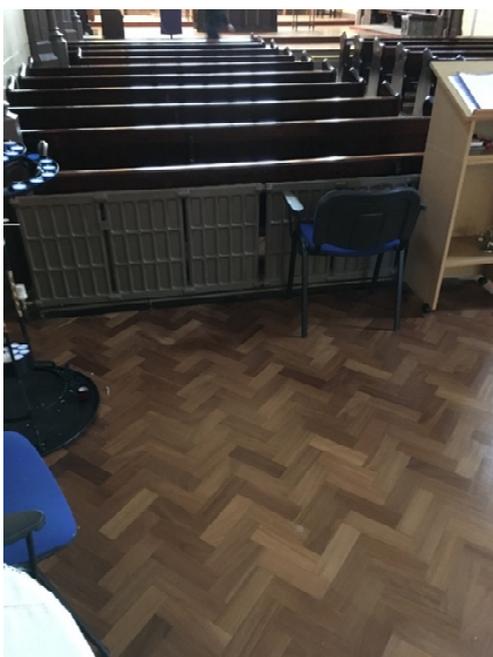
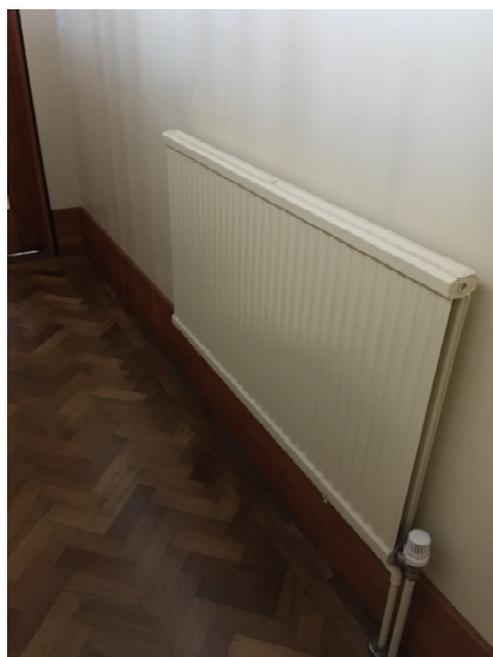
Photographs 4 & 5: Church Heat Emitters

Heating to the church is served via 8no. wall-mounted radiators. There are an additional 2no. radiators in the vestry, 4no. in the dining area, 3no. in the entrance space and 1no. in the kitchen. These radiators are supplied by heating pipes running in under the ground-floor in the basement (photograph 4). Radiators are typically obstructed by furniture which limits the effectiveness of the heating. It is advised that items are removed from the immediate vicinity to allow for better heat convection in the space.

A range of portable plug-in heaters are also present throughout the building and are used to provide additional heating to the smaller rooms when required. This can be an ineffective, inefficient and poorly controlled means of providing space heating, and can easily be left on when unoccupied. It is recommended that a more permanent heating solution be provided to these spaces if and when heating upgrades are undertaken.

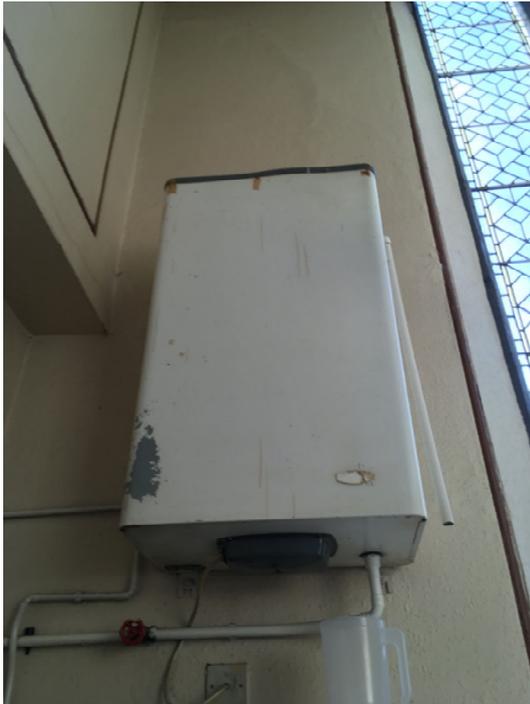
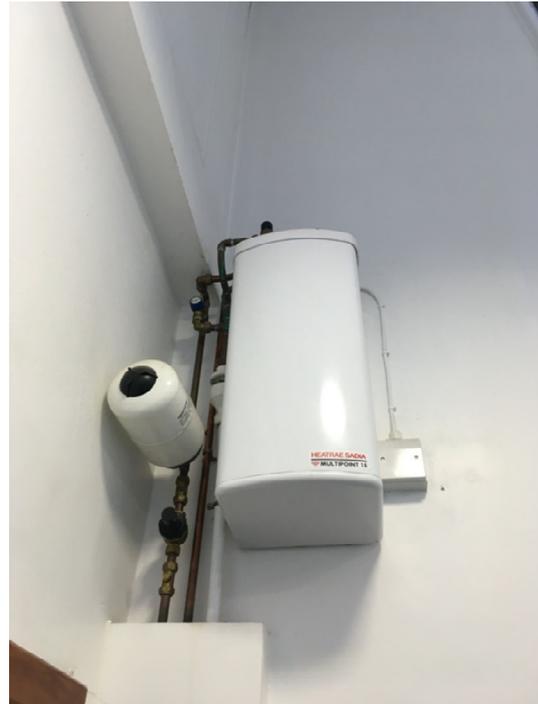
Photographs 6 & 7: Electric Water Heaters

Hot water is provided to the kitchen via a 8kW Sadia electric water heater (photograph 6). It is unclear how old the heater is, however during the site visit it was noted that the heater is in poor condition. Based on this, it is assumed that the efficiency of the heater may have dropped to as little as 60%. As such, it is recommended that it is replaced with a high efficiency electric water heater. There is also a Lincat electric point of use water heater located in the kitchen.

Hot water is provided to the WCs by a Heatrae Sadia Multipoint 15 electric water heater (photograph 7). Hot water consumption in WCs is considered to be nominal.

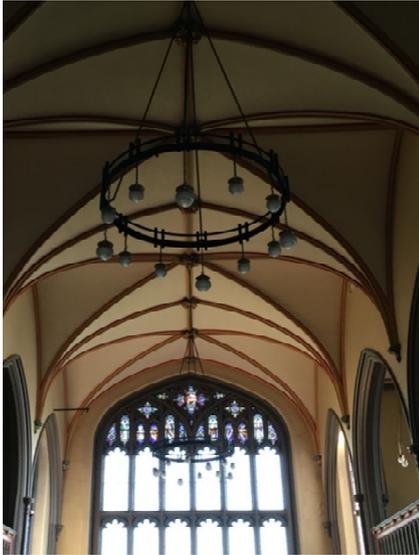
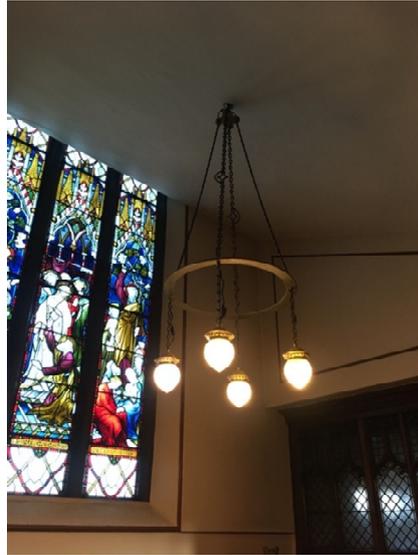
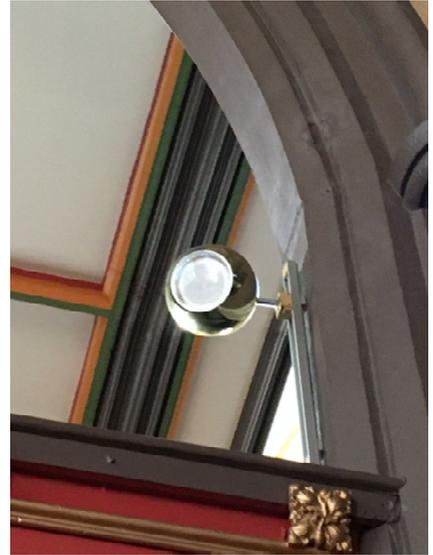
Photographs 8, 9 & 10: Church Light Fittings

- ▲ 2no. chandeliers, consisting of 12no. 25W fluorescent lamps – recommended to be replaced with 3.5W LED alternatives.
- ▲ 9no. chandeliers, consisting of 4no. 25W fluorescent lamps – recommended to be replaced with 3.5W LED alternatives.
- ▲ 4no.7.5W LED spotlights.

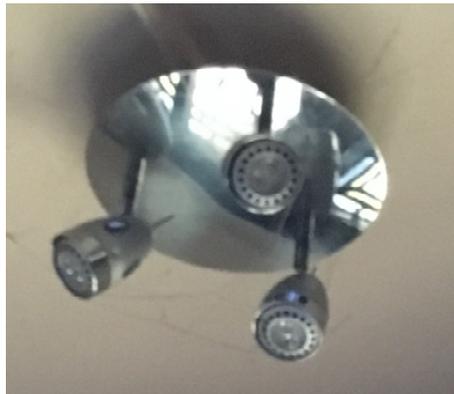
Photograph 11: LED Spotlights

- ▲ 9no. LED spotlights

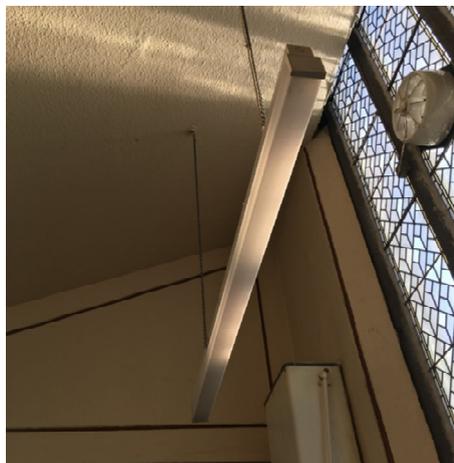
Photograph 12: Fluorescent Tube

- ▲ 2no. 58W T8 fluorescent tubes – recommended to be replaced with 22W LED alternatives.

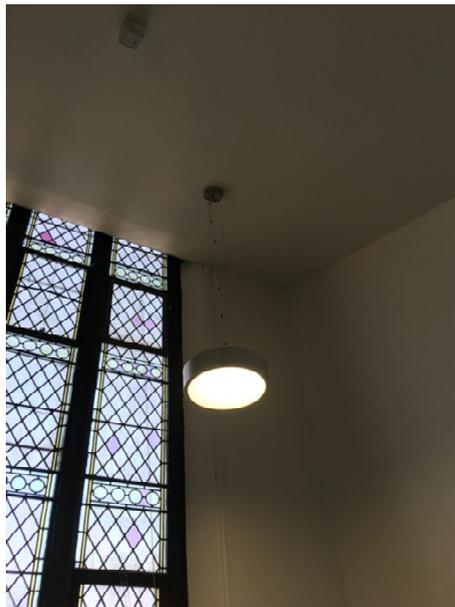
Photograph 13: LED Hanging Lamps

- ▲ 2no. 3.5W LED pendant lamps
- ▲ 5no. 58W T8 fluorescent tubes – recommended to be replaced with 22W LED alternatives.
- ▲ 1no. chandelier, consisting of 4no. 25W fluorescent lamps – recommended to be replaced with 3.5W LED alternative.
