Energy Audit Report for St. Paul's Church

Site Address	St. Paul's Church, Bolton, BL1 8BP
Church Code	624191
Author	Tim Mawby Graduate Consultant
Date	19 th December 2019
Version	1.0

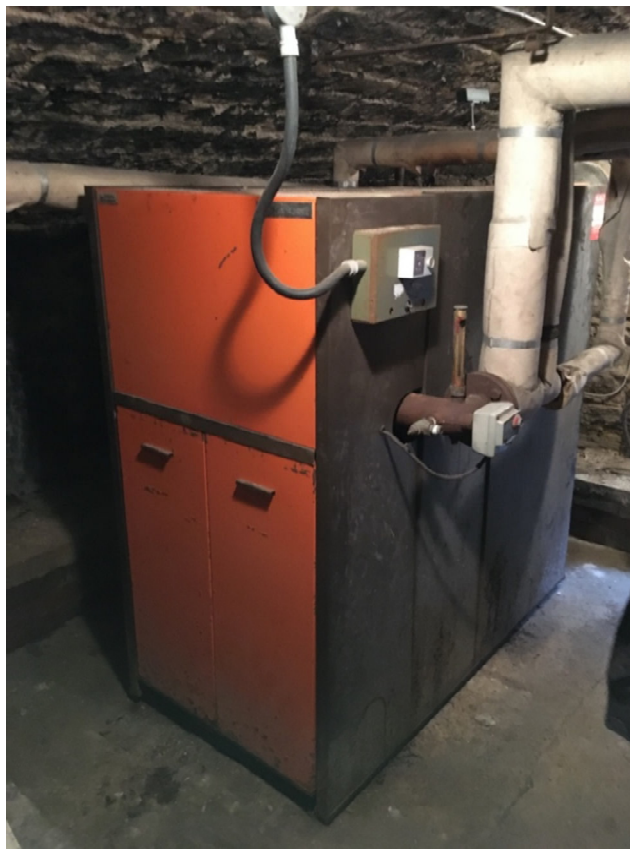
Photograph 2: Church Boiler

Heating is provided to the church by a Satronic TF1735 gas fired boiler located in the basement plant room. This boiler serves all church heating and is programmed to be active between 1:00am and 11:30am on Sundays. A control panel is located in the vestry, allowing for a manual override to provide heating outside of the programmed hours and the changing of the temperature set point. It is unclear how old the boiler on-site is, however during the site visit it was noted that the unit is approaching the end of its serviceable life, (assumed to be at least 40 years old). Based on this, it is assumed that the efficiency of the boiler may have dropped to as little as 60%. As such, it is recommended that the boiler is replaced with a high efficiency gas condensing boiler.

It is recommended that the existing gas boiler be replaced with a modern alternative. Additionally, the client may consider exploring the possibility of installing an air to water heat pump heating system in order to move towards the goal of decarbonising energy consumption.

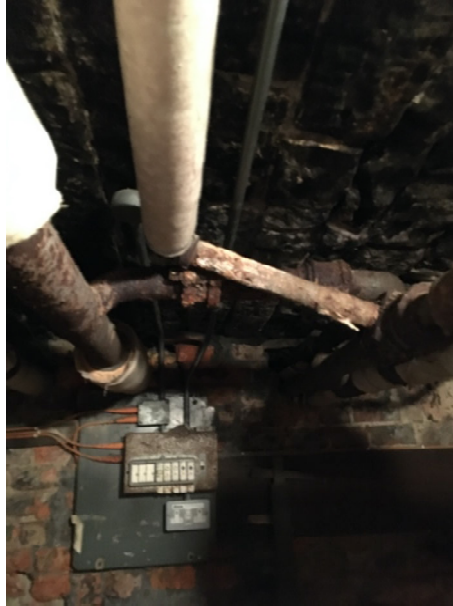
Photograph 3: Heating Pipework

The boiler's heating pipework is partially fitted with insulating lagging. However, large parts of the piping network are exposed. It is recommended that the exposed pipework is fitted with insulating lagging so that heat loss into the basement plant room is reduced.

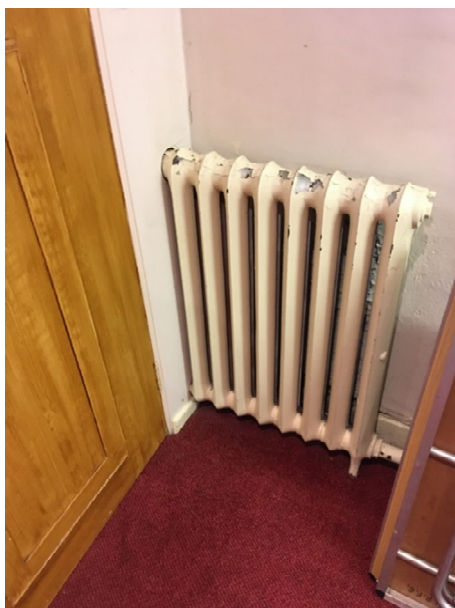
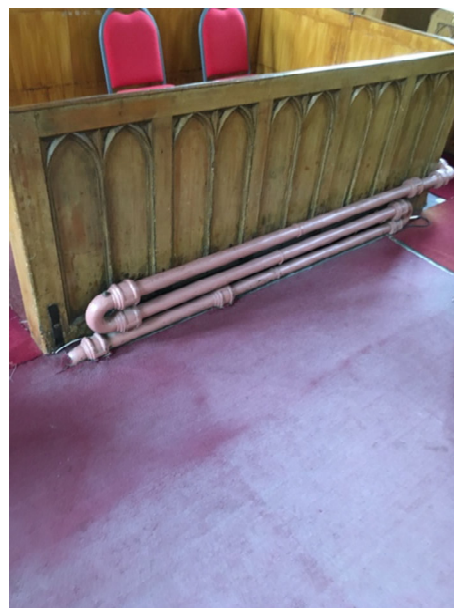
Photographs 4 & 5: Church Heat Emitters

Heating to the church is served via 8no. cast-iron radiators, supplied by pipes fixed to the walls and exposed at ground-level.

A range of portable plug-in heaters are also present throughout the building and are used to provide additional heating to the smaller rooms when required. This can be an ineffective, inefficient and poorly controlled means of providing space heating, and can easily be left on when unoccupied. It is recommended that a more permanent heating solution be provided to these spaces if and when heating upgrades are undertaken.

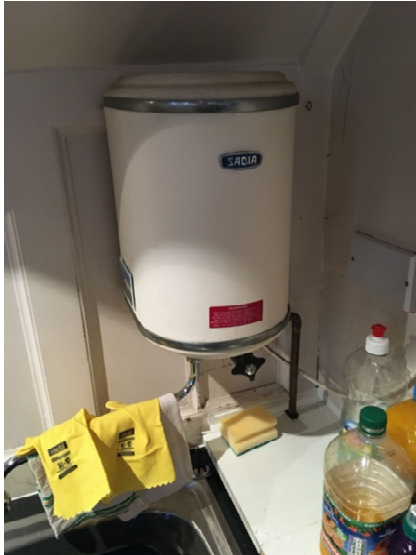
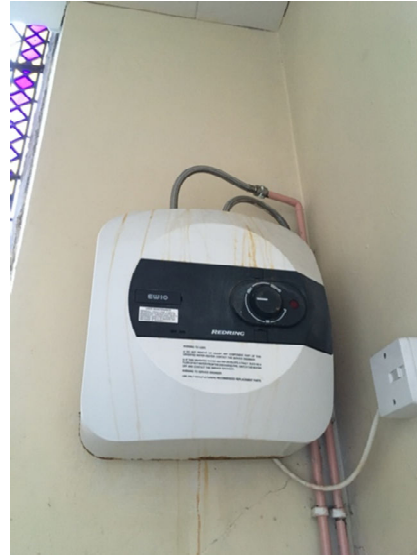
Photographs 6 & 7: Water Heaters

Hot water is provided to the kitchen by a Sadia electric point of use water heater. WCs are supplied with hot water by a Redring EWIO electric water heater. Hot water consumption is considered to be minimal.

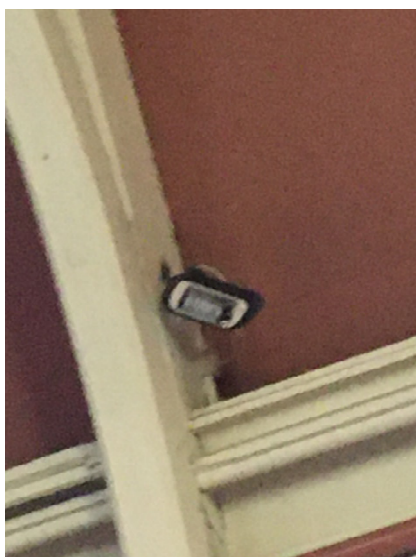
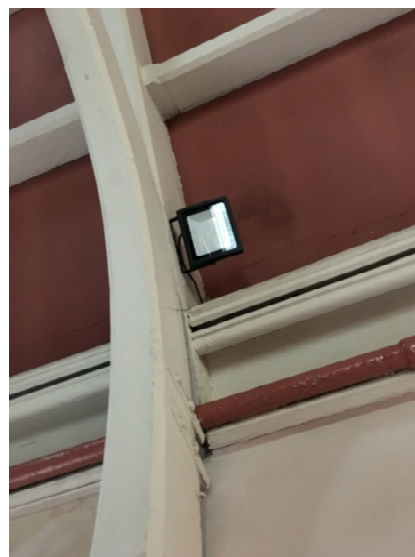
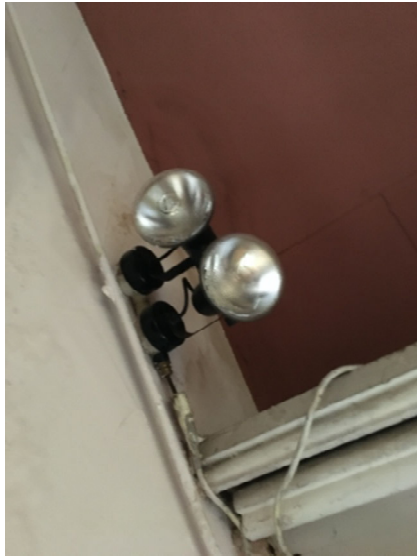
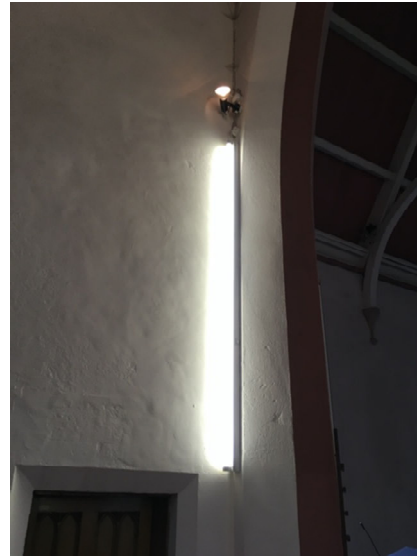
Photographs 8, 9, 10 & 11: Church Light Fittings

There is no lighting control system, motion detectors or daylight dimming controls. All light fittings are controlled via manual on/off switches.

- ▲ 14no. 500W halogen floodlights (photograph 8) – recommended to be replaced with 60W LED alternatives.
- ▲ 2no. LED floodlights (photograph 9)
- ▲ 6no. 50W halogen spotlights (photograph 10) – recommended to be replaced with 7.5W LED alternatives.
- ▲ 2no. 100W T12 fluorescent tubes (photograph 11) – recommended to be replaced with 30W LED alternatives.

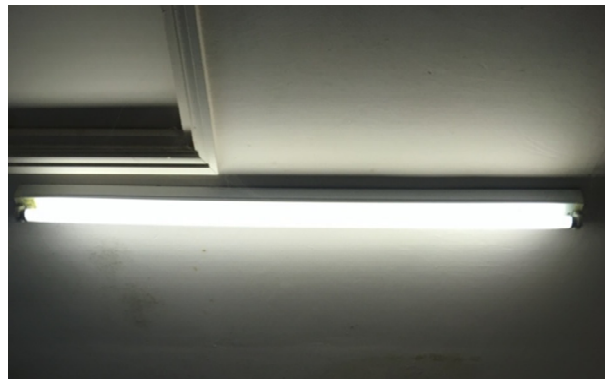
Photograph 12: Compact Fluorescent Lamps

- ▲ 1no. 58W T8 fluorescent tube – no recommendation due to nominal energy consumption.

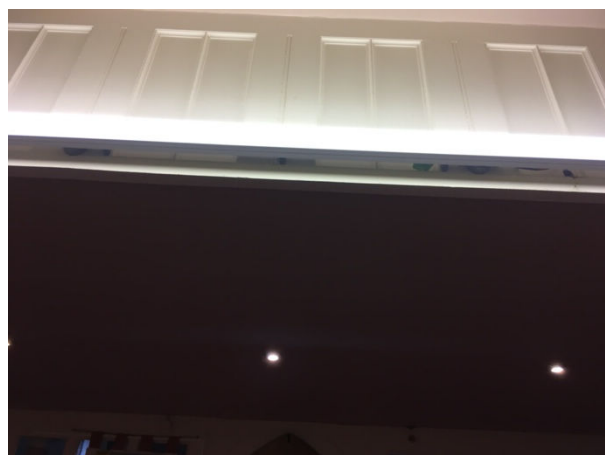
Photograph 13: Entrance Lighting

- ▲ 2no. 100W T12 fluorescent tubes – recommended to be replaced with 30W LED alternatives.
- ▲ 9no. 25W fluorescent spotlights – recommended to be replaced with 3.5W LED alternatives.
