Energy Audit Report for St. Marys Church Heworth

Site Address	St Mary's Church Heworth, NE10 0PA
Church Code	613076
Author	Tim Mawby Graduate Consultant
Date	16 th December 2019
Version	1.0

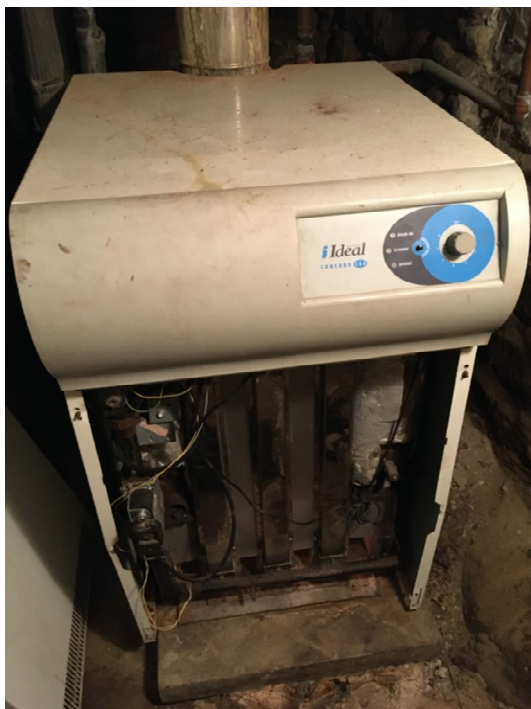
Photographs 2 & 3: Church Boilers

Heating is provided to the Church via an Ideal Concord CXA gas fired boiler (photograph 2), stored in the basement plant room. This boiler is operational for approximately 11 hours per week and can be manually overridden to provide additional heating. During the site visit it was noted that the unit is approaching the end of its serviceable life, (assumed to be at least 15 years old). Based on this, it is assumed that the efficiency of the unit may have dropped to as little as 60%.

Energy Saving Measure	Annual Energy Savings (kWh)	Annual Cost Savings (£)	Estimated Capital Cost	Payback Period (Years)	Annual Carbon Savings (Tonnes CO ₂ e)
Replace the older existing boiler (photograph 2) with a new condensing gas boiler (90% efficiency)	17,689	£373	£6,000	2.9	16.0
Install insulating lagging to the boilers' pipework (estimated 3% saving)	1,769	£37	£200	5.4	0.4
Church - replace 4x20W chandeliers with 3.5W LED alternatives	463	£62	£300	4.4	0.1
Church - replace 200W halogen floodlights with 60W LED alternatives.	262	£35	£200	5.7	<0.1
Church - replace 20W bulbs with 3.5W LED alternatives.	62	£8	£40	5.0	<0.1
Church - replace 25W spotlights with 7.5W LED alternatives.	74	£10	£45	4.5	<0.1
Church - replace twin 58W T8 fluorescent tubes with 22W LED alternatives.	67	£9	£40	4.4	<0.1
Vestry - replace 20W lamps with 3.5W LED alternatives.	23	£3	£15	5.0	<0.1
Vestry - replace twin 58W T8 fluorescent tubes with 22W LED alternatives.	67	£9	£40	4.4	<0.1

It is recommended that the existing Ideal Concord CXA gas boiler be replaced with a modern alternative. Additionally, the client may consider exploring the possibility of installing an air source heat pump heating system in order to move towards the goal of decarbonising energy consumption.

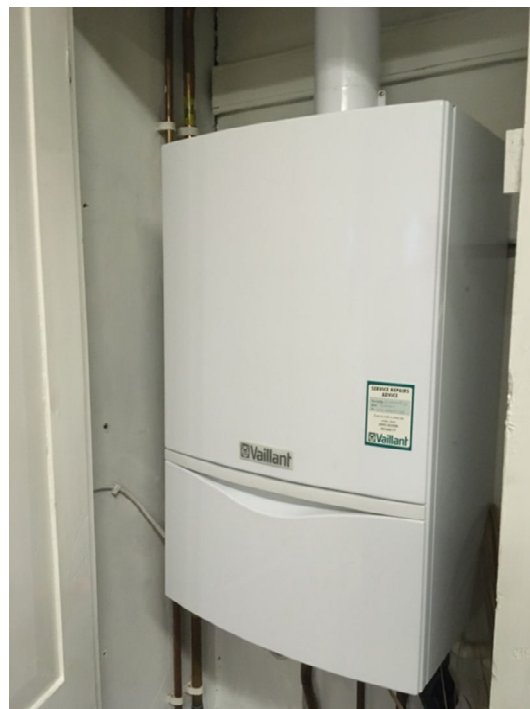
A second, Valliant gas condensing boiler (photograph 3) is located in the vestry. This system serves the vestry and was installed within the last 5 years. This boiler is controlled using a control panel located in the vestry and is operational for approximately 4 hours per week.

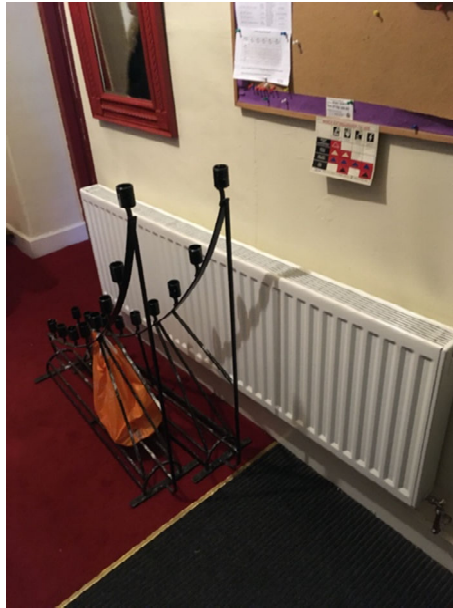
Photograph 4: Church Radiators

Heating to the church is served via 4no. twin panel radiators. These radiators are supplied by heating pipes fixed to the walls. Wall-mounted heaters supply heat to the vestry and entrance.

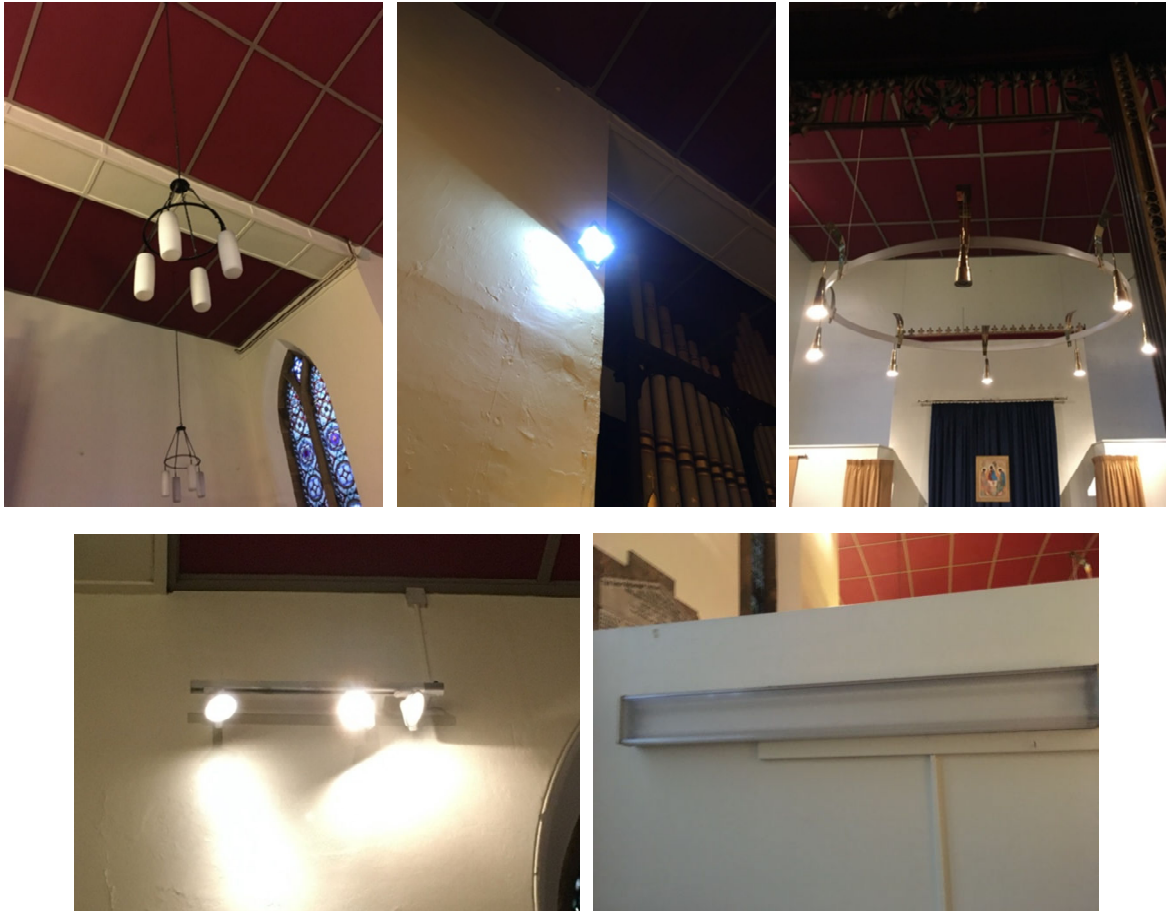
Photographs 5, 6, 7, 8 & 9: Church Lighting

There is no lighting control system, motion detectors or daylight dimming controls. All light fittings are controlled via manual on/off switches, in a panel in the office.

- ▲ 15no. chandeliers, each consisting of 4no. 20W bulbs (photograph 5) – recommended to be replaced with 3.5W LED alternatives.
- ▲ 4no. 200W halogen floodlights (photograph 6) – recommended to be replaced with 60W LED alternatives.
- ▲ 8no. 20W bulbs (photograph 7) – recommended to be replaced with 3.5W LED alternatives.
- ▲ 9no. 25W spotlights (photograph 8) – recommended to be replaced with 7.5W LED alternatives.
- ▲ 2no. twin 58W T8 fluorescent tubes (photograph 9) – recommended to be replaced with 22W LED alternatives.

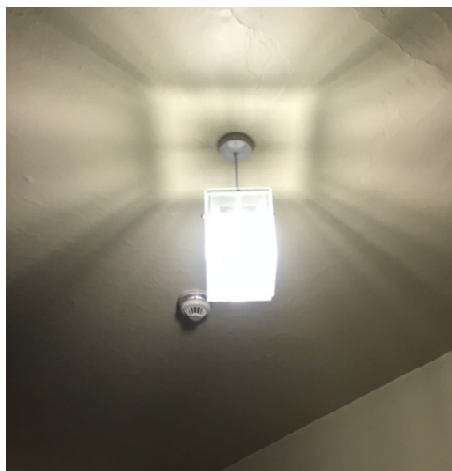
Photograph 10: Pendant Lamps

- ▲ 3no. 20W lamps – recommended to be replaced with 3.5W LED alternatives.
- ▲ 2no. twin 58W T8 fluorescent tubes – recommended to be replaced with 22W LED alternatives.

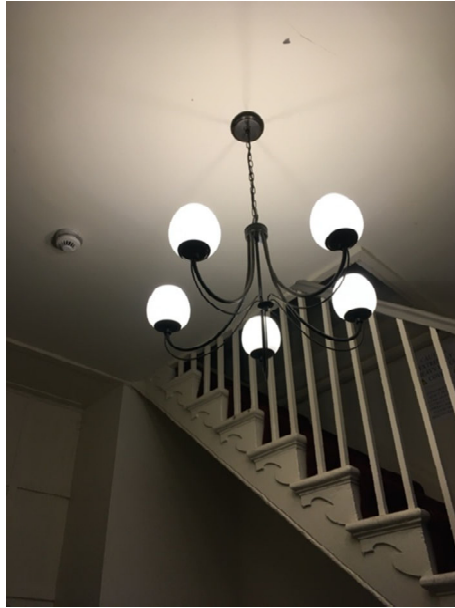
Photograph 11: LED Pendant Lamps

- ▲ 1no. chandelier, consisting of 5no. LED lamps.
