Energy Audit Report for St. Michael & All Angels Church

Site Address	St. Michael & All Angels Church, Houghton le Spring, DH4 4DN
Church Code	613099
Author	Tim Mawby Graduate Consultant
Date	3 rd December
Version	1.0

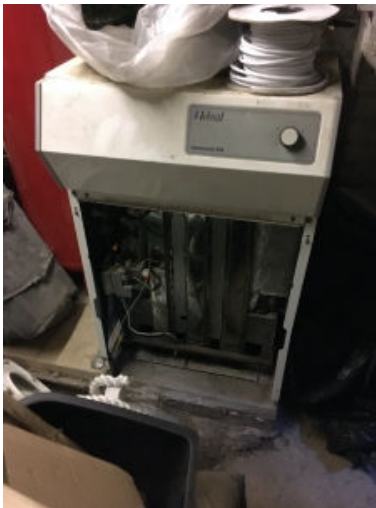
Photographs 2, 3 & 4: Church Boilers

Heating is provided to the church via 4no. boilers. A gas fired Ideal Concord CX boiler (photograph 2) is located in the plant room. It is unclear how old the boiler on-site is, however during the site visit it was noted that the unit is approaching the end of its serviceable life, (assumed to be 20 years old). Based on this, it is assumed that the efficiency of the boiler may have dropped to as little as 60%. As such, it is recommended that the boiler is replaced with a high efficiency gas condensing boiler.

Category	Actions	Potential Annual Savings			Investment (£)	Simple payback (yrs.)
		Elec/Gas (kWh)	Cost (£)	(tCO ₂)		
Heating	Replace the older existing boiler (photograph 2) with a new condensing gas boiler (90% efficiency)	10,918	£326	2.3	£1,100	3.4
Lighting	Chapel - replace 25W CFLs with 7.5W LED alternatives	273	£46	0.1	£125	2.7
Lighting	Vestry - replace 58W fluorescent tubes with 22W LED alternatives	90	£15	<0.1	£40	2.7
Lighting	Vestry - replace 25W CFLs with 3.5W LED alternatives	40	£7	<0.1	£15	2.1
Lighting	Office - replace 58W fluorescent tubes with 22W LED alternatives	90	£15	<0.1	£40	2.7
Lighting	Heritage Centre - replace 25W CFLs with 3.5W LED alternatives	81	£14	<0.1	£30	2.1
TOTAL ELECTRICITY SAVINGS		574	£97	0.2	£250	2.6
TOTAL GAS SAVINGS		10,918	£326	2.3	£1,100	3.4
GRAND TOTAL		11,492	£423	2.5	£1,350	3.2

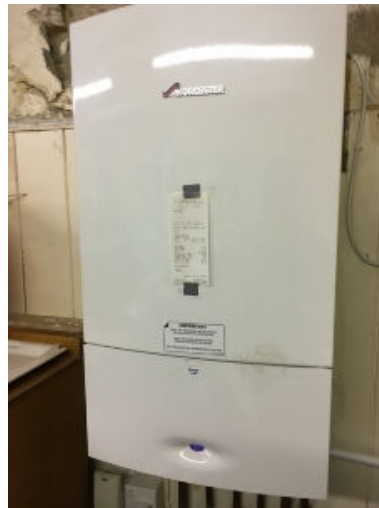
A Worcester gas combination boiler (photograph 3) was installed in 2009 and is located in the vestry. This boiler has been programmed to operate for 2-hours per day.

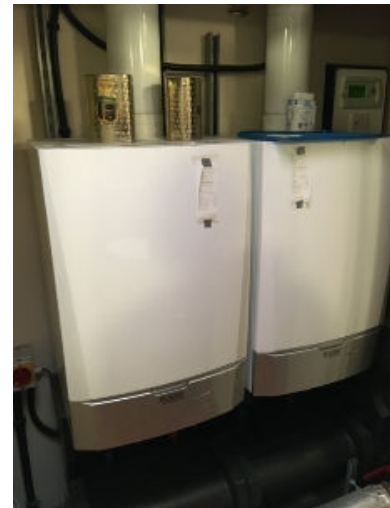
2no. 60kW Remeha gas combination boilers (photograph 4) were installed in a cupboard in the back of house entrance in 2015. These serve the main church area. These boilers are operated via a control panel situated in the vestry, where a timer is programmed to turn the boilers on depending on the planned weekly occupancy hours. The boilers' controls allow for a manual override so that they can be switched on outside of these hours. As such, no recommendations have been made in this area.

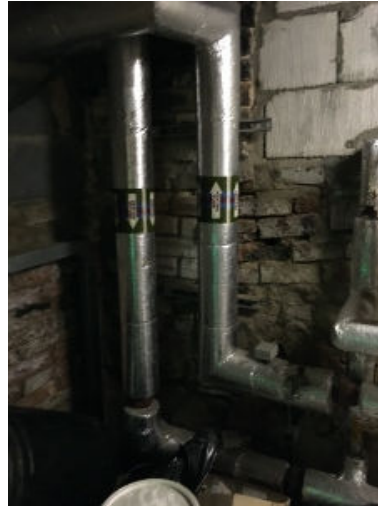
Photograph 5: Heating Pipework

The heating systems' plant room pipework is generally good, with insulating lagging in good condition. As such, no recommendations have been made in this area.

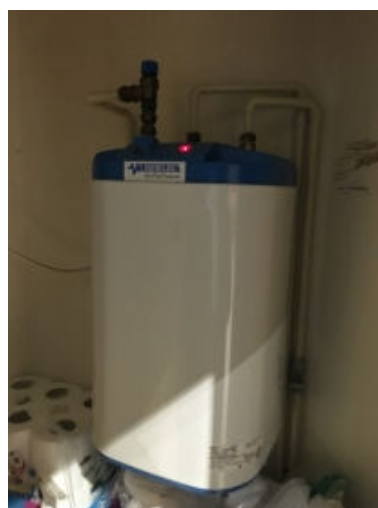
Photograph 5: Electric Water Heater

Hot water is supplied to the building via a Newlec electric water heater. This supplies kitchen and WC areas. A Zip Hydroboil electric point of use water heater is also present in the kitchen. Hot water usage is considered to be nominal.

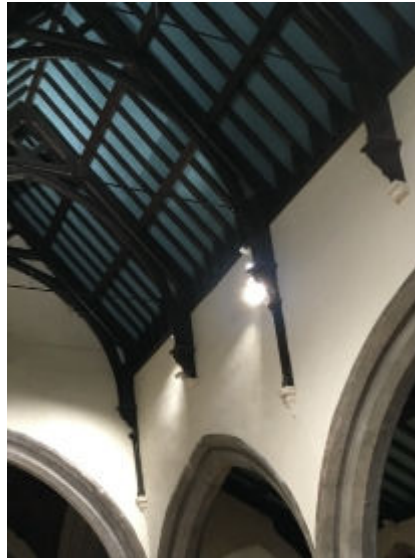
Photograph 6: Compact Fluorescent Lamps

- ▲ Approximately 25no. 25W compact fluorescent lamps – recommended to be replaced with 3.5W LED alternatives.

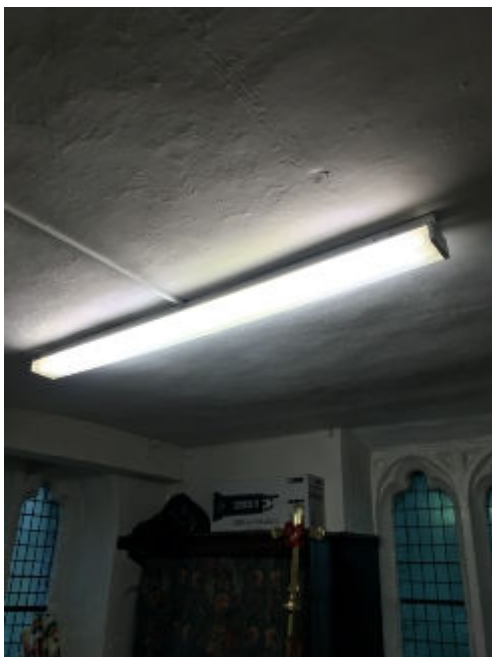
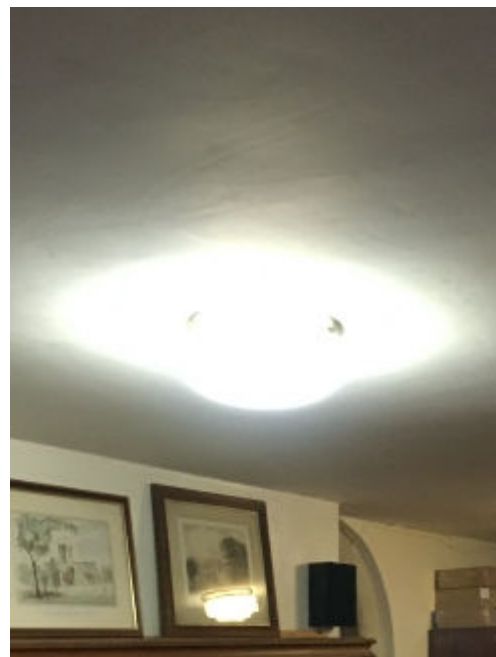
Photographs 7 & 8: Fluorescent Tubes

- ▲ 4no. 58W fluorescent tubes – recommended to be replaced with 22W LED alternatives.
- ▲ 3no. 25W compact fluorescent lamps – recommended to be replaced with 3.5W LED alternatives.

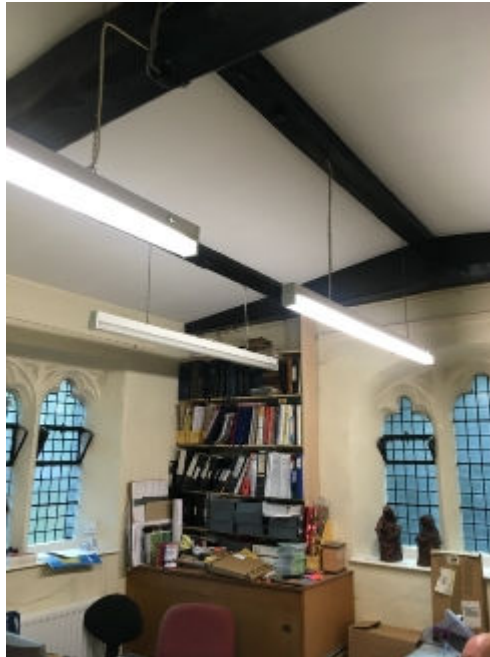
Photograph 9: Fluorescent Tubes

- ▲ 4no. 58W fluorescent tubes – recommended to be replaced with 22W LED alternatives.

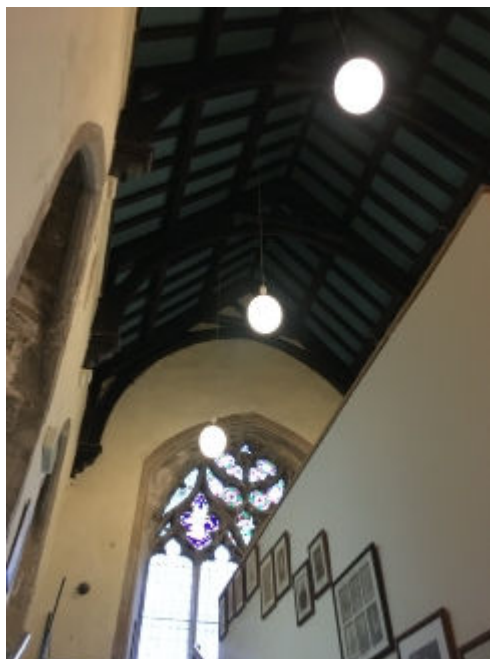
Photograph 9: Fluorescent Lamps

- ▲ 6no. 25W fluorescent lamps – recommended to be replaced with 3.5W LED alternatives.
