# Energy Audit Report for Stockton St. Peter's Church

| Site Address | Stockton St. Peter's Church, TS18 3PJ |
| Date | 13 <sup>th</sup> December 2019 |

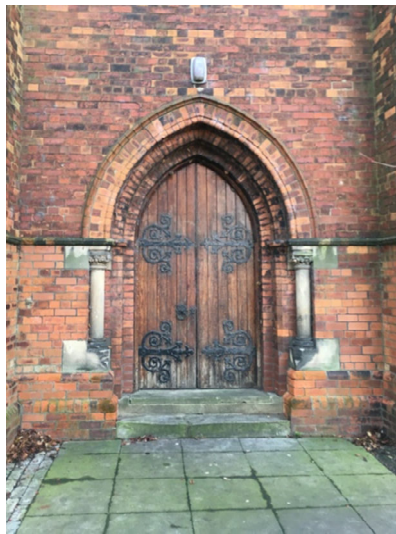
**Photograph 2: Sealed Entrance**

From visual inspection, the majority of the building envelope appears to be in a reasonably good state of repair, however there is no roof or wall insulation. The building's original entrance was sealed shut; however the condition of the seal is deteriorating, leading to a draft entering the building. It is recommended that this is resealed.

| Category | Actions | Potential Annual Savings | | | Investment (£) | Simple payback (yrs.) |
|---|---|---|---|---|---|---|
| Heating | Replace or repair the sealing on the original church entrance pipework (estimated 5% saving) | 4,050 | £168 | 0.8 | £100 | 0.6 |

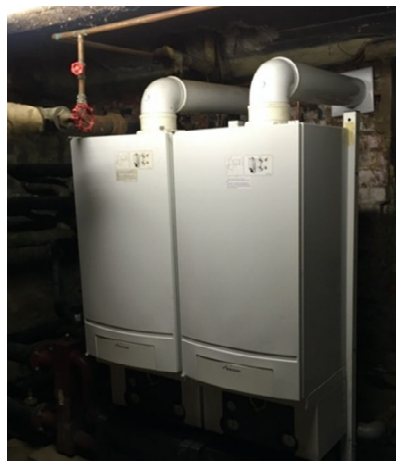
**Photograph 3: Gas Combination Boilers**

Heating is provided to the church via 2no. Worcester combination boilers (installed in 2014) located in the basement plant room. The boilers are operated by a control panel situated in the vestry, where a timer has been set to turn the boilers on between 12:00 and 14:00. The boilers' controls allow for a manual override so that they can be switched on outside of these hours.

The existing boilers are well within their expected operating life, and so are not required to be replaced in the near future, however the client may wish to explore the possibility of installing an air to water heat pump heating system in order to move towards the goal of decarbonising energy consumption.

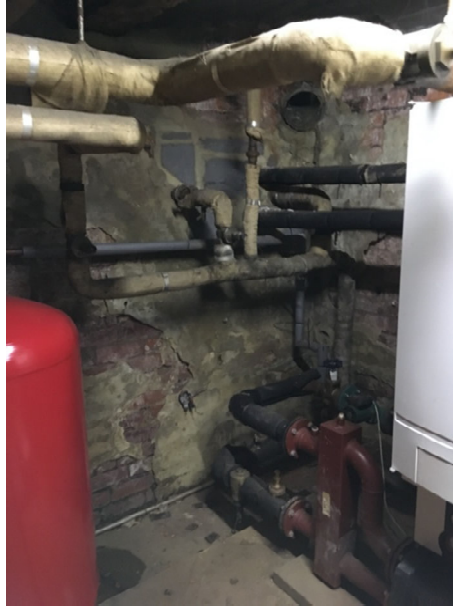
**Photograph 4: Heating Pipework**

Portions of heating system pipework in the basement plant room are entirely exposed. Where pipework is insulated, this is aging and in poor condition in parts. It is recommended that insulating lagging is installed to the exposed pipework, and existing pipework lagging be replaced to reduce heat loss into the plant room.

| Category | Actions | Potential Annual Savings | | | Investment (£) | Simple payback (yrs.) |
|---|---|---|---|---|---|---|
| Heating | Install insulating lagging to exposed heating pipework (estimated 3% saving) | 2,430 | £101 | 0.5 | £200 | 2.0 |

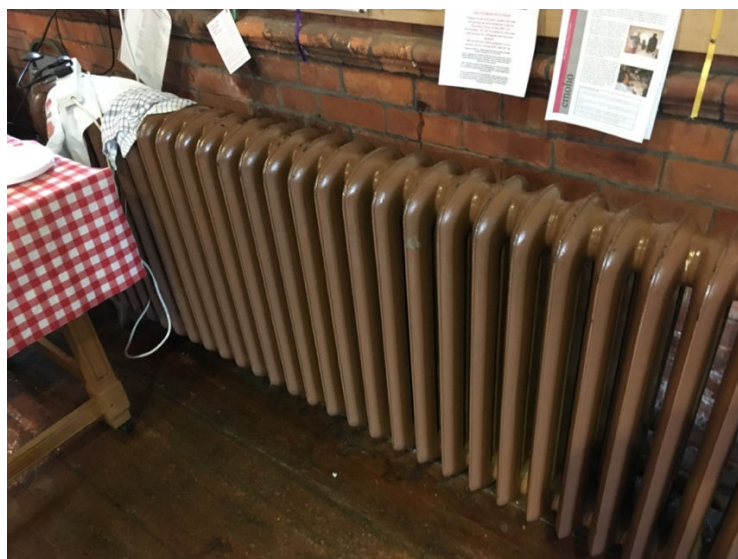
**Photograph 5: Church Radiators**

Heating to the church is served via 20no. cast iron radiators. These radiators are supplied by heating pipes running in floor trenches covered with grilles. Radiators are partially obstructed by furniture which limits the effectiveness of the heating. It is advised that items are removed from the immediate vicinity to allow for better heat convention in the space.

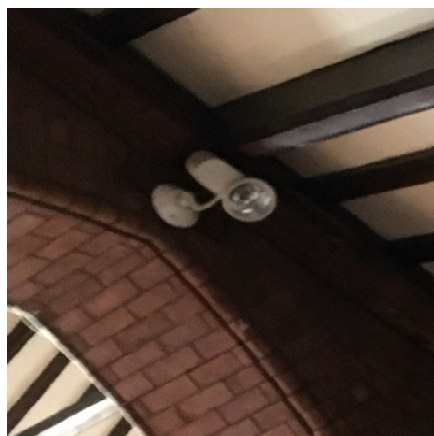
**Photograph 6: Compact Fluorescent Lamps**

- ▲ Approximately 24no. 25W compact fluorescent lamps – recommended to be replaced with 3.5W LED alternatives.

| Category | Actions | Potential Annual Savings | | | Investment (£) | Simple payback (yrs.) |
|---|---|---|---|---|---|---|
| Lighting | Chapel – replace 25W CFLs with 3.5W LED alternatives. | 564 | £81 | 0.2 | £120 | 1.5 |

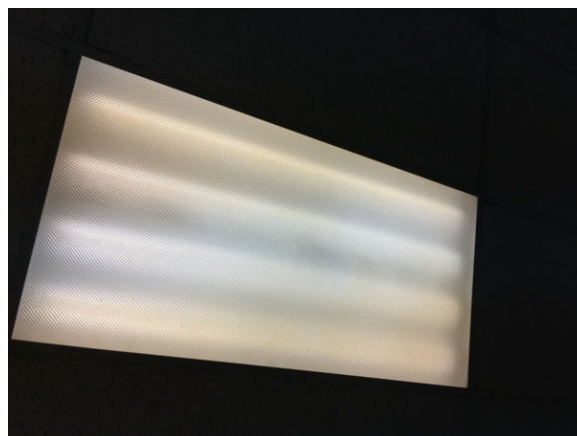
**Photograph 7: Fluorescent Panels**

- ▲ 4no. fluorescent panels (each containing 4no. 58W fluorescent tubes)– recommended to be replaced with 22W LED alternatives.

| Category | Actions | Potential Annual Savings | | | Investment (£) | Simple payback (yrs.) |
|---|---|---|---|---|---|---|
| Lighting | Office – replace 4x58W fluorescent tubes with 22W LED alternatives. | 629 | £91 | 0.2 | £160 | 1.8 |
