project no: **18138**  
project: **Church St James the Great**  
site: **Lower Leigh Road, Westthoughton**

visit no: **005**  
purpose of visit: **Site Inspection**  
date/ time of visit: **13/11/19 9.30am**  
visit by: **Victoria Alderton**  
contractor's rep: **Andy Sharp**

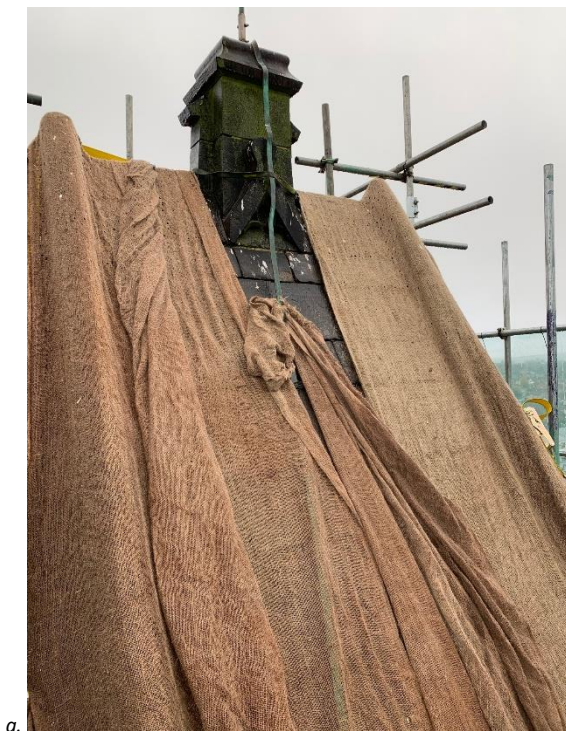
Work has progressed in earnest on the repointing; however, a spell of particularly wet weather has delayed progress, particularly at the top of the turret where it is to exposed to the elements to continue in the rain, and protection to joints has been necessary. (*image a.*)

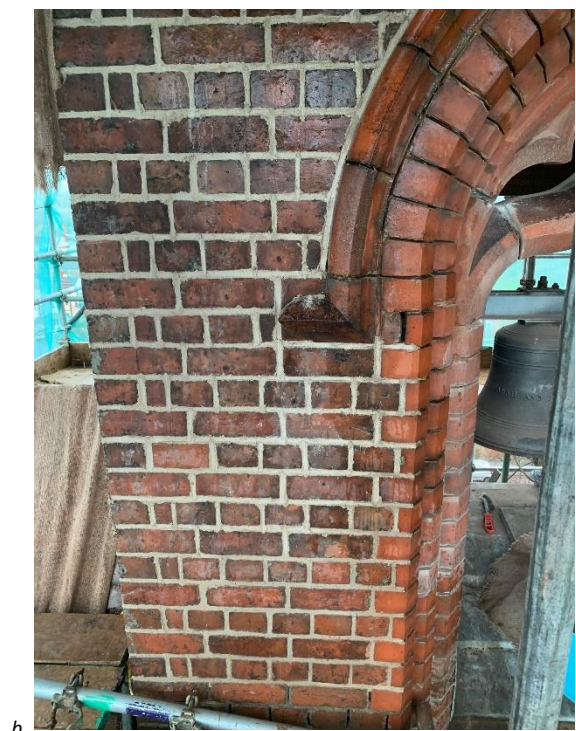
Repointing at lower levels where the scaffold provides some protection to the elements has continued at pace. However, the wet weather means it is taking longer for the pointing to dry sufficiently for brushing off and cleaning down (*image b., c., d., e., & f.*). All replacement bricks have now been installed, delivery of the replacement terracotta units is still awaited.
