Energy Efficiency and Zero Carbon Advice

St Stephen's Church, Colchester **PCC of St Stephen's Church**

Author	Reviewer	Audit Date	Version
Paul Hamley	Ian Shellard	21 st January 2023	1.0

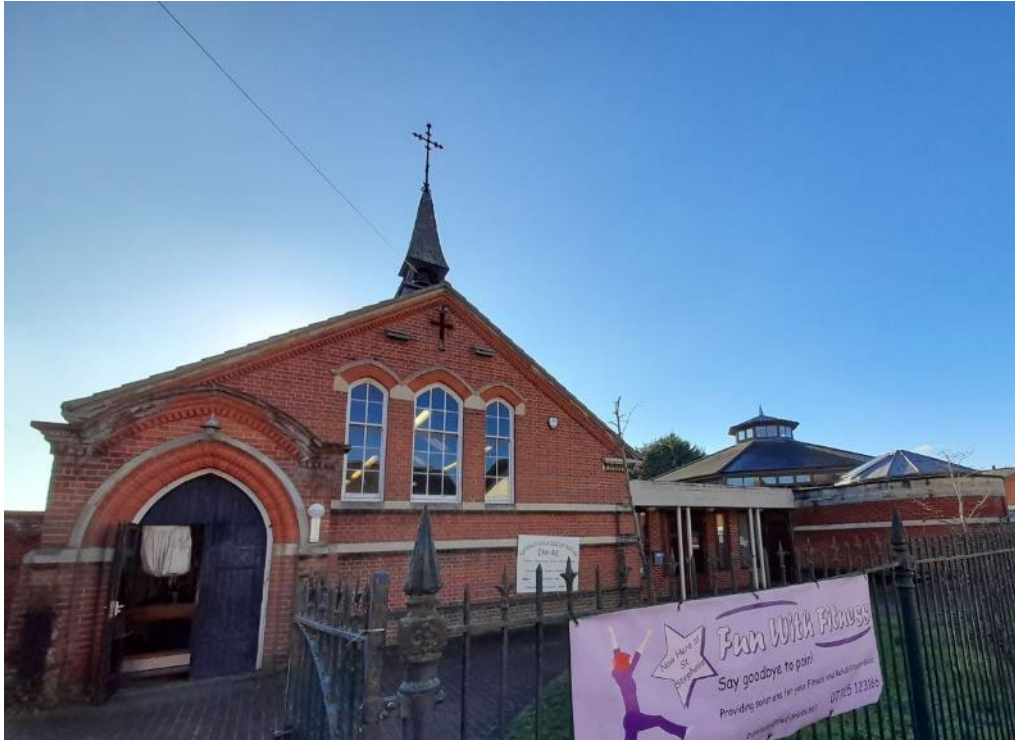
View with the 1902 hall to the left, which has its own independent entrance. This allows parallel, separate events to be held. To the right of the main entrance into the central foyer is a chapel which also has an independent entrance.

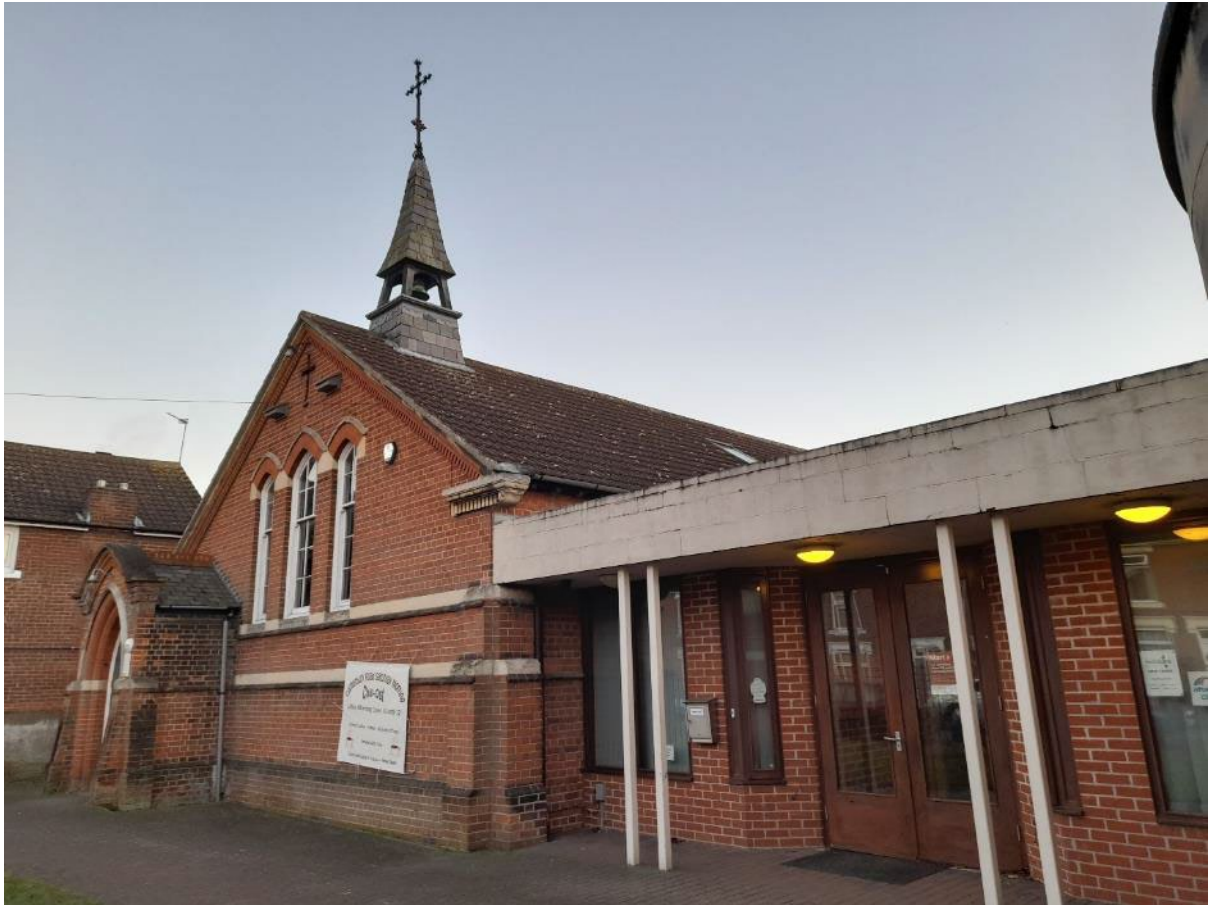
The entrance to the main foyer.

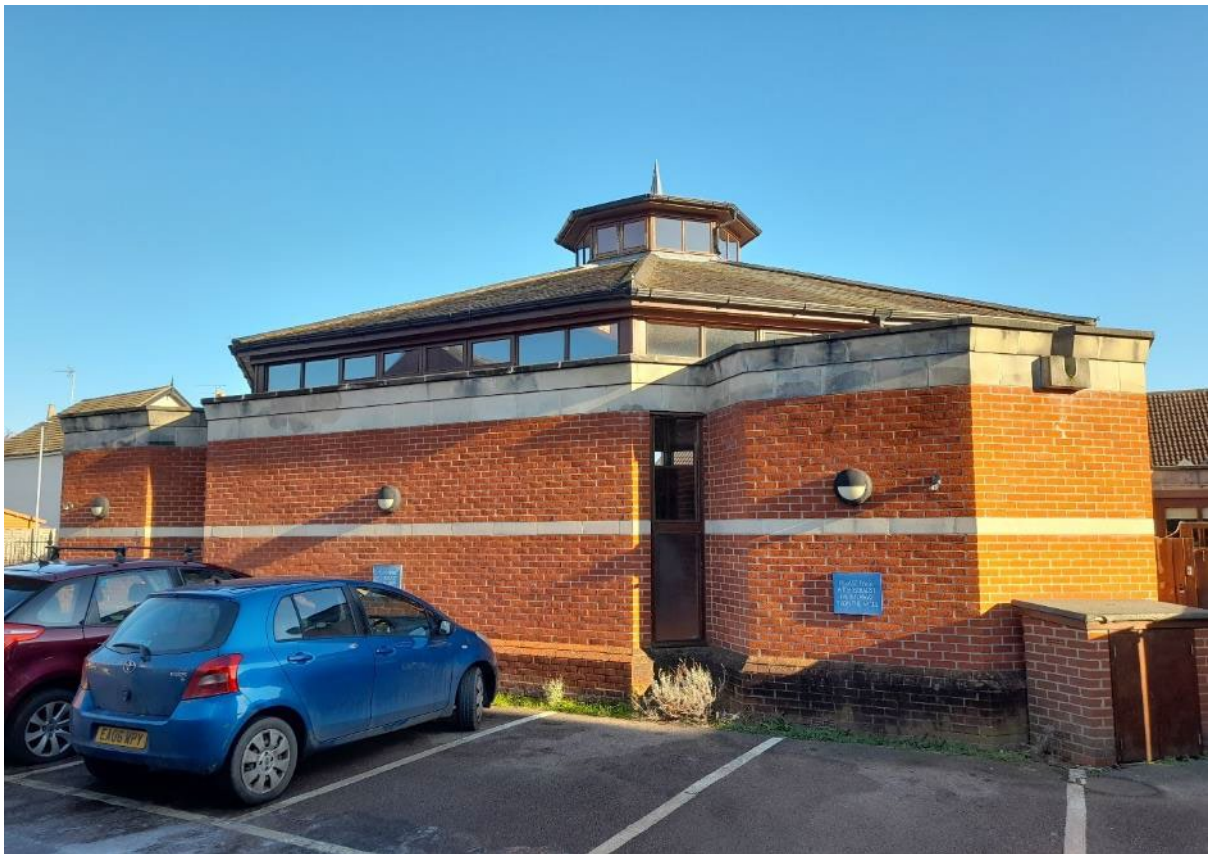
The worship area is surmounted by an octagonal cupola. Two of the eight sides lead to storage areas, one (above, right) containing the boilers.

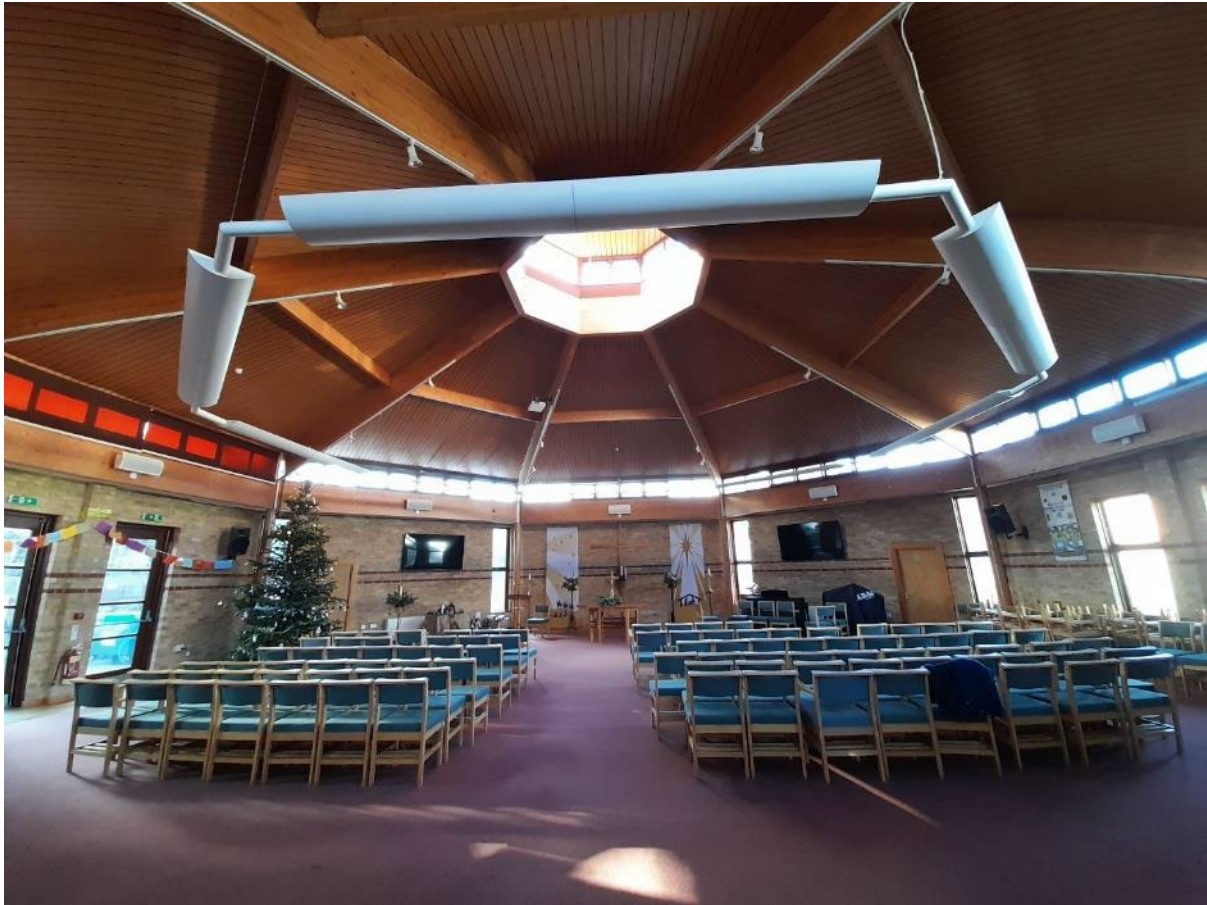
The worship area is seated by chairs and lit by fluorescent lighting, due to be replaced by LEDs.

The lighting makes up a relatively large overall energy proportion of the electricity used within the church, and large areas are lit by relatively inefficient large fluorescent tubes within the sanctuary and main hall. The work in the main hall should be scheduled as part of ceiling insulation works if this is proceeded with.

It is recommended that the fluorescent tubes are replaced by a form of LED lighting strip – not necessarily LED tubes sourced to fit the existing luminaires (which will have non compatible

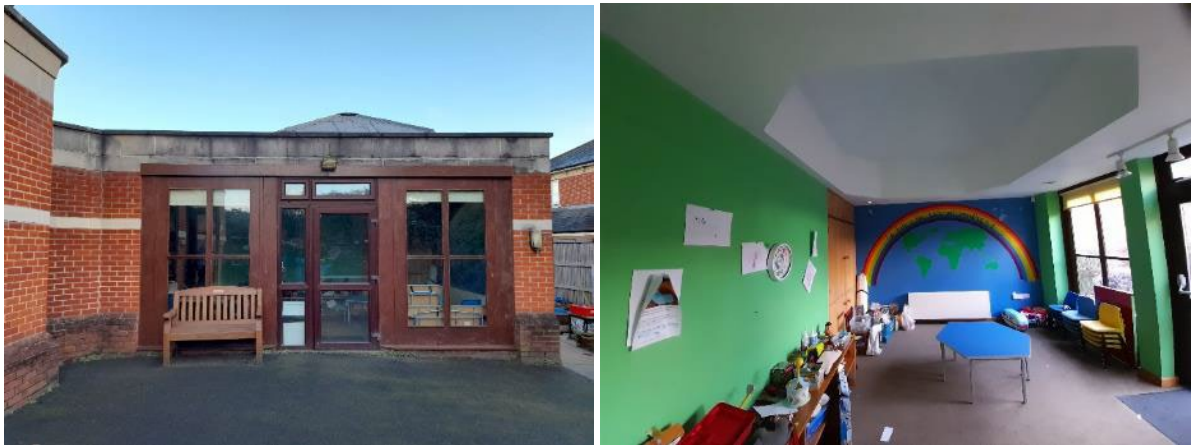
To the rear is a small room (the Playroom) which has potential for use for small meetings.

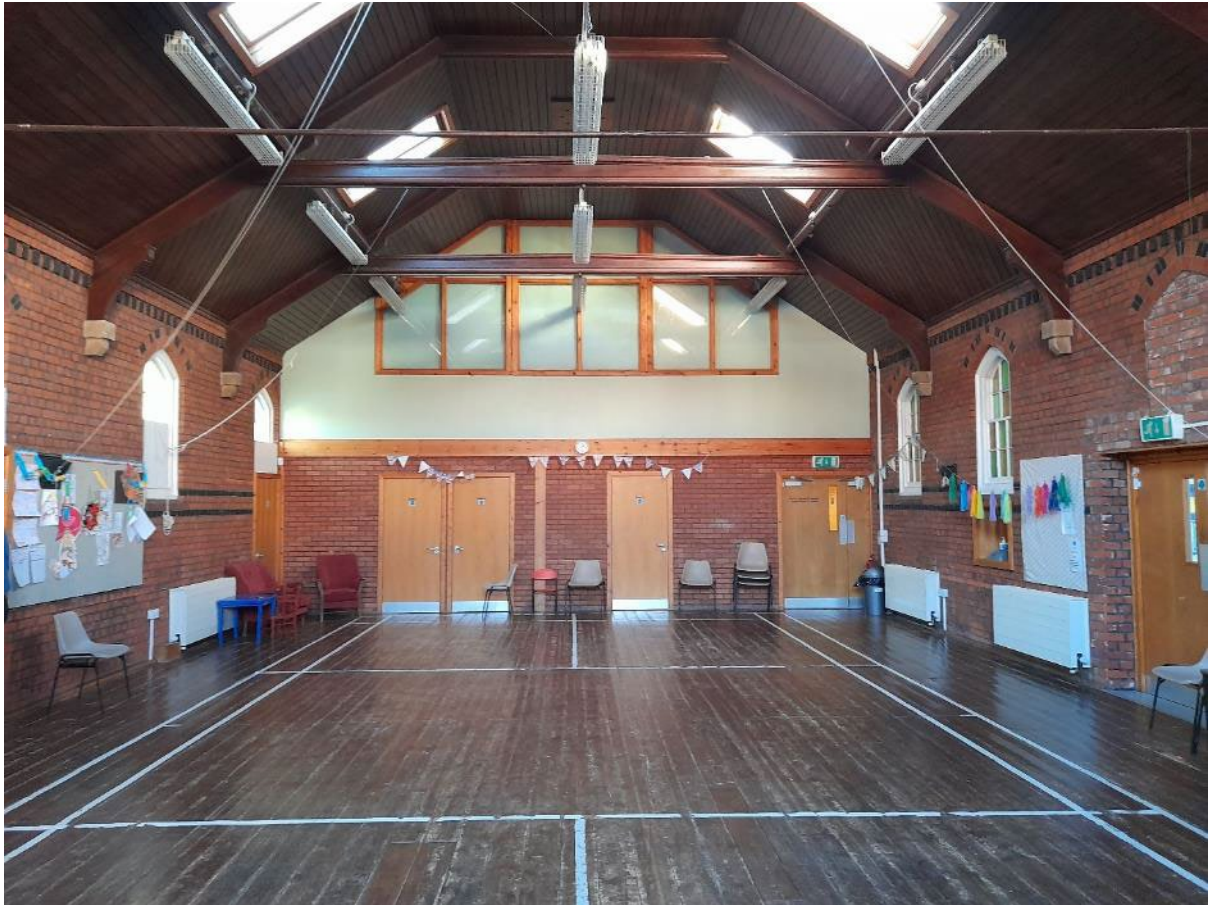
The 1902 hall has been subdivided with a mezzanine floor inserted at the south end which contains a room used for pilates classes.

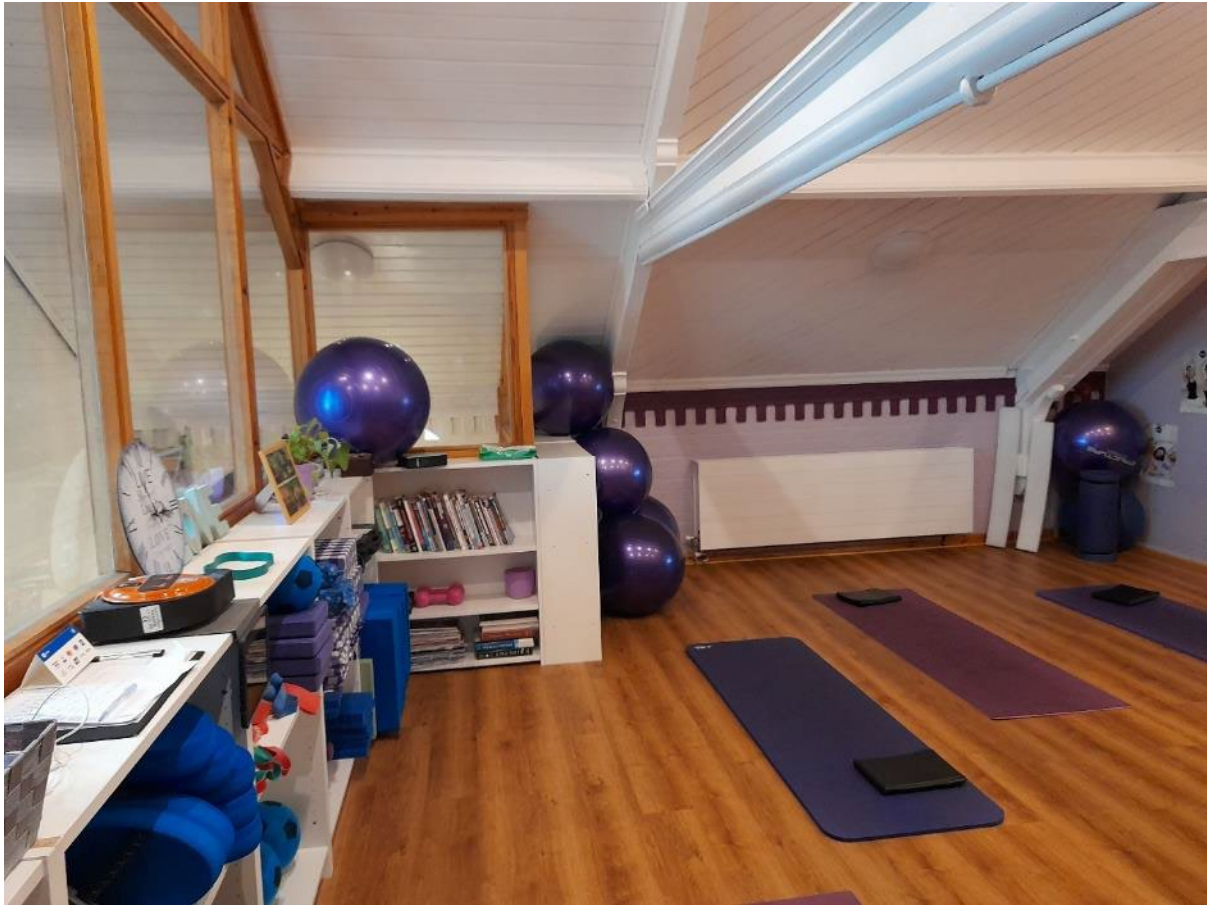
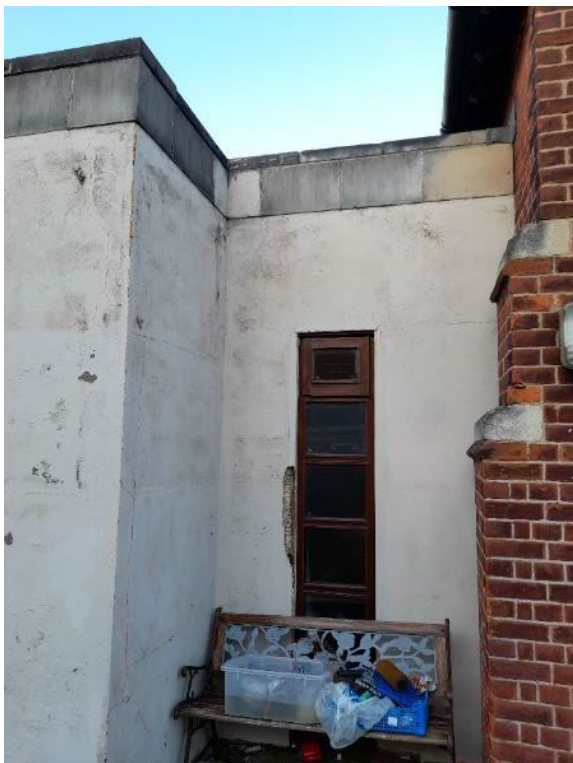
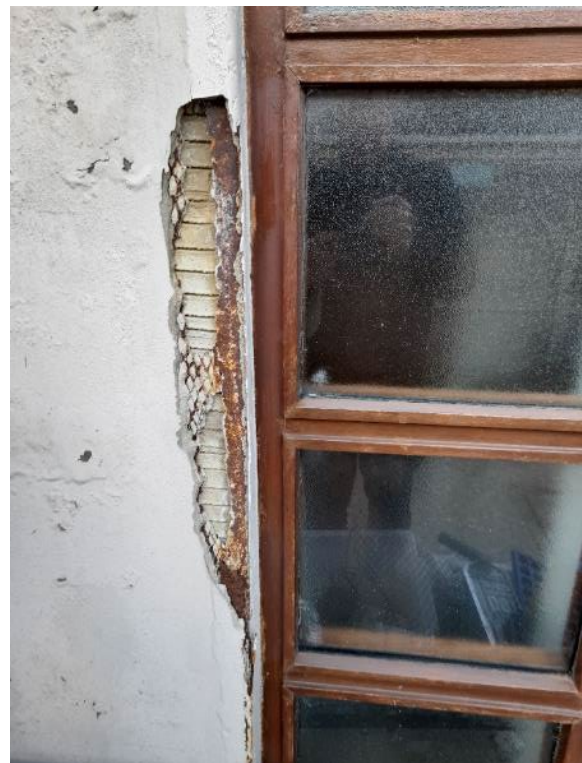
The construction suffers from various defects which are reported as resulting from wall cappings at the edges of the central flat roof area allowing water to penetrate the walls. Results include the render on the south façade of the playroom / disabled toilet / vestry detaching, mould growth on the wall indicating high moisture level and areas where the render has fallen away.

The sanctuary, which has an octagonal form is believed to have structural weaknesses at the eight corners.

The reasons leading to the problems are outside of the scope of this energy audit, but the issue of damp and water penetration which lead to greater energy use (as a result of the extra energy required to vaporise the water emanating from the wall surfaces) is relevant.

The church is embarking on a program of fundraising and remedial works which are likely to involve re-roofing and re-capping the walls in a water tight manner.

An overall recommendation is that, where roof covering replacement is to be undertaken, this opportunity should be used to ensure that roof insulation is either already present, or is installed up to the current standards.

This will require some preliminary work – assessment of the building plans and inspection of test areas to ascertain what insulation is present. If it is insufficient, installation of further insulation should be included as part of the work program – but structural engineering calculations will be necessary to ensure the roof structures are able to support the additional weight.

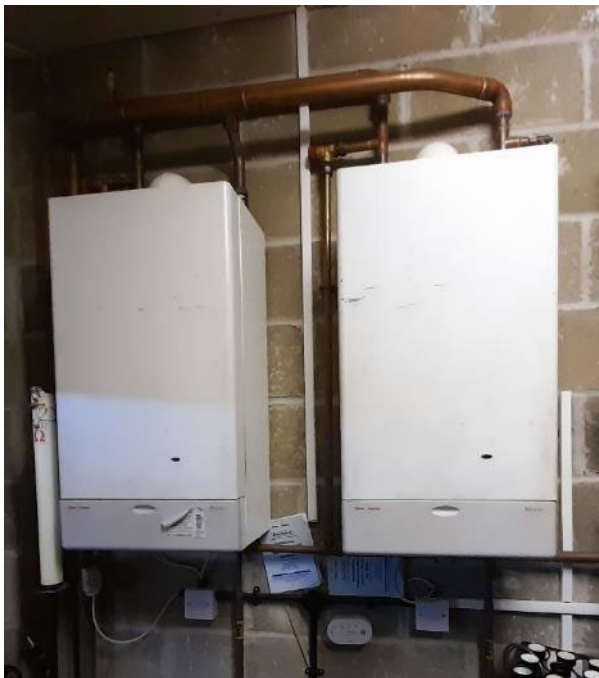
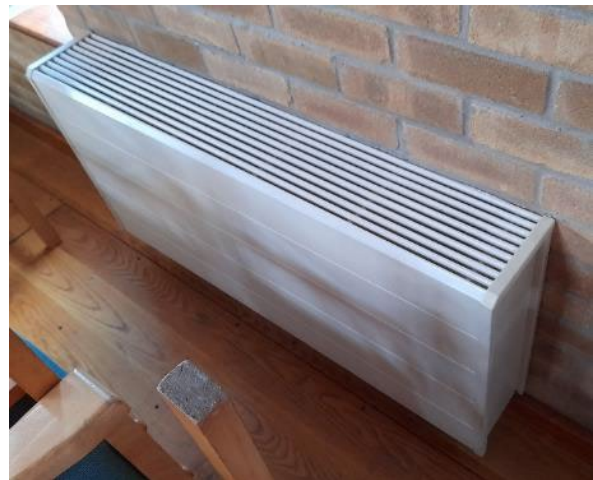
The site is heated by two Glowworm micro boilers giving a combined output of 65kW. These are about 20 years old. They serve the entire site, for which the 1902 hall has a heat loss of 32kW. The 2000 building, if fully insulated to modern standards would require 28kW heating (to maintain a stable temperature). Thin air gap (6mm) double glazing reduces this performance. It is unknown whether the roof insulation was installed to current thicknesses. The actual heat requirement is likely to be higher than 28kW. The sum for the whole site is around that of the boiler output.

In the years before the replacement of the existing heating system it is recommended that measures are taken to improve the efficiency of the existing heating system, this should include:

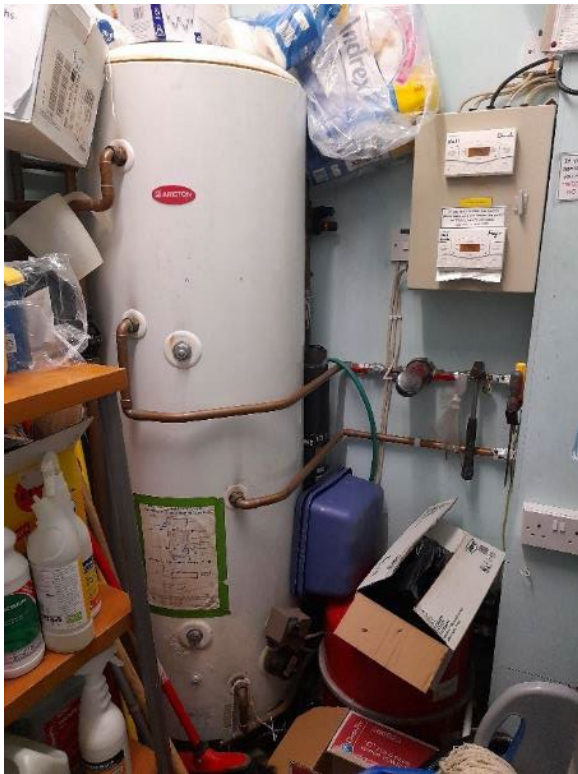
The current 300 litre tank appears to be sized to supply the shower room – which was described as never being used.

If showering facilities are required in future following heat pump installation, an electric shower should be provided.

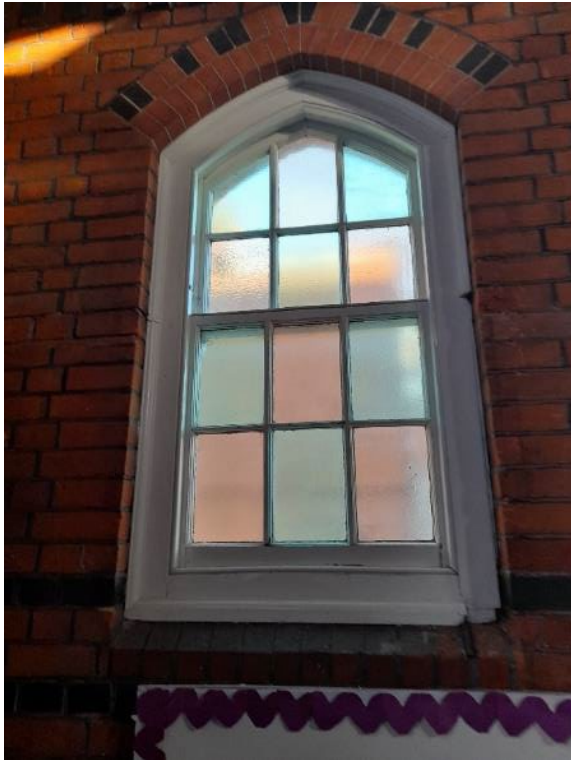
The single glazed sash windows in the 1902 hall were described as never being opened.

It is recommended that secondary glazing is installed.

Internal secondary glazing could be added to the wooden frame using acrylic sheet, attached by magnetic adhesive strips. There are companies who will supply sheet cut to size.

This would be at low cost (compared to ~ £500/m² for framed glass internal glazing units) and are removable (they are held in place by magnetic strips with adhesive backing).

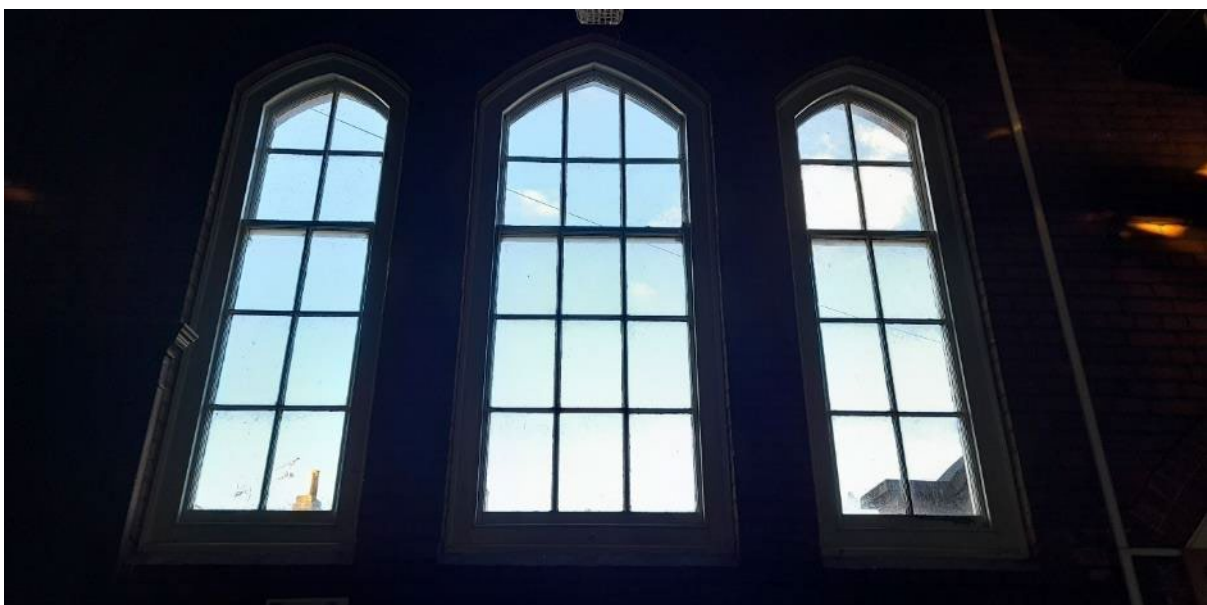
Secondary glazing should also be applied to the street facing three light north window of the hall.

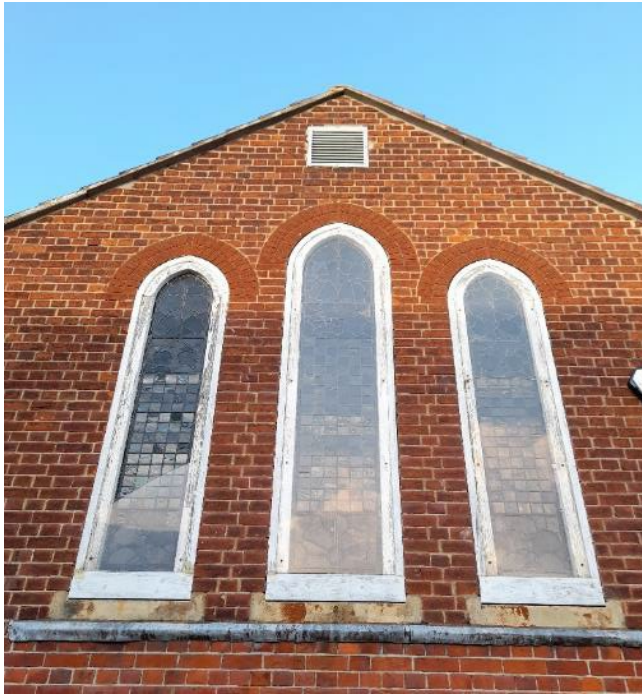
The south facing three light windows have been externally secondary glazed. One of the glazing panels (left) is broken and should be replaced. UV Protected polycarbonate sheet should be used (this prevents yellowing and prolongs lifetime). "Axcgard" is one such product.

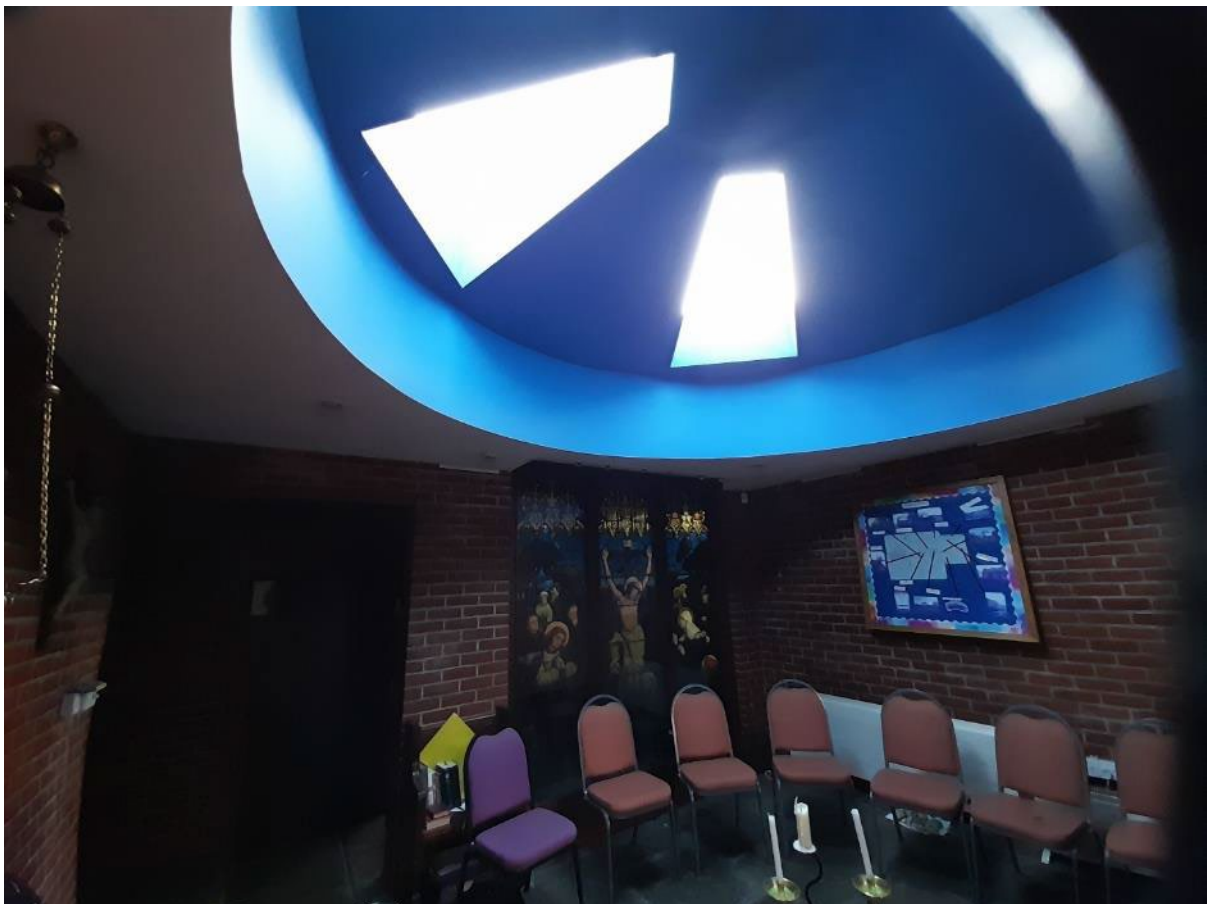
One of the skylights in the chapel is cracked – replacement should be costed as part of the roof refurbishment programme.

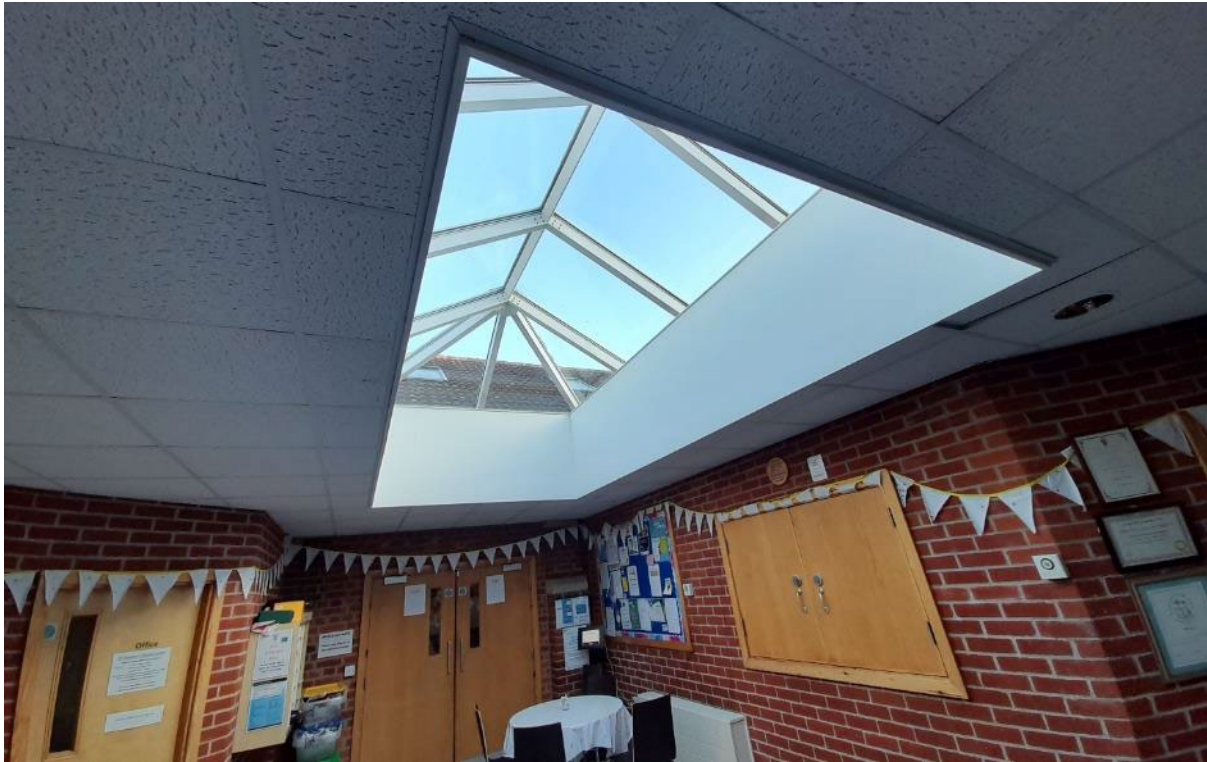
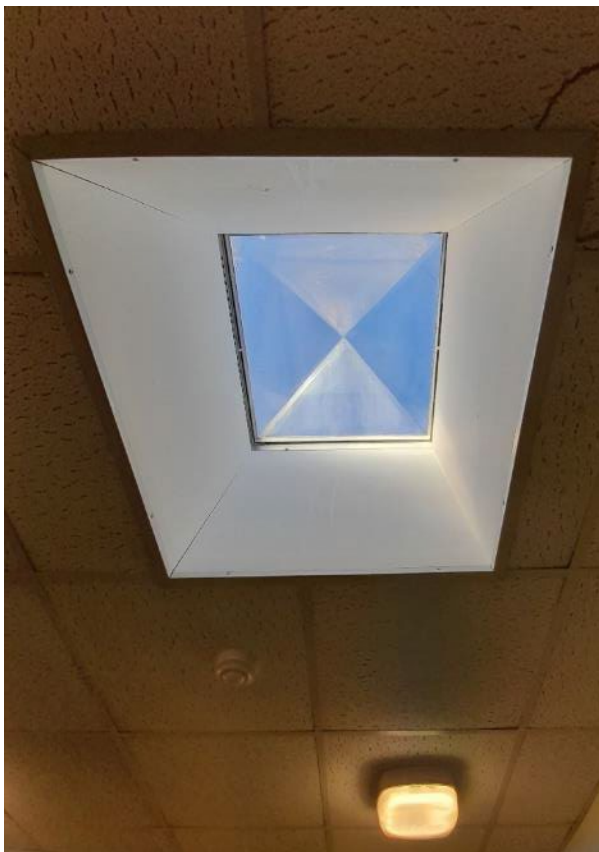
Skylights can import more light if the vertical portion is lined with highly reflective material. "Light pipes / light tubes / tubular skylights" incorporate collectors (covers) whose geometry maximises incoming light. The church may wish to consider incorporating these into the reroofing project for the centre to serve toilets and the rear passageway. This would reduce the amount of lighting needed, but only if the lights are controlled by presence detectors which also incorporate light sensors.

- As well as taking the opportunity of roof and wall repairs to ensure that the “new” building is effectively insulated, if the roofing is completely replaced, the skylights could be replaced by light pipes. If the skylights themselves are retained, fitting light pipe reflective tubing underneath to bring extra light down through the structure is recommended.

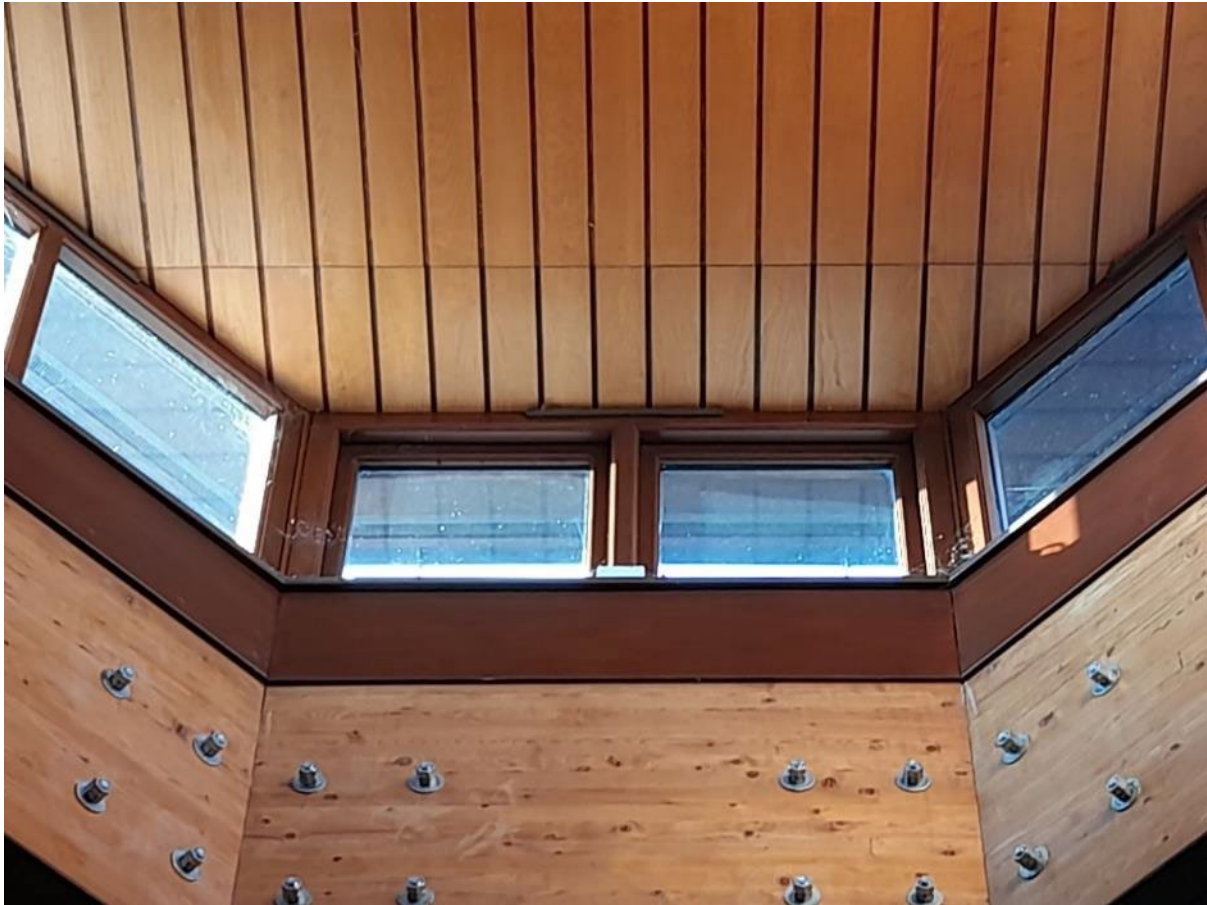
The glazing at high level around the worship area and the cupola above should be double glazed. If not, this should be provided on refurbishment (or secondary glazing added).
